Protection against rock falls, Sterling Mountain Tunnel, NC (USA)

7. Protection against Rock Falls, Sterling Mountain Tunnel, NC (USA)

Owner: North Carolina Department of Transportation
Engineer: Parsons Brinckerhoff Quade & Douglas, Inc.
Contractor: Oman Construction Co., Inc./ Jensen Drilling, Inc.
Works' Duration: 9 months for design and construction
Service Date: November, 1985

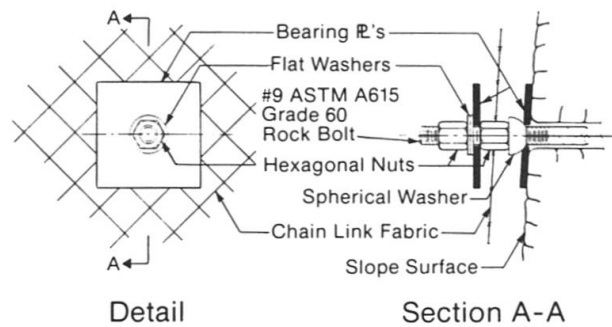
Fig. 2 Detail of chain link fabric/rock bolt assembly

Six major areas were stabilized by in-situ rock reinforcement. Loose small rock blocks were removed by scaling prior to reinforcement. Some large rock overhangs were removed by careful drilling and blasting. Reinforcement was provided by rock bolts 6 m in length, installed mainly on a 1.5 m by 1.5 m pattern. No. 9 (28 mm) ASTM A615 Grade 60 rock bolts were used. Galvanized chain link fabric was anchored to the rock bolts in one area to hold back small rock pieces that may break as a result of the blocky nature of the rock at that area. (Fig. 2)

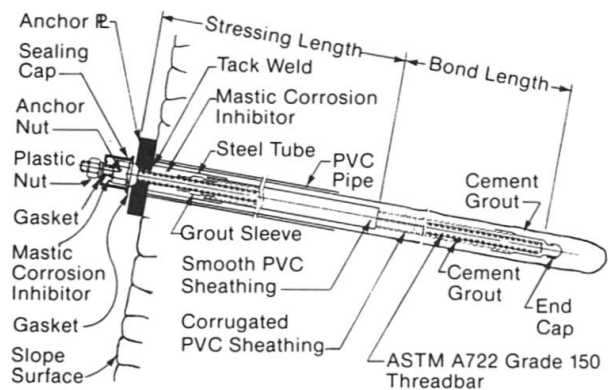
Fig. 3 Detail of high-strength rock anchor with double corrosion protection

Two potential large block failures were identified in an area of the slope parallel to the roadway. A large crack, 45 cm wide at the top, was measured behind two rock blocks 3 to 5 m thick. Because the loosened blocks were too large to be removed safely by blasting, they were stabilized by the installation of 12 m long high-strength bolts on a 3 m by 4.5 m pattern. Between these bolts, 6 m long rock bolts were installed at 1.5 m intervals vertically and horizontally to tie back smaller blocks and produce a final 1.5 m by 1.5 m pattern. Fig. 3 illustrates details of the high-strength rock anchors used on the project.

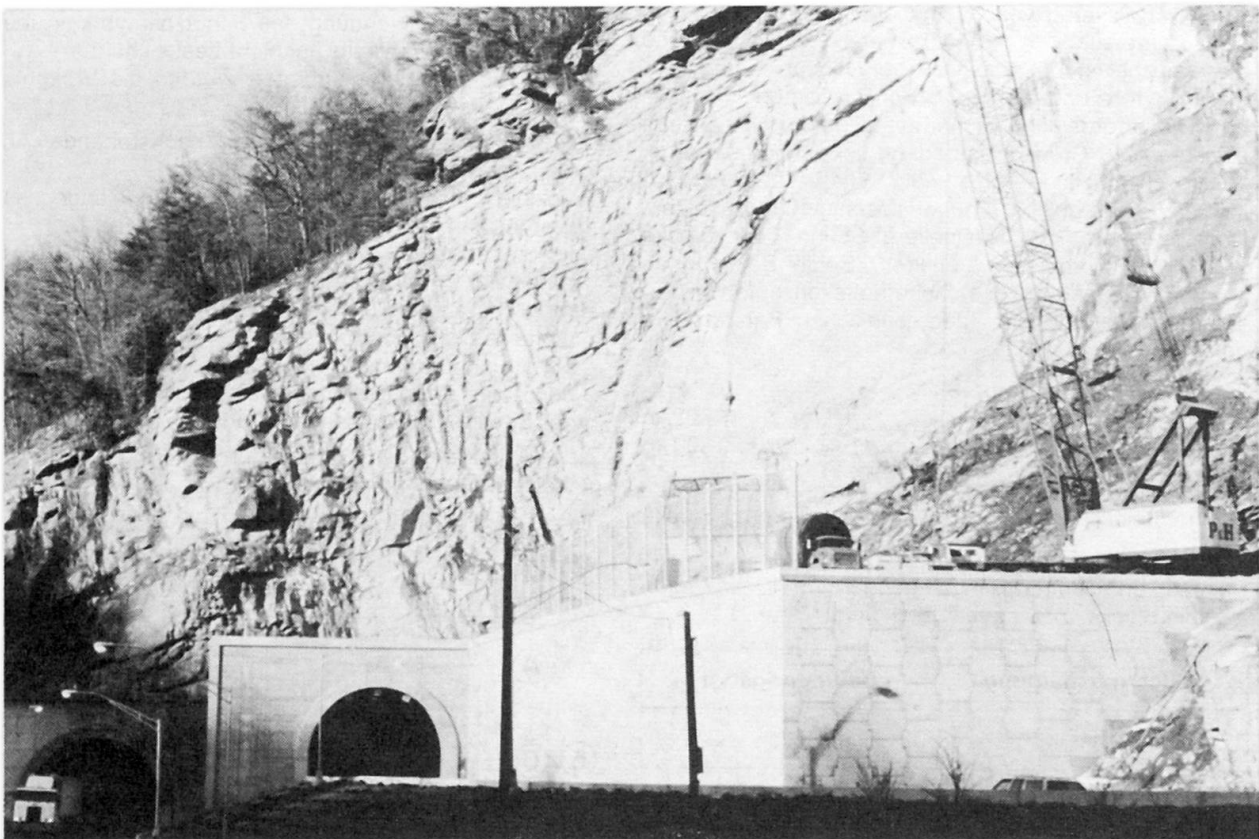
Fig. 4 Reinforced Earth wall with rock fence

A reinforced earth wall was constructed parallel to the roadway to protect the vehicular traffic from small rock pieces that may move down the rock slope in the future. The wall and its reinforced embankment will serve as a buffer zone between the roadway and the rock slope absorbing the kinetic energy of the falling rocks, and accumulating loose rock behind a rock fence erected above the retaining wall. Aesthetic benefits were also derived from the reinforced earth wall configuration.

Three types of retaining walls were considered for the project: a reinforced earth wall, a gravity-type interlocking concrete modules wall (Doublewal) and a concrete-faced tie back wall. The reinforced earth wall was the most suitable considering schedule, cost, aesthetics and construction requirements. The constructed wall had a constant height of 10.6 m above the roadway and a 90 degree end wall abutting the rock face (Fig. 4). Partial excavation of the rock was required near the portal to accommodate construction of the reinforced earth embankment. The rock fence consisted of 4.5 m high mesh chainlink fabric tied to standard pipe rail and extra strong pipe posts anchored 2.5 m in the compacted reinforced earth embankment. The construction time including materials procurement was about two months for the 63 m long wall.
