Artikel: Ohara Bridge fatigue crack repair (Japan)
Autor: Miyazaki, Shoji
DOI: <https://doi.org/10.5169/seals-20936>

6. Ohara Bridge Fatigue Crack Repair (Japan)

Owner: Toyama Prefecture
 Engineer & Contractor: Kawada Industries
 Work's duration: 6 months
 Date of repair: 1984 – 1985

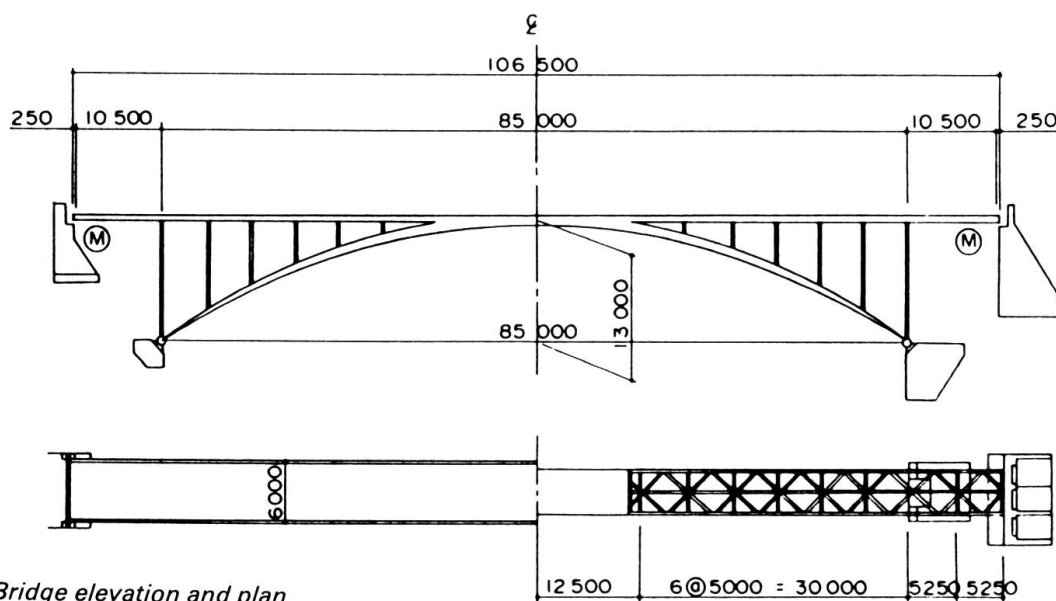
Fig. 1 Bridge elevation and plan

The Ohara Bridge is a two-hinged arch bridge with the bridge span of 106.5 m and the roadway width of 6.0 m, completed in 1963 (Fig. 1). This bridge was designed with the longitudinal support condition as being movable at both ends and had a single box construction with arch ribs having a very small depth. After the elapse of more than 20 years since its erection, fatigue cracks occurred in parts of the members of this bridge, mainly due to increased traffic volume in recent years and frequent passage of heavy motor vehicles associated with dam construction work. Therefore, this bridge was repaired to reinforce the members against loads.

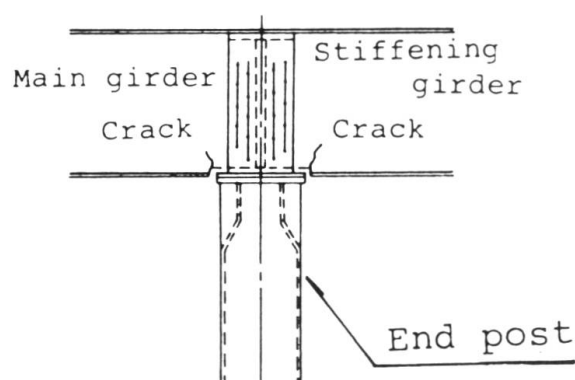
Fig. 4 Location of crack

The fatigue cracks occurred at the connecting gusset plates to each panel of intermediate post, which connects the stiffening girder to arch rib (Fig. 2, 3), and also at the web of stiffening girder above end post, which is the joint between center span and side span (Fig. 4, 5). These cracks were found by visual inspection during patrol in 1982.

According to the results of liquid penetrant tests conducted immediately after finding them, the maximum length of the cracks was 65 mm at the gusset plate of intermediate post, respectively 185 mm at the web of stiffening girder.

With respect to the fatigue cracks in the web of stiffening girder above the end post, the stress concentration by secondary bending stress at the notches, which also resulted from out-of-plane displacement, was found to

Among these cracks, a temporary repair was made for the cracks in the web of stiffening girder immediately after finding them in order to prevent a rapid breakdown as explained below. That is, stop holes were drilled at the end of all cracks in the web. Moreover, steel brackets were installed on all end posts and were used as temporary supports for stiffening girders in side span and center span.
