# Post earthquake construction of Gediz

## POST EARTHQUAKE CONSTRUCTION OF GEDİZ

Aybars Gürpınar

Associate Professor of Engineering Sciences  
Earthquake Engineering Research Institute  
Middle East Technical University, Ankara Turkey

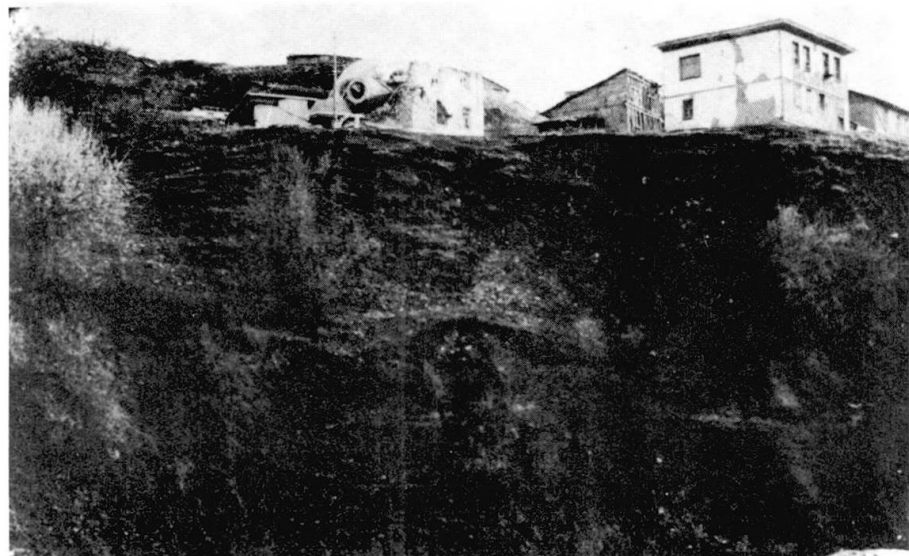
The town is located in the valley of a river of the same name, (Figure 1). In the center of the town a peculiar basaltic formation underlying rubble dominates the scenery, (Figures 2 and 3). The river runs through this formation leaving a strip of narrow flat land on each side for suitable habitation. However, this land was densely populated before the earthquake. Although not as densely as this part; the 'castle' (as the basaltic formation is locally called) also provided habitable land to a considerable population.

Figure 3. Ruins of a Mosque on Basaltic Formation

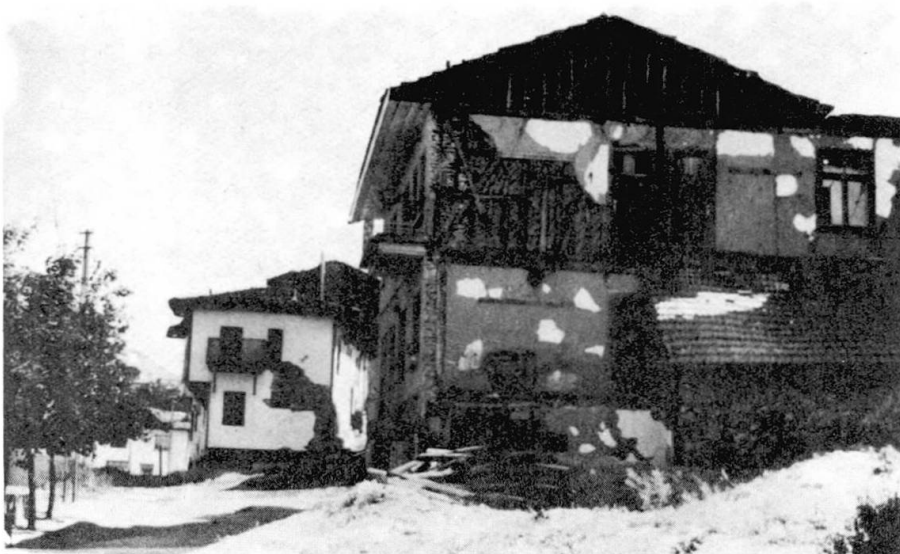
By far the most common residential type of construction in Gediz is wood frame. A typical Gediz house of this type (*Hıms*) may be seen in Figure 4. The major deficiency of this type of construction during an earthquake is the danger of loose infill, improper diagonal bracing and poor masonry foundation. A more refined version of this type of construction may be seen in

Figure 4. Typical Wood Frame Structure (Hımsı)

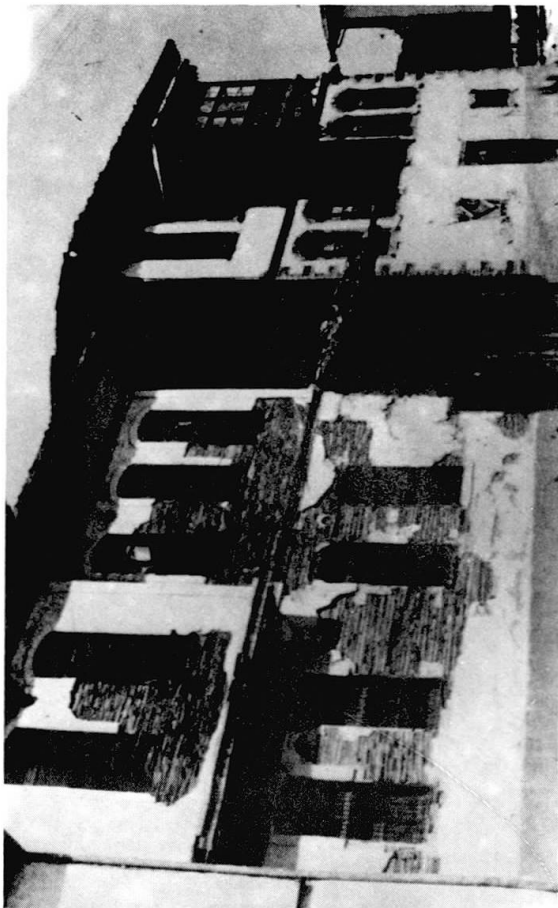
Figure 5. The first two points of deficiency are generally taken care of in this type (Bafidadi) of construction.

Figure 5. Typical Wood Frame Structure (Baghdadi)

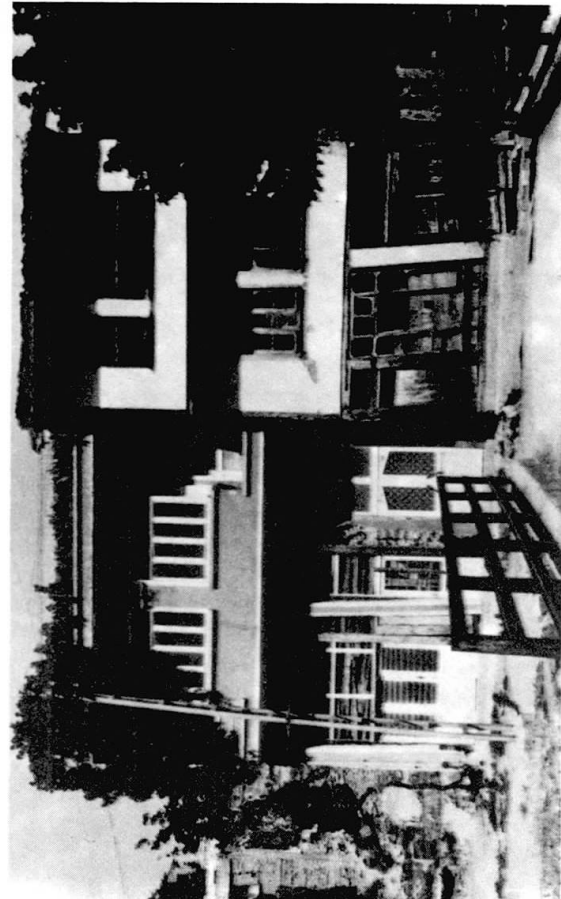
The major causes of failure for wood frame structures were spilling of loose infill material, inadequate cross bracing and poor foundation. Sidesway of one such building due to inadequate cross bracing may be seen in Figure 6. On the whole, however, wood frame structures behaved exceptionally well during the earthquake.

Figure 6. Sidesway Caused by Inadequate Cross Bracing

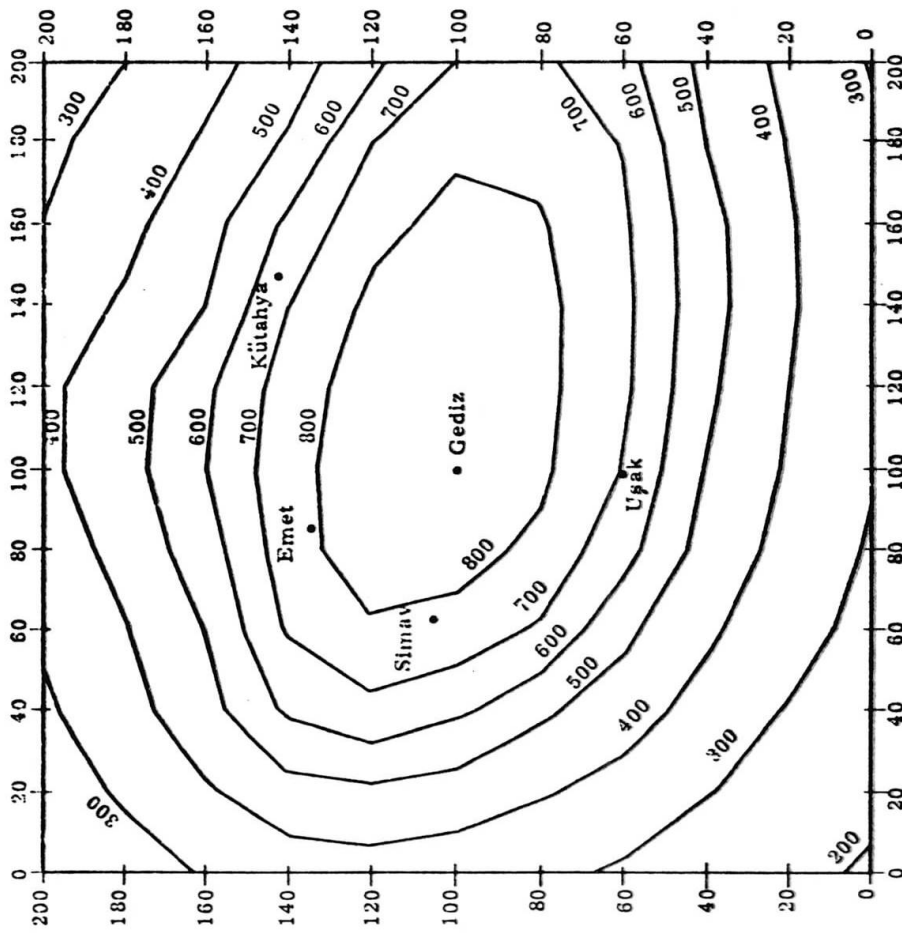
Iso-acceleration contours for 20% probability of exceedance and 50 year time period may be seen in Figure 7. Peak ground acceleration values for some towns in the region are as follows: Gediz, 850; Emet, 780; Simav, 770; Uşak, 690; and Kütahya, 640; all in gals.

It should be pointed out that New Gediz which is only 8 kms south of the old town is still within the 800 gal contour. Although Gediz has the largest peak ground acceleration value for given probability of exceedance and time period, the difference between Gediz and other towns (such as Emet and Simav) is not appreciable enough to decide against habitation in Gediz. The risk curves for 1, 20 and 50 year periods may be seen in Figure 8.

Figure 7. Iso-Acceleration Contours for  $P(A>a) = 0.20$   
50 Years

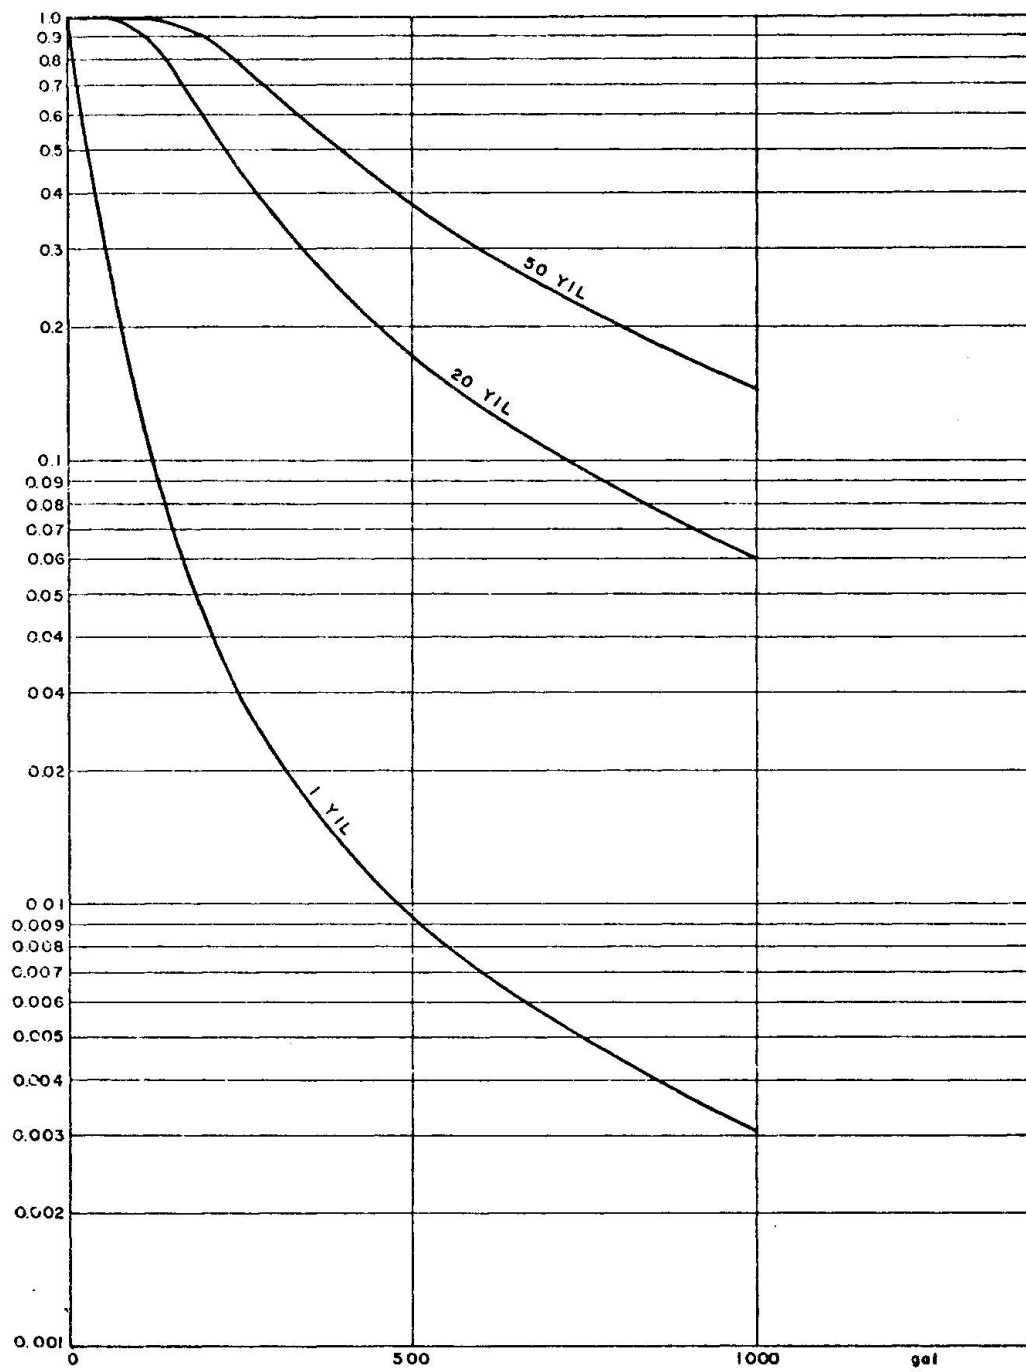
Figure 8. Seismic Risk Curves for Gediz- 1,20,50 Years
