BEHAVIOUR OF AN ASEISMIC STRUCTURE  
DURING CAUCETE EARTHQUAKE  
OF NOVEMBER 23, 1977

SILVESTRO BRUSCHI

TECHINT Engineering Company

S U M M A R Y

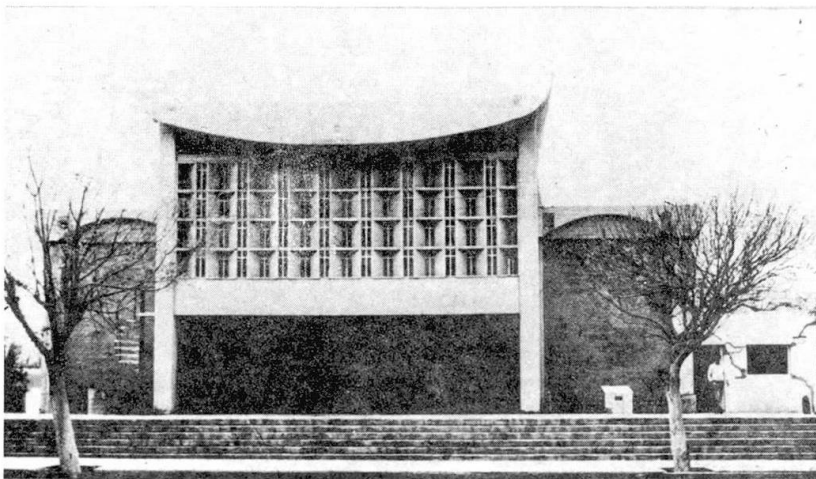
Fig. 1 - Front of the Church

Building examination after the earthquake reveals no damage in the reinforced concrete elements. The front brick walls show limited cracks, while there are no apparent cracks in lateral walls, but inner plaster spalled in wide areas. Some glass breakage in windows occurred (approx. 10 %), and light damages in masonry can be seen at both sides of apse, where roof shell touches the wall.
