## **Some Remarks on the Service Behaviour of Steel Railway Bridges**

**R.A.P. SWEENEY**

CN Rail

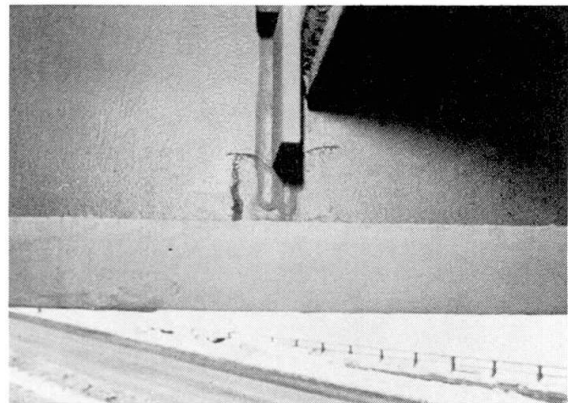
Fig. 4 "U" shape crack

The first group of problems to turn up on our railway on welded structures were cracks at the bottom of stiffeners on skewed structures. Figure 4 is typical of this detail with a diaphragm or brace frame attached to the stiffener. Note that the stiffeners are not extended to the bottom flange. This was in blind obedience to the dictum of an early researcher in welded construction that one should not weld to the tension flange. Because of the stresses introduced by the differential deflections of the connected girders, and to small out-of-plane movements, the first cracks appeared in less than 5 years on heavily travelled lines.

The crack would start at the bottom of the stiffener and form a "U" shape crack around the bottom of the stiffener. If the original stiffener-web weld was of good quality, this crack would turn out into the web and slow down considerably.

Unfortunately in many cases the only adequate cure is not to have the detail in the first place. If the crack isn't going to go anywhere, and if it has not damaged the structure too severely, it is best left alone as the retrofit may make things worse. Cracks at the bottom of stiffeners tend to be in this category.

If the structure cracked because it was restrained from movement and if movement is essential to its function, as in the case of a skew-girder, then a repair of the existing detail will be of no value. In fact it may not crack in the same place next time but at a more serious location. In addition to the obvious differences in vertical deflection of skewed girders, one should consider conceptually that torsion in a girder will occur in the part most capable of rotating. The flange is generally much stiffer than the web, particularly in the space between the stiffener and the bottom flange, and any girder rotation (out-of-plane movement) will be forced to occur in this small

space. Needless to say the stresses will be enormous. To solve the problem, the stiffeners must be run down to the bottom flange, or cut back far enough to relieve the stresses, or the source of rotation removed. If the stiffeners are connected to the bottom flange in a high positive moment area, this may entail a reduction in capacity.
