# Restoration and widening of the Tasman bridge

Autor(en): **Lee, D.J. / Crossley, B.K.G.**

Zeitschrift: **IABSE reports of the working commissions = Rapports des commissions de travail AIPC = IVBH Berichte der Arbeitskommissionen**

## **Restoration and Widening of the Tasman Bridge**

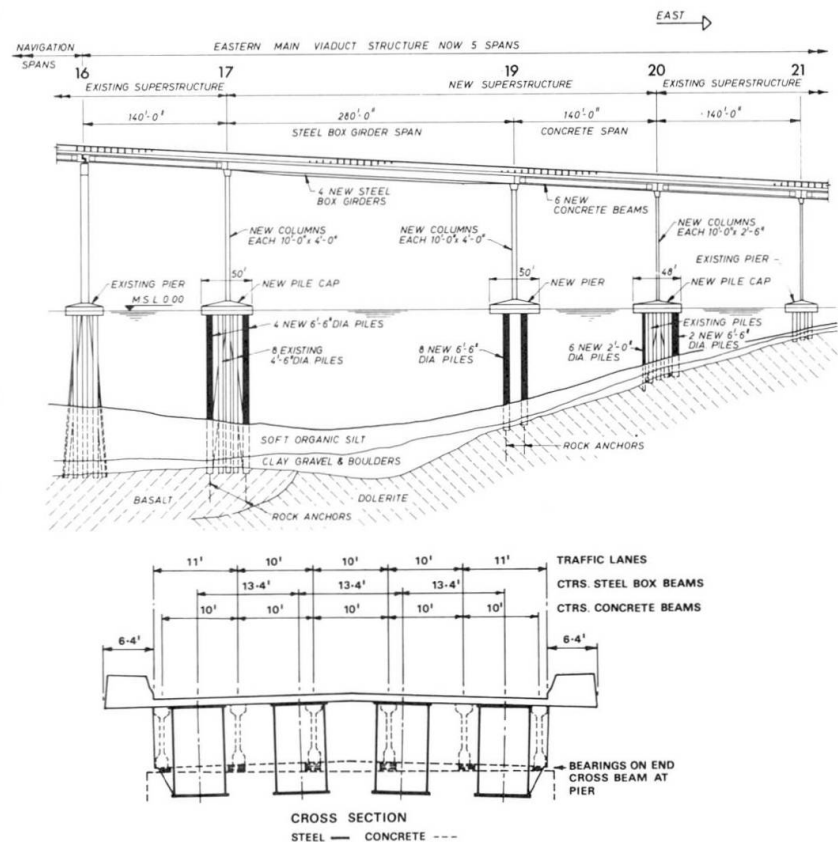
Fig. 4 Details of restoration

The method adopted is shown in Fig. 4 and has been reported on previously by LESLIE [7] and [8]. As the broken 1.4 m diameter piles at Pier 18 (40 m to bed level being the deepest part of the river), rose 15 m above the mud level this pier was omitted and the method involved the replacement of the three fallen spans by two spans; an 85 m steel span 17-19 and 43 m concrete span 19-20. Cross-sections are shown in Figs. 6 and 7. The scheme involved 14 new 2 m diameter vertical piles rock anchored at the base, some of which were to be used both as falsework piles and permanent piles. Foundation conditions were predetermined using one borehole per pile and were good, consisting of almost fresh dolerite at Piers 19 and 20 and partly weathered basalt at Pier 17. At Piers 17 and 20 the existing columns and pile caps had to be demolished and replaced. At Pier 17 additional piles, working in conjunction with the eight existing 1.4 m diameter raking piles, a bigger cap, and heavier columns were required to resist the greater loads from the double span. At Pier 20 there are no additional loads, but it was considered necessary to replace the badly damaged pile cap and columns, and the falsework piles required to achieve this were incorporated into the permanent structure, although not strictly required from a strength viewpoint. As there was a considerable time saving involved, the replacement of the substructure at these two piers was to be undertaken without demolishing the flanking spans (total mass 1,250 tonnes each) supported by them.

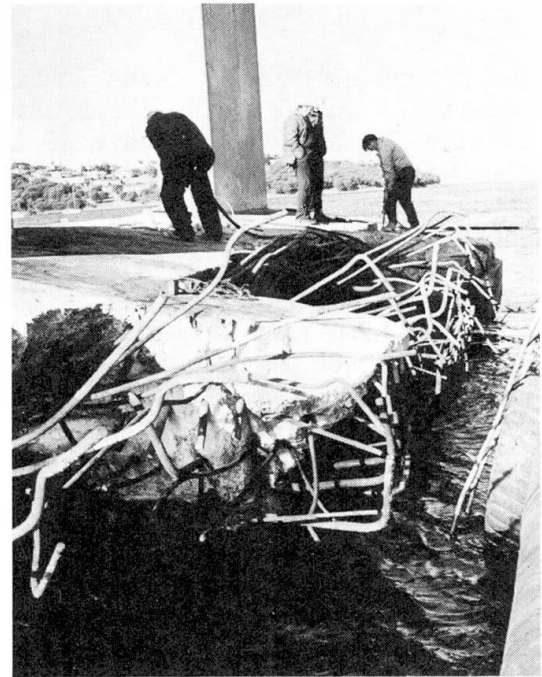
The security of Pile Cap 20 was more difficult as it had lost about one third of its volume (Fig. 5) and the remainder was extensively cracked and in some places crumbled. Its load carrying capacity was unknown and although it had to be replaced later it was decided to do temporary repairs before any major work commenced. These were in two parts:-

Fig. 5 Damage to Pile Cap 20

- Replacement of the concrete which had been removed without attempting to repair or remove and replace the cracked concrete.

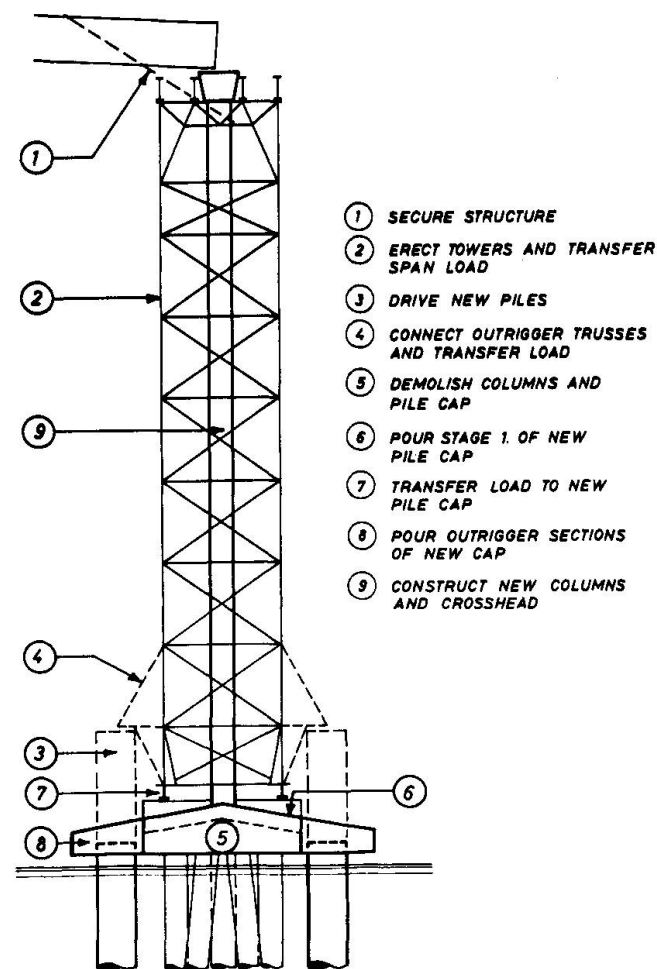
Fig. 8 Pier 17 construction sequence

The steel towers fulfilled many functions, including support of existing spans during column demolition, bracing for new concrete columns during construction, supports for the erection derricks and landing points for the new beams. The construction sequence involved in the use of the tower at Pier 17 is shown in Fig. 8.

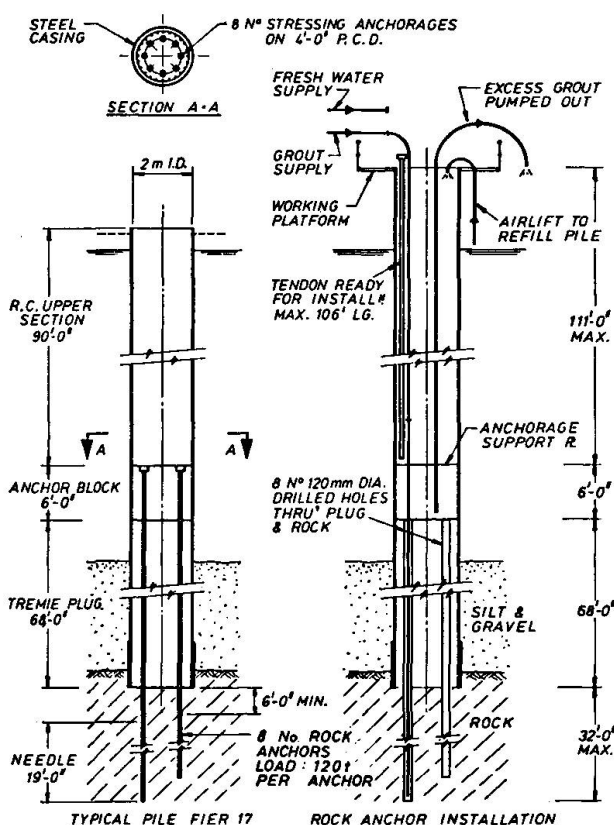
Fig. 7 Pile details

Details of the new vertical piling are shown in Fig. 7. 2 m diameter was selected as being the largest size which could be

reasonably handled. Base fixity to the piles was provided by means of rock anchors. At Pier 19 where all piles are vertical deck deflection under a 45 m/sec. transverse wind is 40 mm being 1 in 1,500 of the deck height above foundation level. The maximum loads per pile at this pier were 10,630 kN and 4,650 kNm.

The principle design features of the piles were; casing designed to be dewatered; reinforced concrete tremie plugs (40 MPa) to give F of S against flotation of 1.1; rock anchors designed for maximum corrosion resistance and each one tested in accordance with FIP recommendations. For safety reasons the test load was 70% UTS and lock off load 54% UTS.

At Pier 17 due to frequent rock joints the anchor holes could not be sealed and the installation method was modified to enable anchors to be grouted in a flooded pile (Fig. 7). Individual holes were kept grout filled while the grout leaking into adjacent holes was flushed out. A reservoir at the top of the plug enabled the grout quality to be monitored by underwater TV camera while visibility was maintained by downward circulation of fresh water.

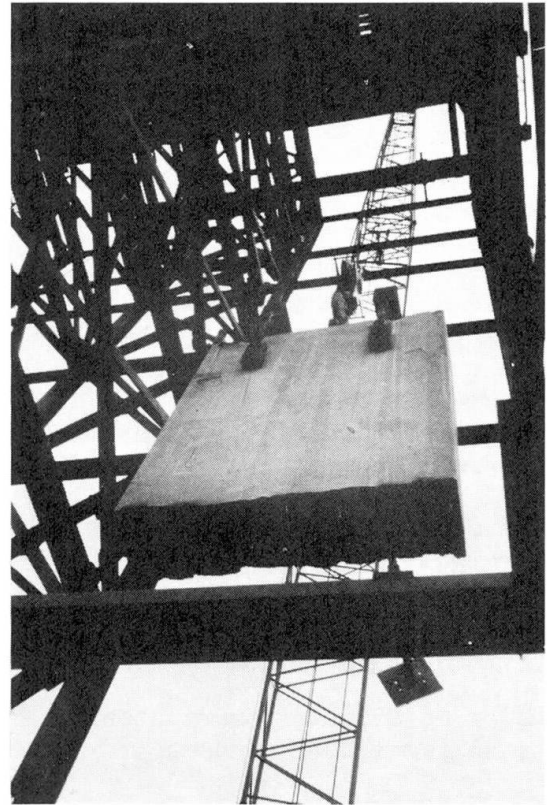
Fig. 9 Column demolition

The original columns were made up of precast concrete blocks, vertically stressed together with Macalloy bars. They had a cross-section of 3 m x 0.75 m and were cut horizontally using a thermic lance and hydraulic wedge splitters. The 25 tonne pieces were lifted out through the top of the falsework tower (Fig. 9). Twelve working days were required to remove the two legs of the Pier 20 column.

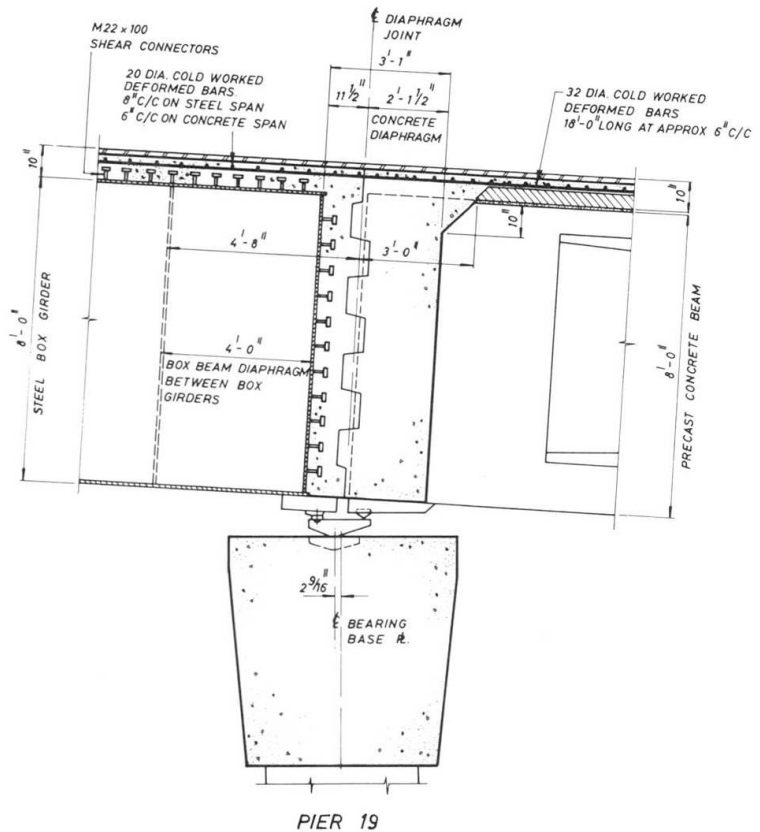
Fig. 10 Continuity connection steel/concrete spans

the finite element analyses of the end crossbeams. The continuity detail between the steel and concrete spans over the piers (Fig. 10) was similar to that used in the original design.

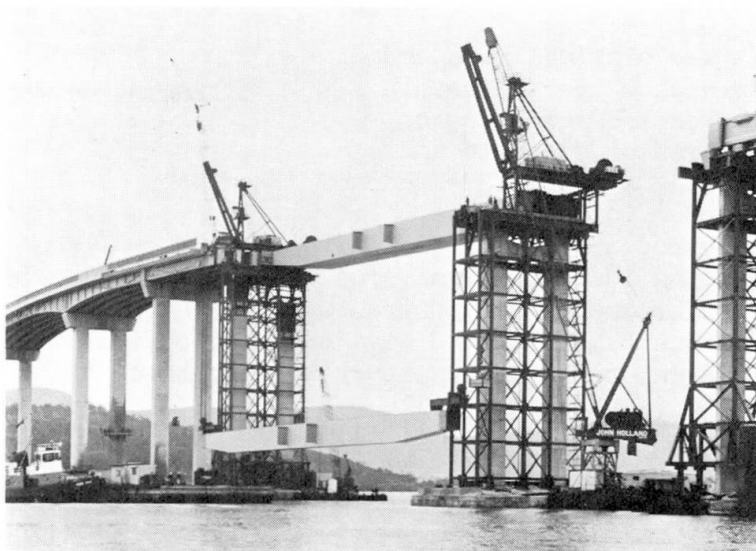
Fig. 11 Box girder erection

The adopted scheme used luffing 'A' frame lifting derricks specifically designed by the Contractor for the purpose (Fig. 11). By using temporary cantilever extensions at the ends of the boxes, they were lifted outboard of the towers as a single unit and positioned on top of the towers. The boxes were towed to site on a barge and then lifted. The operation from mooring of the barge to lifting the girders 40 m, and positioning them on temporary bearings on the falsework towers took about 20 minutes.

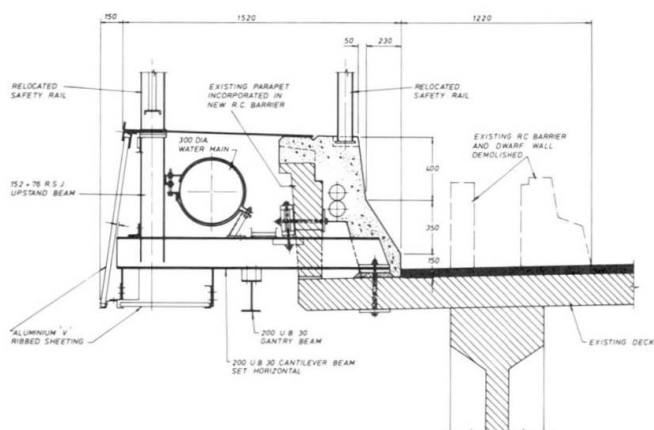
Fig. 12 Bridge widening details

While the bridge was out of service the opportunity was taken to widen it from four to five lanes over its full length. This permitted the operation of a rather more comfortable 3:2 tidal flow system rather than 3:1 as previously. The widening was achieved by cantilevering new footways and using the existing concrete deck for the five lanes (Fig. 12).

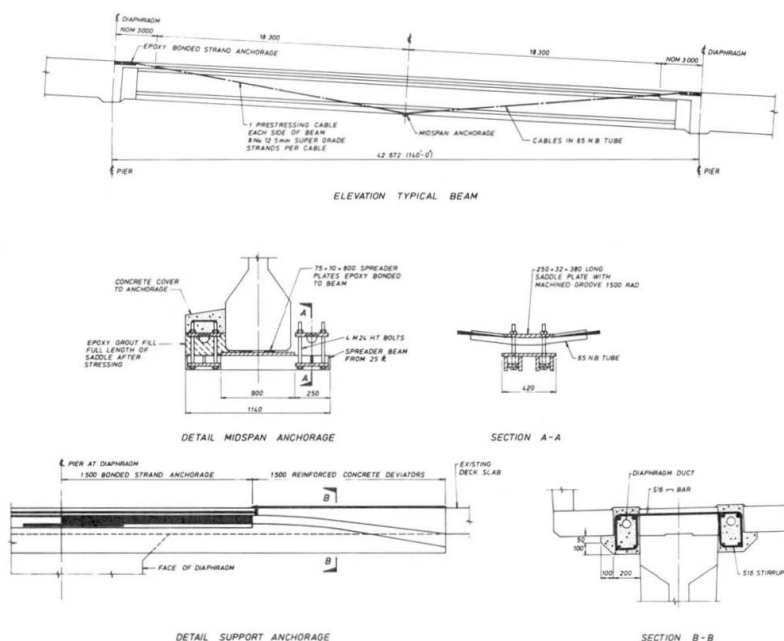
The 42.7 m span, prestressed concrete beams in the main viaducts were constructed segmentally. Due to the extra load from the widening, the outer beams were in tension at working loads and for serviceability reasons it was decided to

Fig. 13 Beam strengthening details

strengthen them by adding external tendons in a "Vee" shape one on each side of the web (Fig. 13). The tendons were 8 x 12.5 mm strands grouted into a 75 mm steel pipe and were stressed by pulling them down at mid span, and anchored by bolting to the mid span saddle to give an uplift force of 38 tonnes.

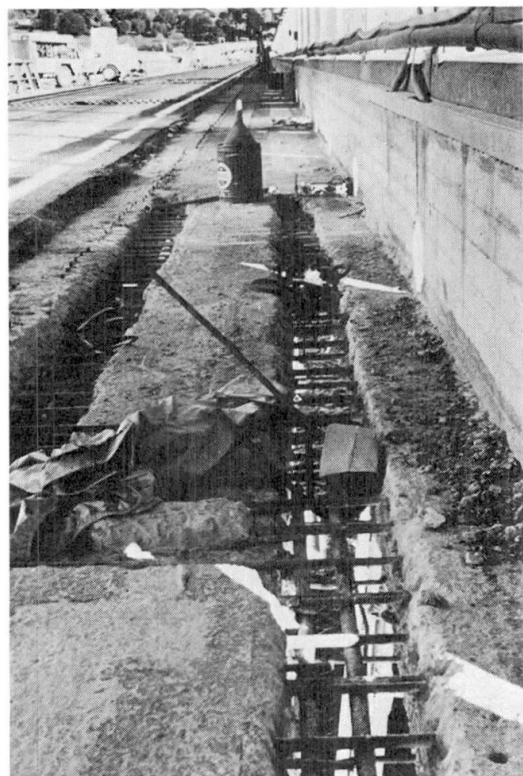
Fig. 14 Slots

It was originally intended to anchor the tendons in the deck by breaking out an area of concrete and casting a traditional anchor block. To reduce the required demolition and avoid cutting the main transverse deck reinforcement, the Contractor, Pearson Bridge (Tas.) Pty. Ltd. proposed cutting a slot 3 m x 200 mm (Fig. 14) into which the bare strands were anchored using an epoxy with fillers. The method worked very well.
