Artikel: Fatigue failures of steel railway bridges in China
Autor: Yongji, Shi / Zegan, Chen / Yenman, Yang
DOI: <https://doi.org/10.5169/seals-28950>

Fatigue Failures of Steel Railway Bridges in China

SHI YONGJI

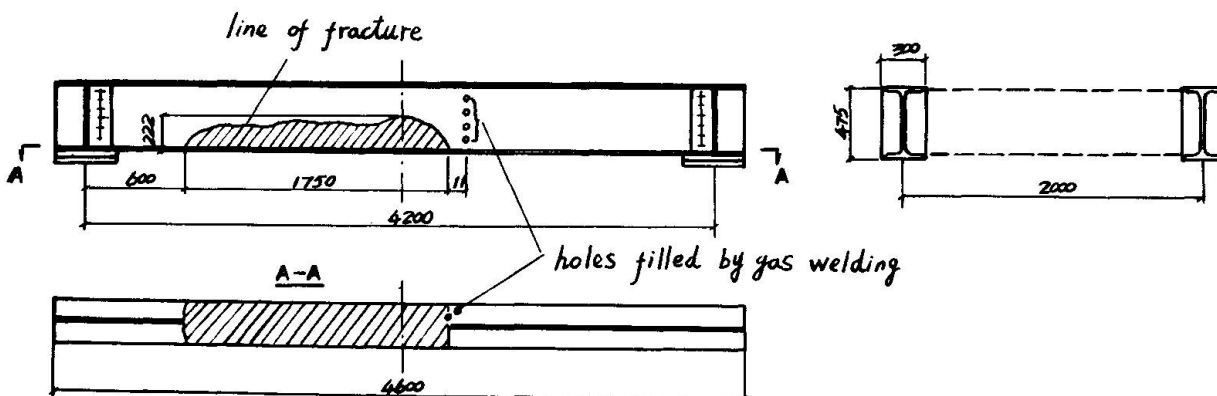
Fig 1 Sketch of the girder bridge No. 248 and its failure location

Bridge No. 248 on the Beijing-Baotou Railway Line was a rolled I-beam bridge which was manufactured in Britain in 1898 and erected in 1903. Its original length was 7 M and was cut down to 4.6 M in 1947 to be used as a simple span. There were four drilled holes of $\phi 19$ on the webs and two on the bottom flanges. These holes were filled later by gas welding when it was cut. It so happened that at about 11 o'clock in the morning of November 30, 1967, after a heavy snow fall, a large piece of flange metal broke off together with a portion of the web. Fig 1 is a sketch of the girder and the failure location. Photo 1 is the fallen off piece. From the fracture surface, we could find that the weld quality was very poor. Under repeated action of train load through a long period of time, fatigue crack was initiated at the notch (Photo 2).

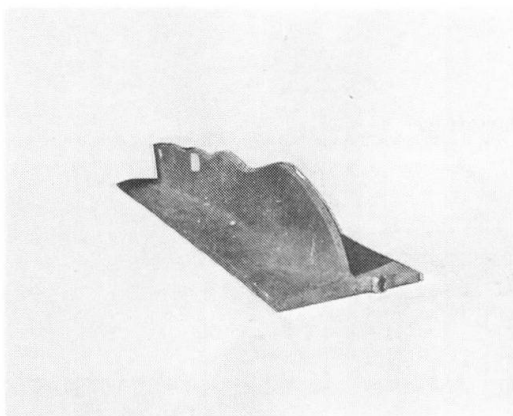
Photo 1 The fallen off metal of bridge No. 248

Samples were taken from the girder for chemical analysis and mechanical test. The steel strength was equivalent to that of the carbon steel but was high in S, P and N content which made it difficult for welding. The ductility of the material at low temperature was rather poor and the ageing effect tendency was quite strong. U-notch impact test showed that the brittleness transition temperature was about $+15^{\circ}\text{C} - 0^{\circ}\text{C}$.

This accident once more teaches that direct repair welding on steel girders must be strictly forbidden. Otherwise it would be very much likely that weld defects or weld cracks should appear and deterioration, a decrease in ductility in particular of the weld metal and the heat affected zone would happen. And these would certainly give rise for the formation of fatigue crack and brittle fracture. This is an important problem we must pay attention to in the reconstruction and maintenance of bridge in the future.

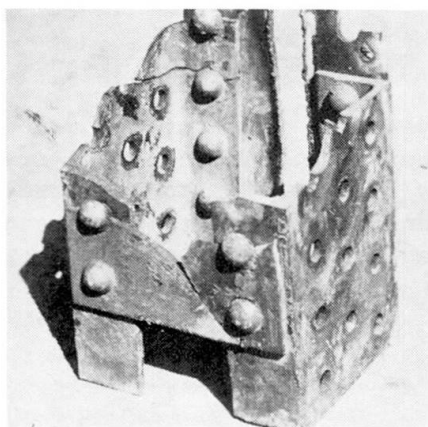
Photo 3 The form of the fracture member of Taizi River Bridge

On March 23, 1973, the fracture occurred at the upper panel point of the first diagonal of the 16th truss built in 1930, with a span length of 33.54 M.

Field investigation revealed that fatigue crack took place at an early stage in one of the diagonal channels. The other channel was pulled to break with obvious appearance of a bottleneck. The causes of the formation of the fatigue cracks are as follows:

At the time of design 50 years ago, the fatigue behaviour of the riveted joints was not clearly understood. The present train load and train load and train density (about 80 trains per day) on the bridge were much greater than those when the

bridge was first constructed. The lateral bracings were too weak, so the passing trains caused the truss to produce great vibration in the horizontal direction.

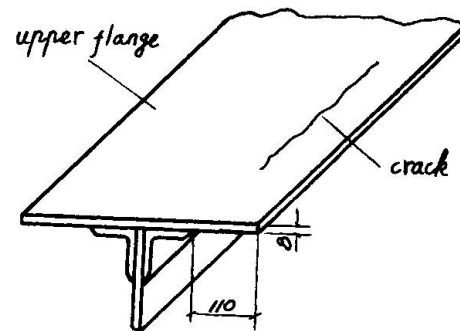
Fig 3 Crack on the upper flange

In some old-type riveted girders, both the upper and lower flange cover plates were provided in conformity to the moment diagram. Some of them often stopped at a distance from the bridge support. The flange plate between the support and stopped point was rather thin (8 mm only), but it cantilevered out as many as 110 mm (Fig 3). This was why longitudinal fatigue cracks often took place at this location. The two major causes of the formation of this longitudinal fatigue cracks are: (1) high impact forces under the direct train wheel load. (2) Transverse deflection of the upper flange induced by the vertical deformation of sleeper under train load. The beam action of sleepers on D.P.G. Bridges arose from a difference that existed between the center to center distance of the main girders which was 2 M and the gauge distance of the rails which was 1.435 M.

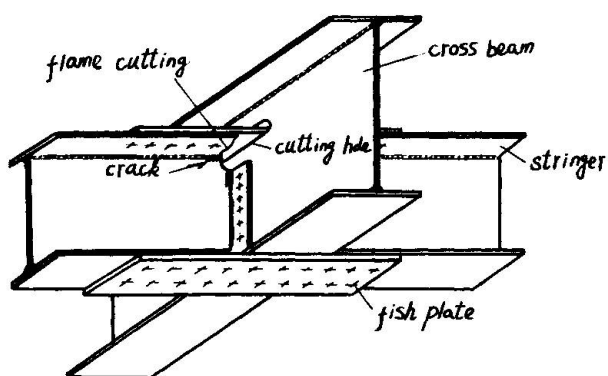
Fig 5 Cracks at the toe of filled welds of stringer flange and connecting plate between cross beam and stringer.

The most serious one appeared at the fillet weld near the end of the upper flange of the stringer in the 8th panel. The crack ran 25 MM along the toe line and then turned an angle of 30° into the web 17 MM (See Fig 5).

During manufacture, flame cutting of the flanges and the web was done in one operation. The cut face was not machined nor ground with disk sander. Its zigzagged outlook showed that the cutting quality was very poor and did not meet the need of design. Considering the location of the crack, its tendency and course of propagation, and the length of service time, it is quite possible that crack(1) owes its origin from the toe crack which developed under the effect of thermal

stress during flame cutting accompanied by a complicated state of residual stresses induced around the crack. As a result, under the train load, first of

all developed into the web plate, and then extended along the direction normal to the principal stress in the web.

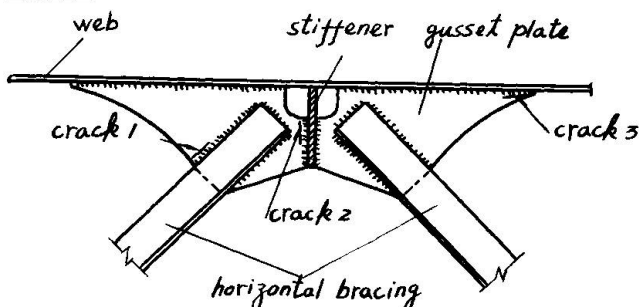
Fig 6 Cracks at the toes of fillet welds of the gusset plate of horizontal bracing

Fig 6 shows the cracks found at the welds of the gusset plates of the horizontal bracing on the deck girder bridges of 22.0 M span in the Shenyang Railway Administration. These bridges were erected after being fabricated in 1974-1975. Very soon thereafter, the cracks were generally found. During an overall inspection in April, 1976, cracks of this kind were found at as many as 29 places on five of the 22.0 M span girders on the No.3 Anshanhe Bridge on the Changchun-Dalian Railway Line. It was more

than four years from the cracks found up to now, they did not propagate. These cracks, in the main, were essentially welding cracks at the toe of weld.

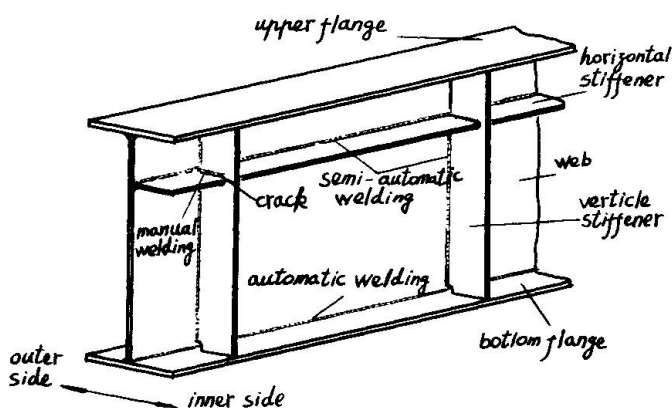
Fig 7 Cracks in the welds connecting horizontal and vertical stiffeners

Fig 7 shows the crack found at the toe of weld connecting the horizontal and vertical stiffeners on welded deck girder bridges. To avoid this kind of welding cracks, aside from that it is essential to select the right type of welding rod, to strictly control the baking temperature of the rod so as to reduce its hydrogen content, to reduce the assembly tolerance as much as possible, and to clear the steel plates of rust, it is also advisable to modify the structural details and to rearrange the welding sequence. The horizontal stiffener can be made with a whole piece of the same length as the web passing through the notches of the vertical stiffeners,

and weld up the stiffeners after assembling before other welds are done. An alternative is to leave the horizontal and vertical stiffeners unwelded as arranged in the above-mentioned manner.
