Fatigue Failures of Steel Railway Bridges in China

SHI YONGJI

Eng., Group Leader
China Academy of Railway Sciences
Beijing, China

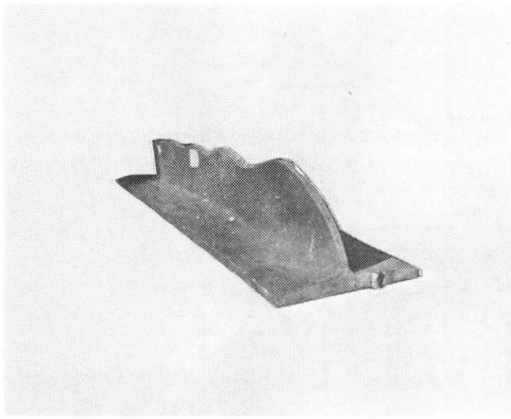
Samples were taken from the girder for chemical analysis and mechanical test. The steel strength was equivalent to that of the carbon steel but was high in S, P and N content which made it difficult for welding. The ductility of the material at low temperature was rather poor and the ageing effect tendency was quite strong. U-notch impact test showed that the brittleness transition temperature was about $+15^{\circ}\text{C} - 0^{\circ}\text{C}$.

Photo 1 The fallen off metal of bridge No. 248

This accident once more teaches that direct repair welding on steel girders must be strictly forbidden. Otherwise it would be very much likely that weld defects or weld cracks should appear and deterioration, a decrease in ductility in particular of the weld metal and the heat affected zone would happen. And these would certainly give rise for the formation of fatigue crack and brittle fracture. This is an important problem we must pay attention to in the reconstruction and maintenance of bridge in the future.

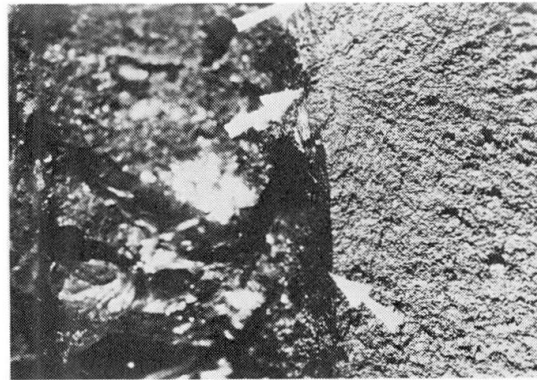
Bridge No. 248 on the Beijing-Baotou Railway Line was a rolled I-beam bridge which was manufactured in Britain in 1898 and erected in 1903. Its original length was 7 M and was cut down to 4.6 M in 1947 to be used as a simple span. There were four drilled holes of $\phi 19$ on the webs and two on the bottom flanges. These holes were filled later by gas welding when it was cut. It so happened that at about 11 o'clock in the morning of November 30, 1967, after a heavy snow fall, a large piece of flange metal broke off together with a portion of the web. Fig 1 is a sketch of the girder and the failure location. Photo 1 is the fallen off piece. From the fracture surface, we could find that the weld quality was very poor. Under repeated action of train load through a long period of time, fatigue crack was initiated at the notch (Photo 2).

Photo 2 Fatigue crack at the notch of bridge No. 248

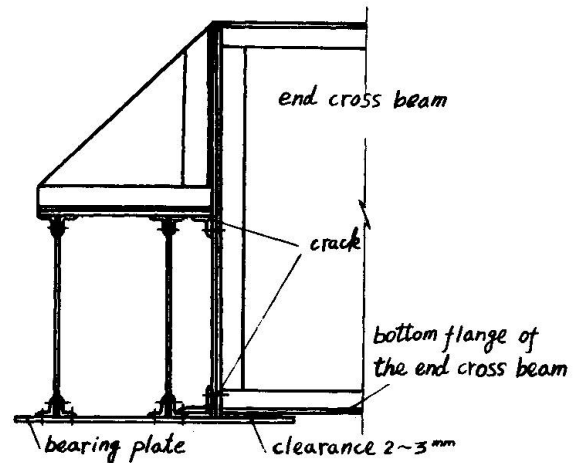
In Fig 2 is indicated the fatigue cracks occurring at the angles connecting the end cross beam and the main truss. In the original design, the bottom flange of the end cross beam was placed directly against the bearing plate so that the reaction force might be partly transmitted through the plate. However, after many years of operation, a gap of 2-3 MM was formed between the bottom flange of the cross beam and the top of the bearing plate, which had deformed and worn out. As a result, the line of transmission of the reaction force was so

altered that the stresses in the connecting angles were greatly increased. This was the major cause of the fatigue cracks.

Fig 2 Fatigue cracks occurring at the connecting angles

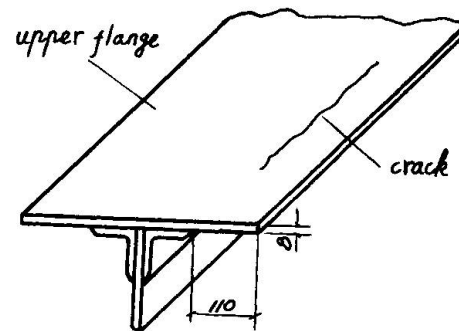
In some old-type riveted girders, both the upper and lower flange cover plates were provided in conformity to the moment diagram. Some of them often stopped at a distance from the bridge support. The flange plate between the support and stopped point was rather thin (8 mm only), but it cantilevered out as many as 110 mm (Fig 3). This was why longitudinal fatigue cracks often took place at this location. The two major causes of the formation of this longitudinal fatigue cracks are: (1) high impact forces under the direct train wheel load. (2) Transverse deflection of the upper flange induced by the vertical deformation of sleeper under train load. The beam action of sleepers on D.P.G. Bridges arose from a difference that existed between the center to center distance of the main girders which was 2 M and the gauge distance of the rails which was 1.435 M.

Fig 3 Crack on the upper flange

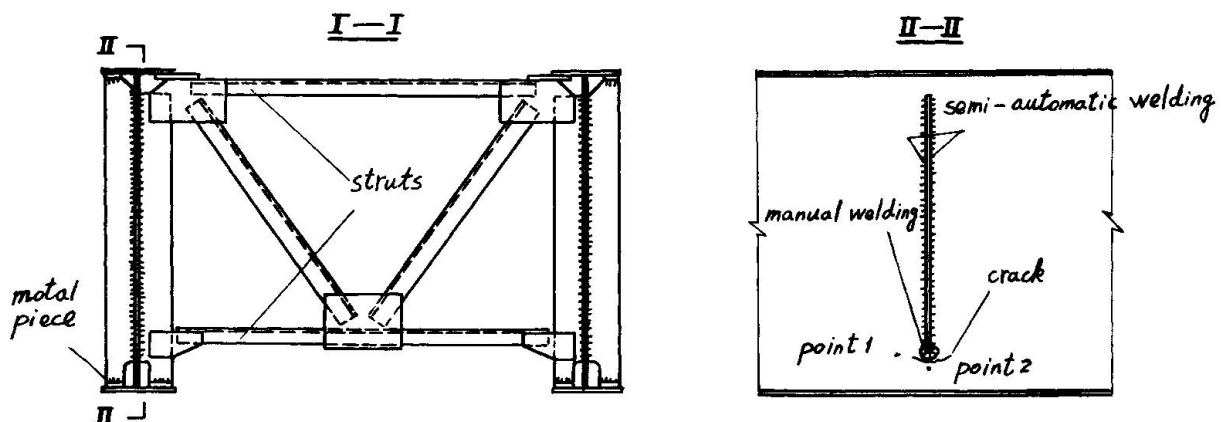
Langjiang Bridge on the Changsha - Liuzhou Railway Line, which was completed and opened to traffic on November 28, 1964, was the first bolt-weld railway through truss bridge using 16 Mn steel, with a span length of 61.44 M. One hundred days later, a horizontal crack was observed right beneath the manual weld, which connected the semi-automatic welds on both sides of stiffener, at the end of the center stiffener of stringers on March 8, 1965 (Fig 4).

Fig 4 Crack at the end of the center stiffener

After the crack was revealed, the stringer was subjected to a test. Test result showed that, under the long-term action of train load, the metal pieces, which

were inserted in the gaps between the stiffener ends and flange, could hardly keep bearing tight against the flanges. It was obvious that this type of structural detail would not meet the design requirements. In such a case, the vibration frequency measured on point 1 and 2, near the lower end of the center stiffener, was about 30 HZ, this location produced great vibration as the train passed. The maximum alternate stress at point 1 was observed to be +45.6 and -31.0 N/mm^2 . However, when the bottom flange of the stringer and the bottom lateral bracing of the truss were held rigidly together, the vibration frequencies at point 1 and 2 were measured to be 40-50 HZ and the alternate stress reduced to less than $\pm 4.9 \text{ N/mm}^2$.

Furthermore, out-of-plane deformation and angle of rotation are produced in the stringer under the action of train load. The additional flexural stresses were induced at the lower end of the vertical stiffener.

In addition to the above considerations, the welding technologies used for the vertical stiffeners of the stringers were unfit. Employing manual welding to connect the semi-automatic welds on both sides of the stiffener was apt to produce welding defects instead of any favourable effect. It may be concluded that the horizontal crack or under cut (even it was very fine) at the lower end of the vertical stiffener welds would propagate very fast under the action of the above-mentioned additional stresses.

Since the Langjiang Bridge accident, the constructional detail of the stiffener and the strut has been modified. The lower strut of cross brace, instead of being connected to the lower end of the vertical stiffener, was made to connect to the bottom flange of the stringer through gusset plate. Furthermore, 16Mn low alloy steel was used to make the stringers, the height of which was thus reduced from 1,450 to 1,290 MM. After these modifications, no fatigue problem has been encountered at this location.

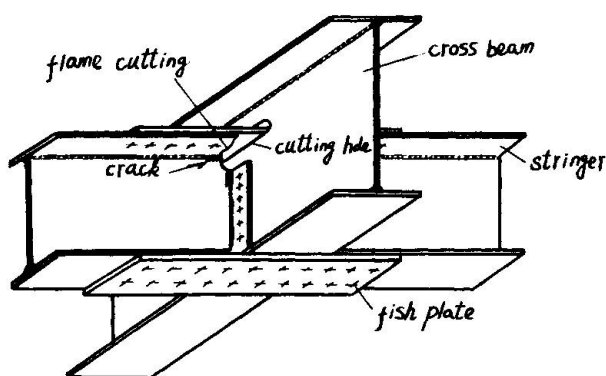
The Puyanjiang Bridge on the Hangzhou-Nanchang Railway Line is a half-through girder bridge with a total length of 166.9 M. The third span is 34.75 M in length. The girder was made in September, 1975 and opened to traffic in 1976. In July, 1979, the first crack was found at the toe of fillet weld of a stringer. Eleven cracks at similar locations of the bridge were found in latter inspection.

Fig 5 Cracks at the toe of filled welds of stringer flange and connecting plate between cross beam and stringer.

The most serious one appeared at the fillet weld near the end of the upper flange of the stringer in the 8th panel. The crack ran 25 MM along the toe line and then turned an angle of 30° into the web 17 MM (See Fig 5).

During manufacture, flame cutting of the flanges and the web was done in one operation. The cut face was not machined nor ground with disk sander. Its zigzagged outlook showed that the cutting quality was very poor and did not meet the need of design. Considering the location of the crack, its tendency and course of propagation, and the length of service time, it is quite possible that crack(1) owes its origin from the toe crack which developed under the effect of thermal

stress during flame cutting accompanied by a complicated state of residual stresses induced around the crack. As a result, under the train load, first of

all developed into the web plate, and then extended along the direction normal to the principal stress in the web.

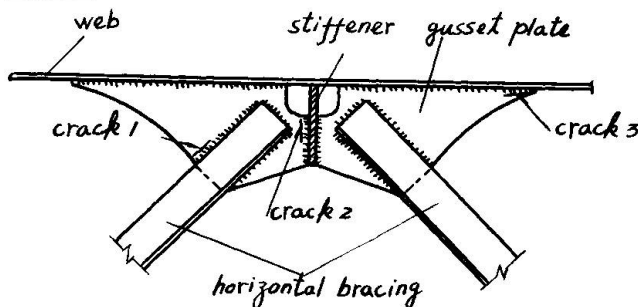
Fig 6 Cracks at the toes of fillet welds of the gusset plate of horizontal bracing

Fig 6 shows the cracks found at the welds of the gusset plates of the horizontal bracing on the deck girder bridges of 22.0 M span in the Shenyang Railway Administration. These bridges were erected after being fabricated in 1974-1975. Very soon thereafter, the cracks were generally found. During an overall inspection in April, 1976, cracks of this kind were found at as many as 29 places on five of the 22.0 M span girders on the No.3 Anshanhe Bridge on the Changchun-Dalian Railway Line. It was more

than four years from the cracks found up to now, they did not propagate. These cracks, in the main, were essentially welding cracks at the toe of weld.

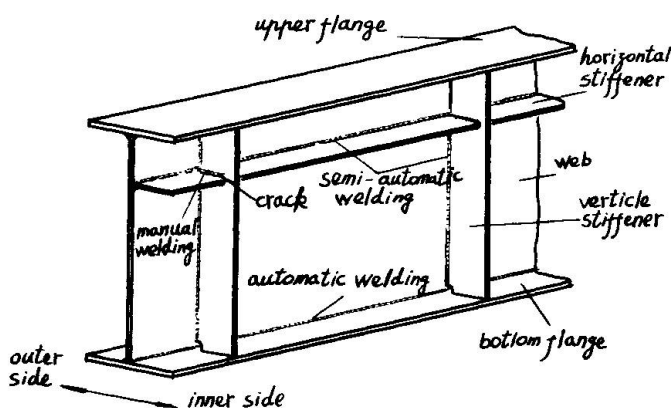
Fig 7 Cracks in the welds connecting horizontal and vertical stiffeners

Fig 7 shows the crack found at the toe of weld connecting the horizontal and vertical stiffeners on welded deck girder bridges. To avoid this kind of welding cracks, aside from that it is essential to select the right type of welding rod, to strictly control the baking temperature of the rod so as to reduce its hydrogen content, to reduce the assembly tolerance as much as possible, and to clear the steel plates of rust, it is also advisable to modify the structural details and to rearrange the welding sequence. The horizontal stiffener can be made with a whole piece of the same length as the web passing through the notches of the vertical stiffeners,

and weld up the stiffeners after assembling before other welds are done. An alternative is to leave the horizontal and vertical stiffeners unwelded as arranged in the above-mentioned manner.
