Newport bridge collision

Newport Bridge Collision Collision au pont de Newport Newport Brückenzusammenstoß

Thomas R. KUESEL Senior Vice President Parsons Brinckerhoff Quade & Douglas, Inc. New York, NY, USA

In 1981 a main tower pier of the 488-m Newport suspension bridge in Rhode Island, USA, was struck head on by a fully laden 45,000-ton tanker. The ship was shortened 3.5 m through bow crushing, but the bridge pier suffered only superficial damage. Details of bridge design and accident are given, and forces developed during the collision are derived.

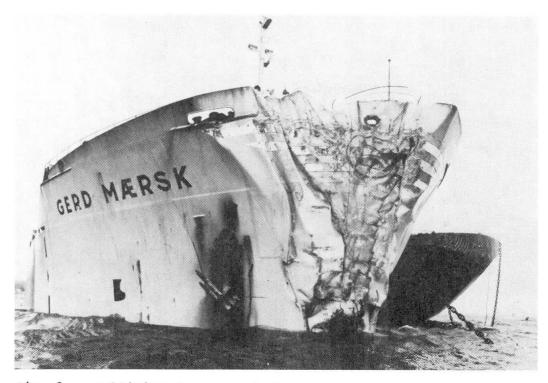
The bow of the ship was crushed in to the extent that the ship was shortened 3.5 m (Fig. 2). The ship came to a complete stop and then drifted off. Although it took on some water through sprung plates, no oil was spilled, and the ship was never in danger of sinking.

Fig. 2. Collision damage to tanker.

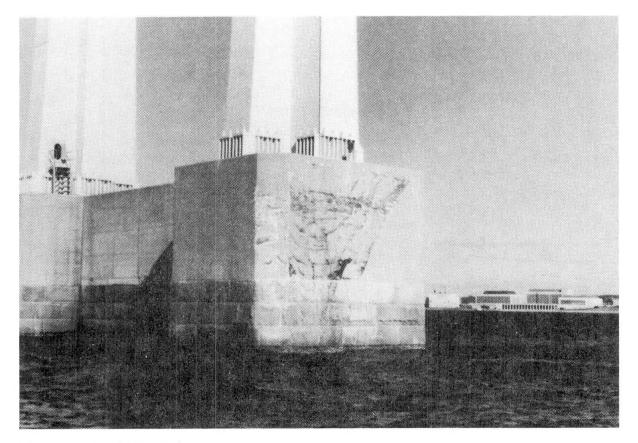
Damage to the bridge was negligible. The pier suffered no displacement or rotation, and there was no misalignment of the roadway deck joints or any other superstructure elements. The side of the pier suffered extensive surface scrapes, gouges, and spalls of the concrete (Fig. 3) to a depth of 2 to 5 cm over an area roughly 7 m wide by 20 m high, approximately equally above and below the water line (Fig. 4).

Fig. 3. Bridge pier damage.

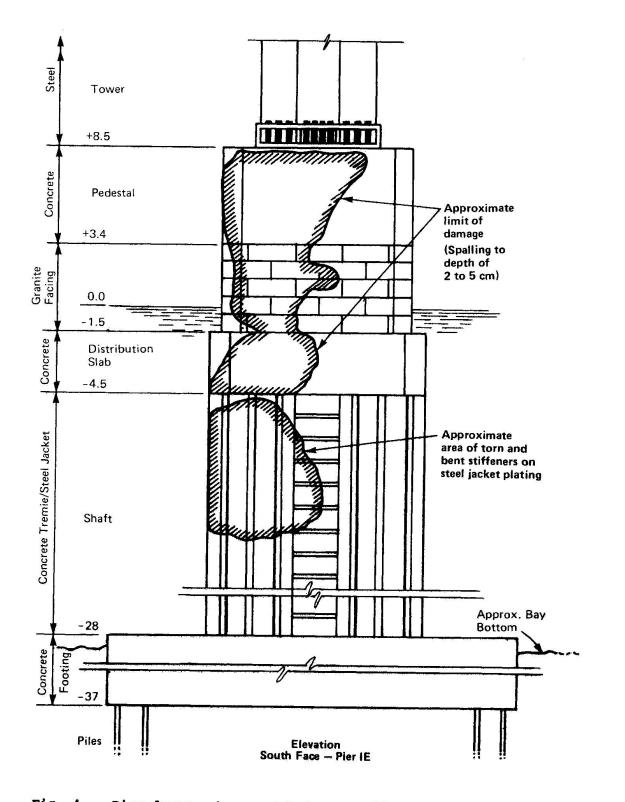
There were a number of superficial tears in steel plating of the underwater caisson structure, but no damage to the concrete behind the plating. A spectacular blotch of gray paint decorated the side of the pier for several days before falling off.

Fig. 4. Pier damage above and below waterline.

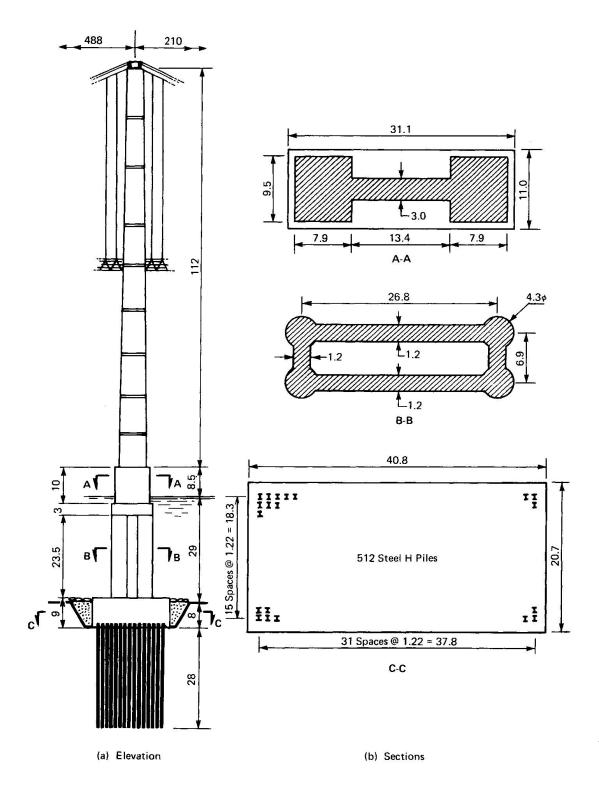
Fig. 5. Details and dimensions of pier.

Details and dimensions of the pier are shown in Figs. 5a and 5b. The dead weight of the pier (neglecting 12,000 tons buoyancy) is 32,000 tons, and the superstructure reaction to the piertop is an additional 11,000 tons.

It was considered impractical to provide free-standing fenders in 30-m water depth, and so the pier was designed for an arbitrary ship impact force of 1,650 tons, applied at Elev. +3 m. This was intended to represent the effect of a 20,000-ton ship traveling with a velocity component normal to the pier of 3 knots.

Analysis of stresses at the bottom of the shaft (top of footing) indicates that under a 6,000-ton collision load the resultant force lies close to the edge of the kern of the section. The maximum compressive stress in the concrete is about 35 kg/cm², and a very slight tension exists on the impacted side. This is well within the capacity of the reinforcing steel, without counting on the steel shell form plate.

The analysis thus indicates that although the actual collision load substantially exceeded that assumed for design, the observed lack of damage to the pier is consistent with the results to be expected from an approximate rational analysis. It further indicates that it is possible to design and construct deep water bridge piers to absorb the effects of collision from substantial large ships.
