Autor(en): **Cuoco, Daniel A. / Velivasakis, Emmanuel E.**

Zeitschrift: **IABSE reports = Rapports AIPC = IVBH Berichte**

Band (Jahr): **57/1/57/2 (1989)**

## Aluminum Curtain Wall Panel Failure, Assessment and Repair

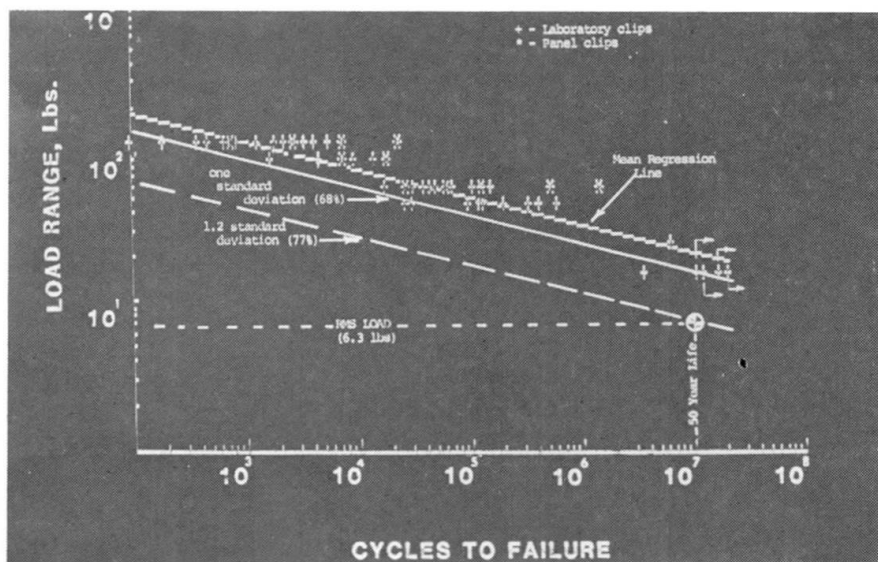
FIG. 2 Load vs. cycles to failure

In order to determine the expected fatigue life of existing panel clips, constant-amplitude cyclic testing of numerous panel clips was performed. These panel clips consisted of existing clips removed from the building, and also new clips fabricated with "imperfect" weldments simulating the existing weldments in the building. The test results were plotted to obtain a "load vs. cycles-to-failure" curve for the clips (Fig. 2).

Based upon the cyclic wind loading spectrum that was derived, a root-mean-square (rms) wind loading of  $10.4 \text{ kg/m}^2$  at 10 million cycles, corresponding to a 50-year life, was computed. This translates to an rms load of  $2.9 \text{ kg}$  at 10 million cycles on the most highly loaded clip. Fig. 2 indicates that there is a 77% confidence level that a maximum-loaded clip weld will survive 50 years.
