Zeitschrift: IABSE reports = Rapports AIPC = IVBH Berichte
Band: 59 (1990)

Artikel: Fatigue crack detection and repair of steel bridge structures
Autor: Fisher, John W. / Menzemer, Craig C. / Yen, Ben T.
DOI: <https://doi.org/10.5169/seals-45726>

Fatigue Crack Detection and Repair of Steel Bridge Structures

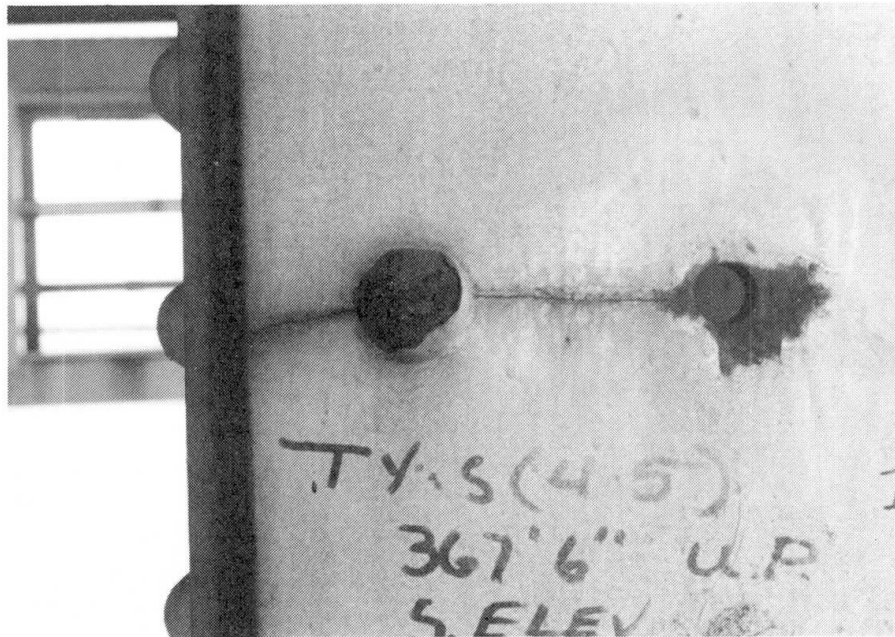
Inspections of the structure revealed fatigue cracks emanating from the rivet holes in several hanger box sections (Fig. 13). In addition to the fatigue cracks, significant amounts of corrosion product was found between the corner angles and both web and flange plates of the hanger sections (Fig. 13). Environmental corrosion was also found between the gusset and hanger plate as well as on the gusset at the elevation of the pin connection (Fig. 14).

Fig. 13 Corrosion Between a Hanger Flange Plate and Interior Connection Angle and Web Crack from Rivet Hole

The hanger connections are located directly below open roadway expansion joints which allows salt, water, and debris to fall and collect on the pin and hangers, thereby assisting and accelerating the corrosion process. Field inspections and strain measurements demonstrated that the development of corrosion caused pin restraint which, in turn, led to bending in the hangers. When the bending moment at the hanger joint was high enough to overcome the restraint, sudden release of the pin connection produced the dynamic action. Lubrication of the pins was effective in minimizing hanger bending and dynamic effects by reducing pin restraint and as such, was recommended as a routine maintenance practice. A longer term correction will require the redesign of the pin connection as well as effective control of water and debris by the elimination of open expansion joints.

Cracked hanger plates were temporarily retrofitted by the drilling of holes to blunt the crack tips. For the cracked hanger flange plates, the maximum measured stress range of 55 MPa exceeded the fatigue limit of 48 MPa for riveted members. Fatigue crack propagation is expected to continue in the flange plates. As a result, twice a year inspection of the hangers will be required, until the eventual replacement of the damaged hangers.
