Fatigue Crack Detection and Repair of Steel Bridge Structures

John W. FISHER

3.0 I-93 CENTRAL ARTERY

4.0 I-95 OVER THE SUSQUEHANNA RIVER

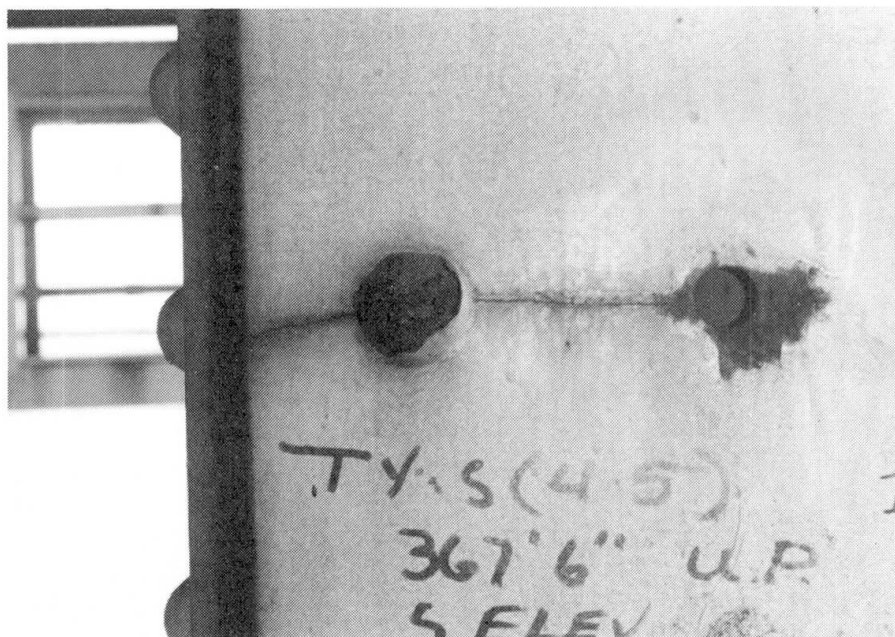
Inspections of the structure revealed fatigue cracks emanating from the rivet holes in several hanger box sections (Fig. 13). In addition to the fatigue cracks, significant amounts of corrosion product was found between the corner angles and both web and flange plates of the hanger sections (Fig. 13). Environmental corrosion was also found between the gusset and hanger plate as well as on the gusset at the elevation of the pin connection (Fig. 14).

Fig. 13 Corrosion Between a Hanger Flange Plate and Interior Connection Angle and Web Crack from Rivet Hole

The hanger connections are located directly below open roadway expansion joints which allows salt, water, and debris to fall and collect on the pin and hangers, thereby assisting and accelerating the corrosion process. Field inspections and strain measurements demonstrated that the development of corrosion caused pin restraint which, in turn, led to bending in the hangers. When the bending moment at the hanger joint was high enough to overcome the restraint, sudden release of the pin connection produced the dynamic action. Lubrication of the pins was effective in minimizing hanger bending and dynamic effects by reducing pin restraint and as such, was recommended as a routine maintenance practice. A longer term correction will require the redesign of the pin connection as well as effective control of water and debris by the elimination of open expansion joints.

Cracked hanger plates were temporarily retrofitted by the drilling of holes to blunt the crack tips. For the cracked hanger flange plates, the maximum measured stress range of 55 MPa exceeded the fatigue limit of 48 MPa for riveted members. Fatigue crack propagation is expected to continue in the flange plates. As a result, twice a year inspection of the hangers will be required, until the eventual replacement of the damaged hangers.

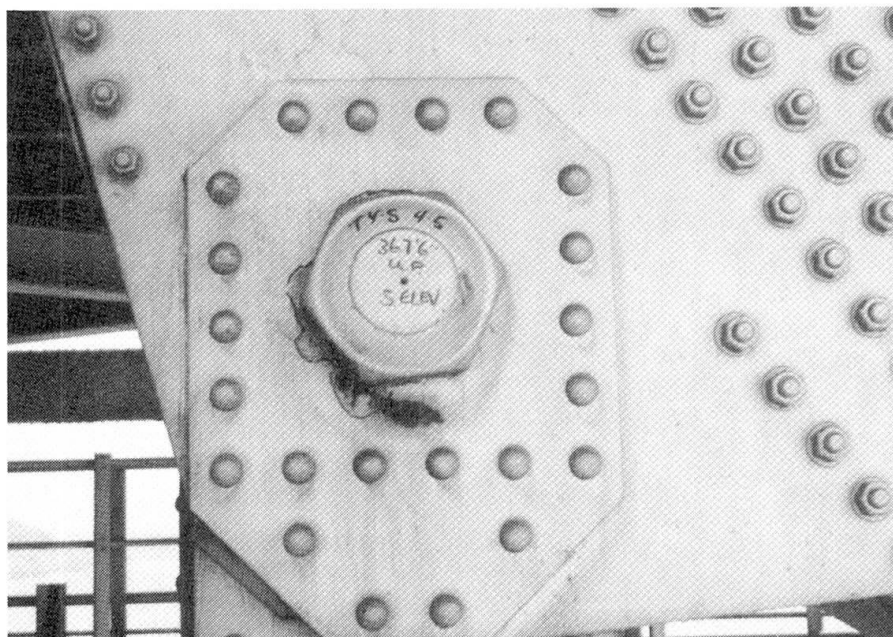
Fig. 14 Corrosion at Upper Pin
