Strengthening of the Parish Church in Farigliano

Autor(en): **Lancelotta, Renato / Pistone, Giuseppe / Rovere, Renzo**

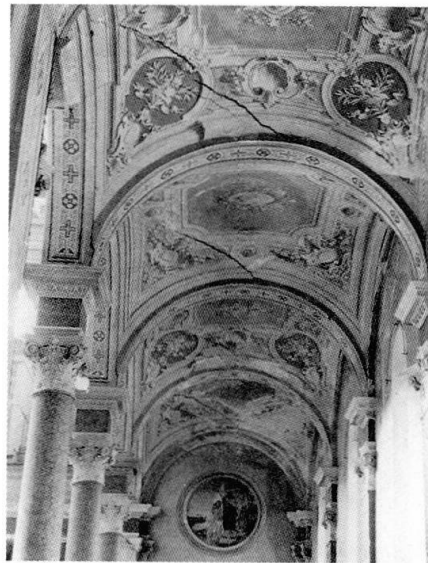
Fig. 3 - Fissures in the thin vaults of the side aisles.

- systematic fissures in the thin vaults covering the side aisles, of ancient origin, but probably made worse by recent damages; their width came to over 4 cm and their position in the building's plan revealed a markedly symmetrical arrangement; in particular, their 45° degree slant isolated, in each vault, a central part which was obviously in compression, as borne out by the relative slip of the crack edges and its enhanced curvature (fig. 3).

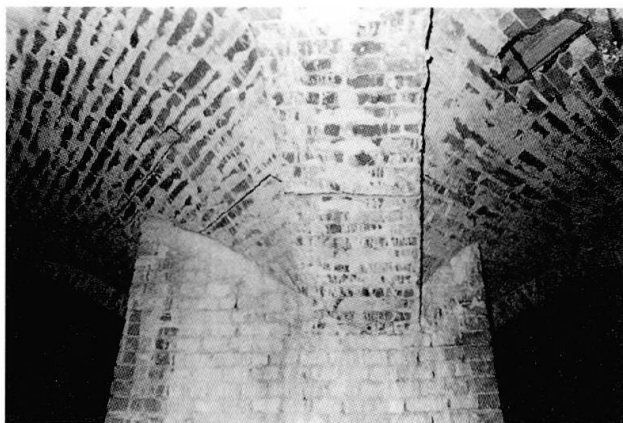
Fig. 4 - Fissures in the the 12 cm thick vaults on the underground level.

- a series of lesions, of recent appearance, involving the vaults and arches in the basement. The most important cracks were located all around the four main piers at the confluence of the transept and the central nave, and were as wide as 19 mm at the arches (fig. 4);

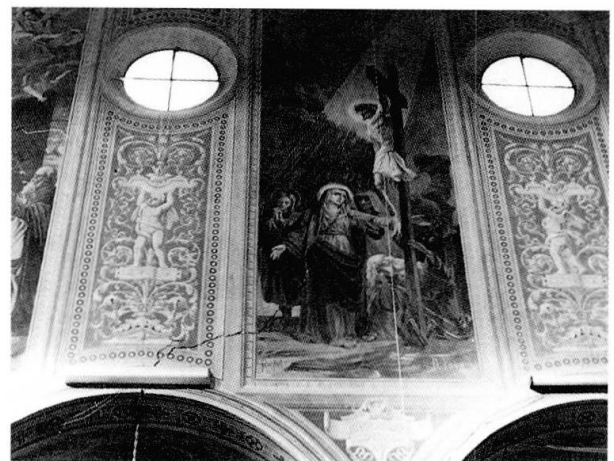
Fig. 5 - Fissures in the the wall defining the central nave.

- a few major cracks affecting the church proper, in the wall at the top of the columns defining the central nave (fig. 5);
- full height lesions of more recent formation (August 1989) in the right-hand side lateral wall of the presbytery, where the transept meets the nave, and in the facade wall.

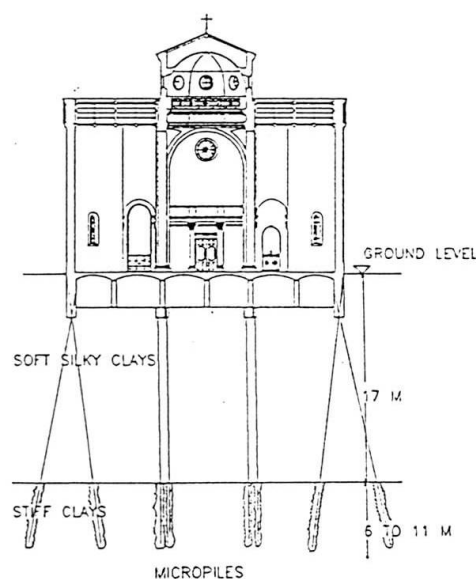
The data collected from 4 bore-holes have shown that the upper stratum of this recent silty clay of low to medium plasticity has a thickness of 17 m. Because of the chaotic structure of this foundation soil and on account of the scarce significance of laboratory tests performed on small samples, in situ compressibility has been evaluated through a back-analysis of the settlements observed in a lower level wall. This has yielded an operational value of soil stiffness as low as 1.5 MPa, which explains the large values of the cracks, fissures and settlements observed in the masonry structures.

Fig. 7 - Cross-section at the transept showing the stratigraphic composition of the soil and micro-piles.

In this situation, the first major protective measure taken was the underpinning of the foundations by means of micro-piles. To prevent the formation of undesirable lateral loads as would be produced by down-drag if the upper layer settled more than the micro-piles, raking piles were not used and the vertical piles were connected to the masonry foundations through reinforced concrete slabs (figs. 6 and 7).

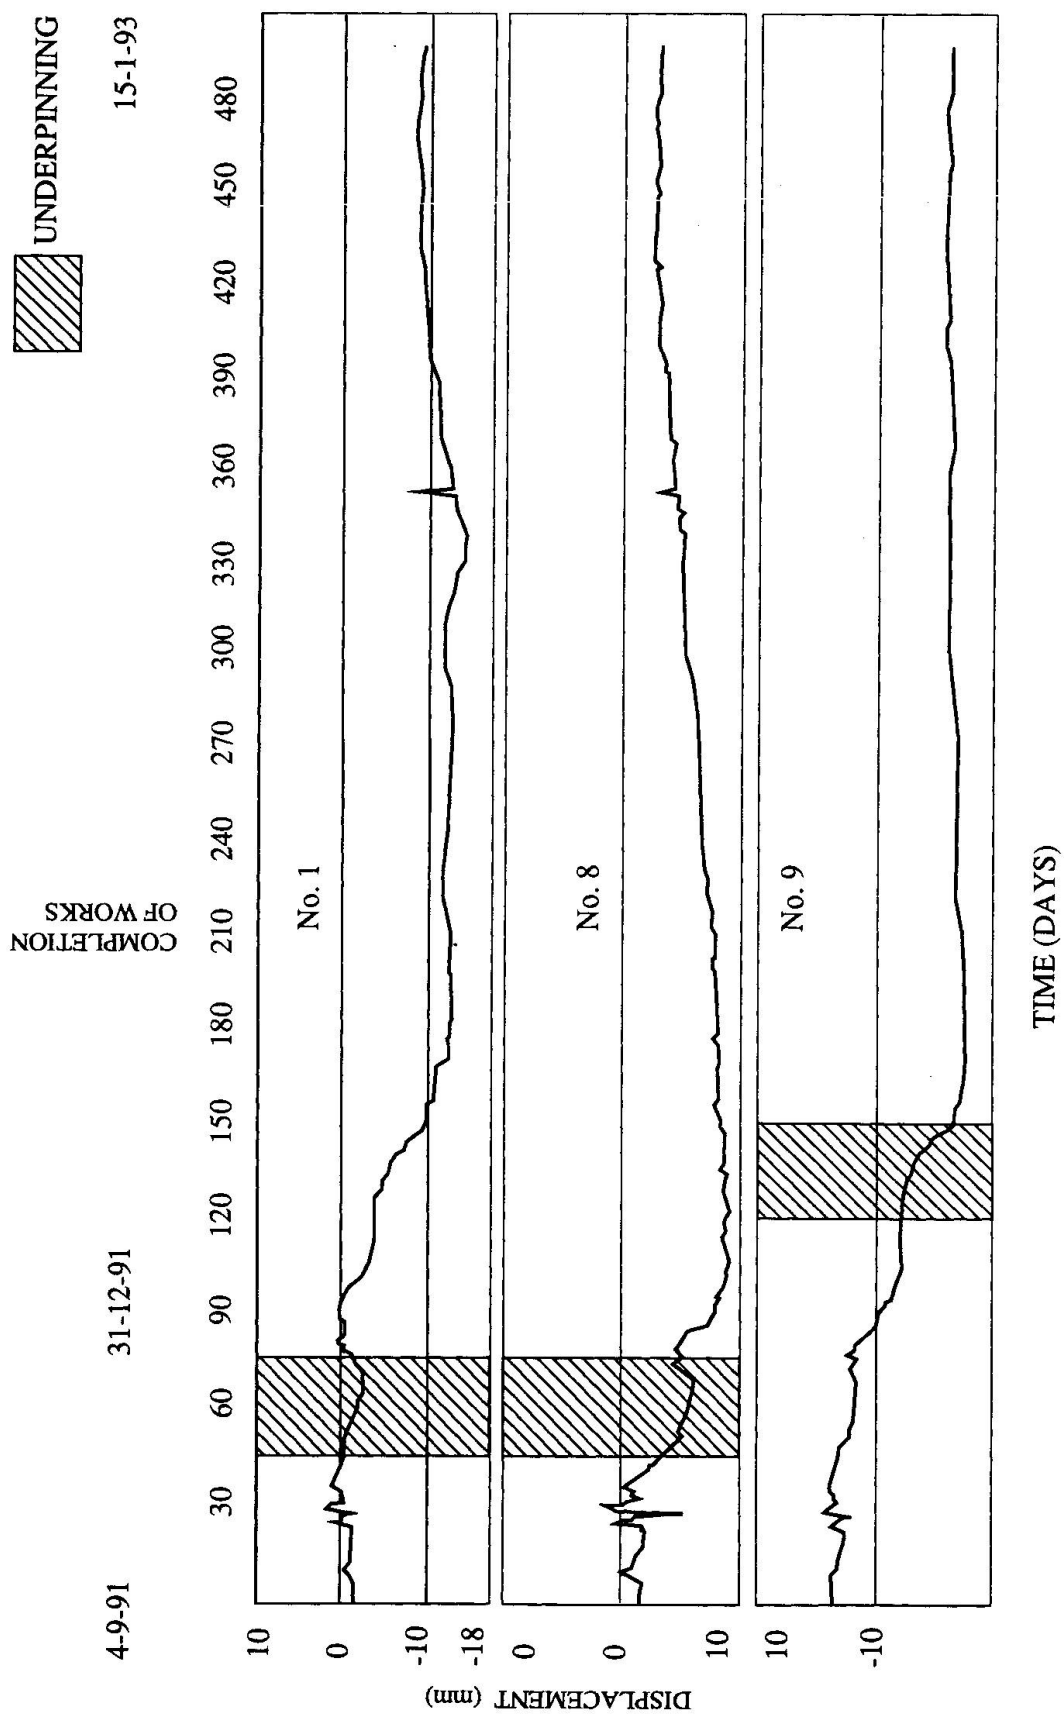
Fig. 8

Due to the re-activation of the movements in 1988, the first part of these diagrams clearly shows that the settlements were still evolving in 1991.

The time periods during which underpinning work was underway are also indicated by shaded portions of the diagrams and it can be seen that after the work was completed the structure did not suffer from any further movement.

Secondly, the settlement pattern shown here has to be understood in terms of relative settlements, because the values given are referred to point 11- a fixed point in the facade wall which certainly underwent minimal movements. This explains, in some cases (see points 1 and 8, for example), the unusual apparent reduction in the extent of the settlements with time.
