Artikel: Strengthening of the Parish Church in Farigliano
Autor: Lancelotta, Renato / Pistone, Giuseppe / Rovere, Renzo
DOI: <https://doi.org/10.5169/seals-53300>

Strengthening of the Parish Church in Farigliano

The foundations of the Parish Church of Farigliano are dug in soft, recently deposited materials with a high degree of compressibility. This explains the precarious behaviour exhibited in recent years by the static conditions of the structure. This report describes the urgent measures taken to protect the building, including the installation of a hydraulic levelling system.

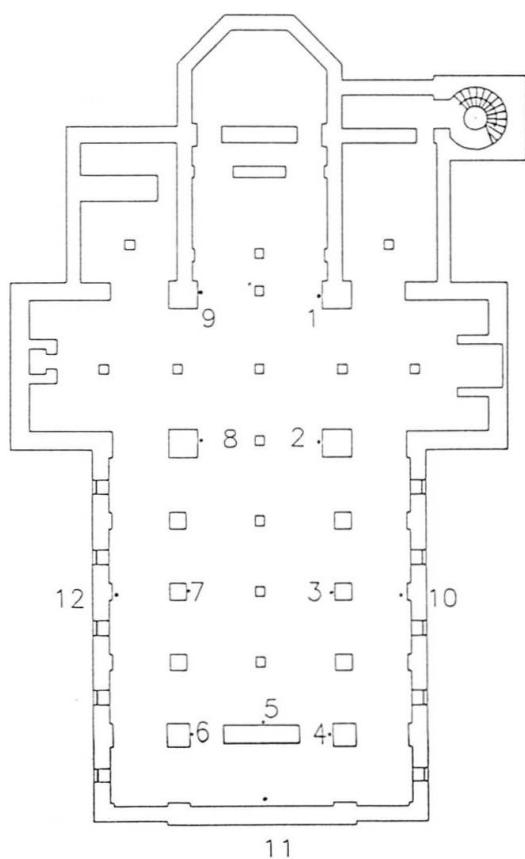
Fig. 2 - Plan of the basement showing the arrangement of the hydraulic levelling system measuring points.

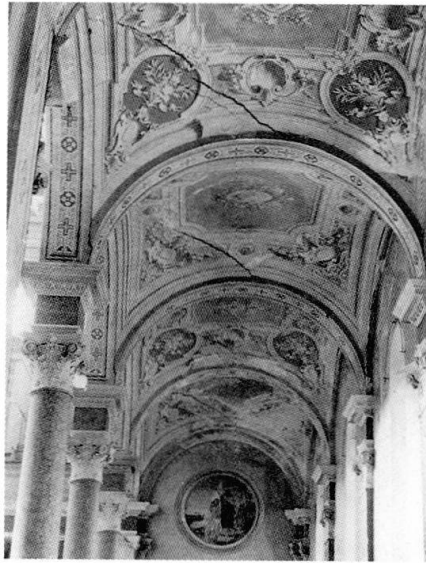
Fig. 3 - Fissures in the thin vaults of the side aisles.

- systematic fissures in the thin vaults covering the side aisles, of ancient origin, but probably made worse by recent damages; their width came to over 4 cm and their position in the building's plan revealed a markedly symmetrical arrangement; in particular, their 45° degree slant isolated, in each vault, a central part which was obviously in compression, as borne out by the relative slip of the crack edges and its enhanced curvature (fig. 3).

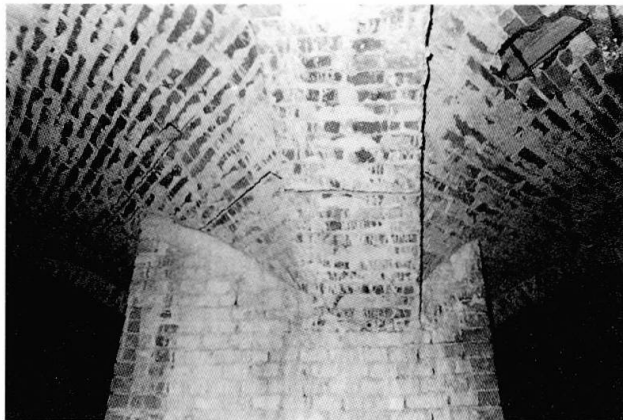
Fig. 4 - Fissures in the the 12 cm thick vaults on the underground level.

- a series of lesions, of recent appearance, involving the vaults and arches in the basement. The most important cracks were located all around the four main piers at the confluence of the transept and the central nave, and were as wide as 19 mm at the arches (fig. 4);

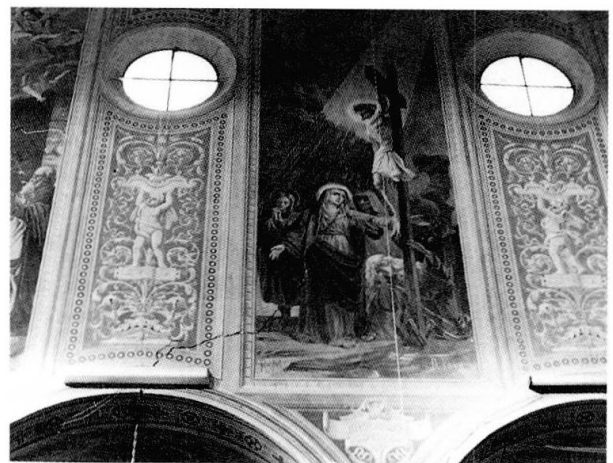
Fig. 5 - Fissures in the the wall defining the central nave.

- a few major cracks affecting the church proper, in the wall at the top of the columns defining the central nave (fig. 5);
- full height lesions of more recent formation (August 1989) in the right-hand side lateral wall of the presbytery, where the transept meets the nave, and in the facade wall.

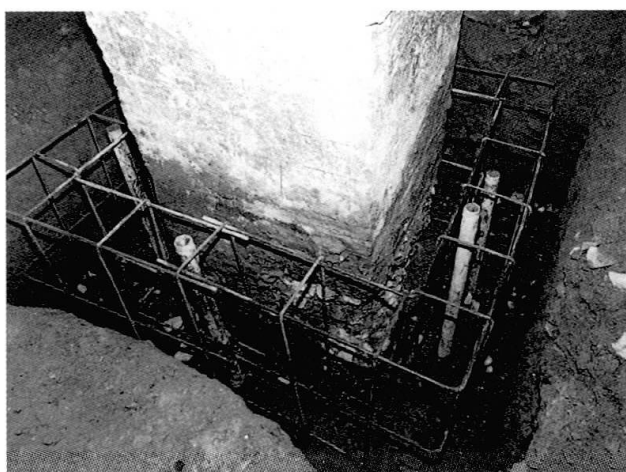
Fig. 6 - Collegamento tra basamento del pilastro e testa dei micropali.

In this situation, the first major protective measure taken was the underpinning of the foundations by means of micro-piles. To prevent the formation of undesirable lateral loads as would be produced by down-drag if the upper layer settled more than the micro-piles, raking piles were not used and the vertical piles were connected to the masonry foundations through reinforced concrete slabs (figs. 6 and 7).
