Studies for the Rehabilitation of the Mexico City Cathedral

Roberto MELI

A. Roberto SANCHEZ-RAMIREZ

SUMMARY

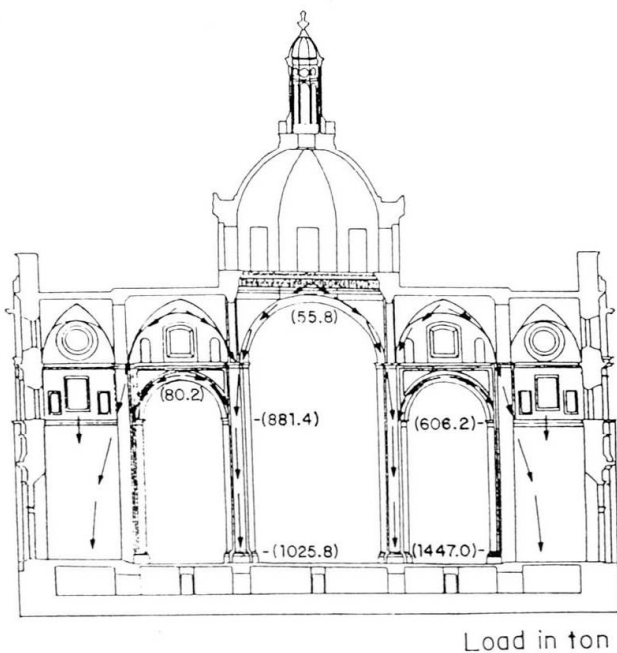
Fig. 7 Flow of self-weight loads in the zone under the central dome

The first mechanism has produced a pattern of transverse cracks in the roof and walls, especially near the central dome, and some separation of the Southern facade, with its very heavy towers, from the rest of the church.
