# **Improving the Durability of Precast Concrete Bridges**

**Tomasz SIWOWSKI**  
Dr. Eng.  
University of Technology  
Rzeszow, Poland

#### **4. CASE STUDY OF PRECAST BRIDGE REHABILITATION**

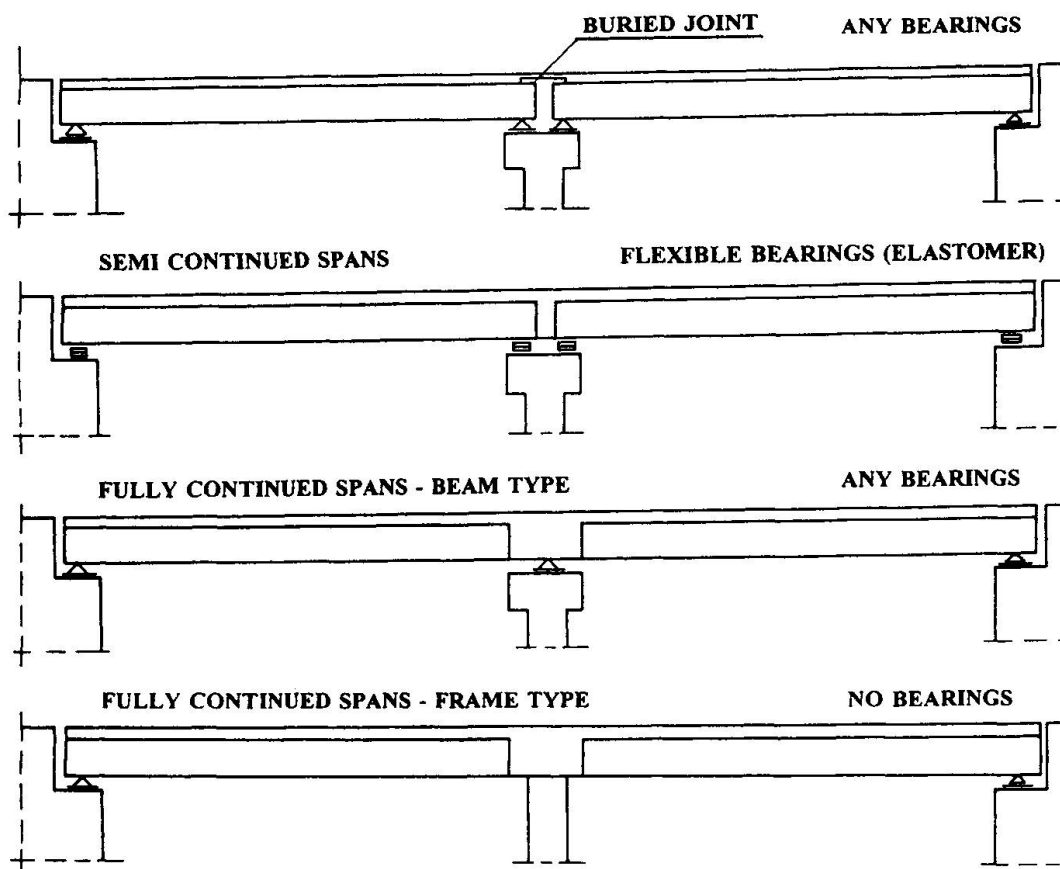
Making the structure continuous aimed mainly at getting rid of faulty expansion joints as the main factor of prefabricated bridge destruction (fig.1). The first way was to join the spans in a chain by means of a flexible slab, covering a gap, shaped in the thickened deck slab of a bridge. It formed a continuous beam scheme regarding horizontal forces and thermal influence, but it was still a chain of simple - supported beams regarding live load. However, this method did not work properly. Theoretical assumption concerning the behavior of a flexible slab allowed its cracking, which really occurred. Consequently, they underwent very fast damage. Thus, they stopped being used.

**Fig.1. Methods of making continuous of simply supported precast spans**

Another method of eliminating expansion joints was performing full continuity of the deck slab without changing existing system of bearings. The static scheme of the structure was changed from a chain of simple - supported spans into a row of quasi - frame segments of several spans.

The technologically most complicated solution necessitating use of assembly supports was obtaining a full continuity of all spans in a continuous beam system or a frame system. A monolithic joint, shaped above the pier, made it possible to place some extra reinforcement on negative moments as well as protect and strengthen the ends of precast RC beams. The change of the static scheme enabled to upgrade the load carrying capacity of the whole structure and to achieve its considerable stiffening.

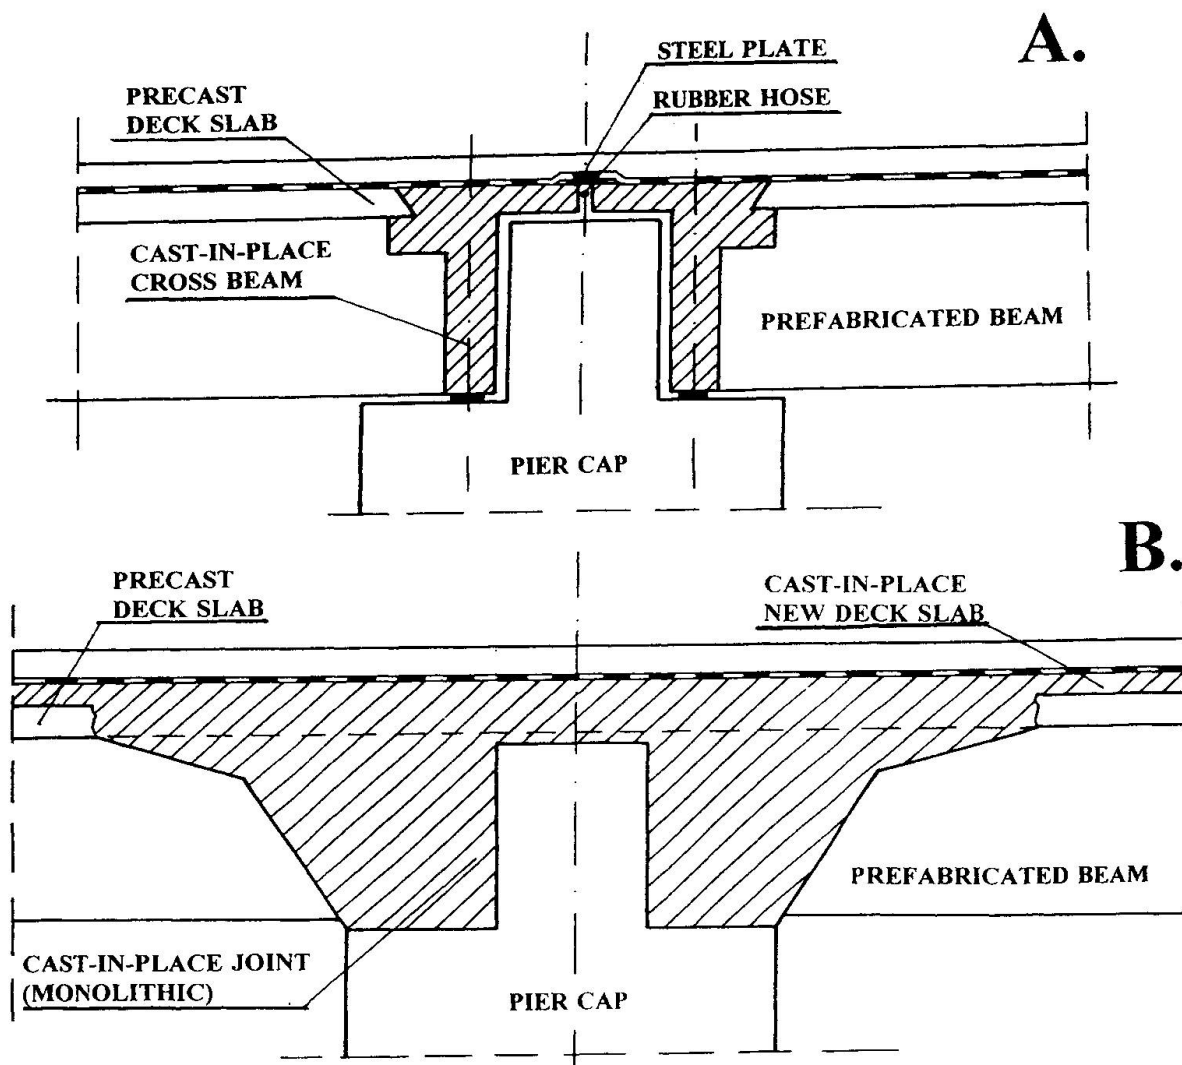
The caps of piers were the most damaged elements of the bridge structure. Leaky expansion joints and also lack of efficient drainage of the pavement caused extensive and deep losses in the concrete, loosening of the cover to the level of the reinforcement, exposure of the corroding rebars, scalling on the whole surface, etc. Besides, hammerhead piers with such a wide cap form too flexible support for bridge structures. The flexibility could easily be felt when heavy lorries were crossing the bridge. The main rehabilitation stages were the following:

**Fig.2. Modernization of the supporting area of piers:**  
a) before reconstruction; b) after reconstruction.

The main goal of making continuity of spans was the upgrading the longitudinal and transverse rigidity of the structure and the elimination of expansion joints, which meant sealing the structure. Concrete cast-in-place joints over the piers create a frame structure. A strongly reinforced joint of considerable size stiffens also the cap of the pier (fig.2).
