Improving the Durability of Precast Concrete Bridges

Tomasz SIWOWSKI Dr. Eng. University of Technology Rzeszow, Poland Tomasz Siwowski, born in 1961, received his civil engineering degree in 1985 and Ph.D. degree in 1994 at Rzeszow University of Technology. He was involved in design as well as in supervision, evaluation and rehabilitation of bridges. Presently he is engaged in the research works on fatigue and service life of steel bridges.

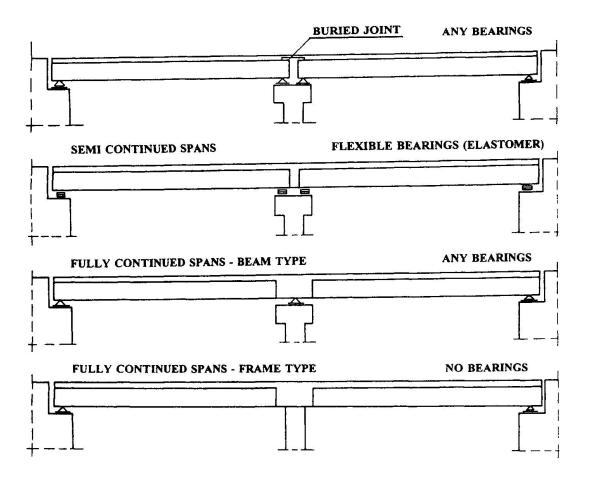
Making the structure continuous aimed mainly at getting rid of faulty expansion joints as the main factor of prefabricated bridge destruction (fig.1). The first way was to join the spans in a chain by means of a flexible slab, covering a gap, shaped in the thickened deck slab of a bridge. It formed a continuous beam scheme regarding horizontal forces and thermal influence, but it was still a chain of simple - supported beams regarding live load. However, this method did not work properly. Theoretical assumption concerning the behavior of a flexible slab allowed its cracking, which really occurred. Consequently, they underwent very fast damage. Thus, they stopped being used.

Fig.1. Methods of making continous of simply supported precast spans

Another method of eliminating expansion joints was performing full continuity of the deck slab without changing existing system of bearings. The static scheme of the structure was changed from a chain of simple - supported spans into a row of quasi - frame segments of several spans.

The technologically most complicated solution necessitating use of assembly supports was obtaining a full continuity of all spans in a continuous beam system or a frame system. A monolithic joint, shaped above the pier, made it possible to place some extra reinforcement on negative moments as well as protect and strengthen the ends of precast RC beams. The change of the static scheme enabled to upgrade the load carrying capacity of the whole structure and to achieve its considerable stiffening.

Except monolithic joints, the upgrading of span stiffness was achieved by casting, on the whole deck, a new reinforced concrete about 12 cm thick deck slab. The slab was made as composite with the existing precast elements or, possibly, with the old deck slab. It ensured the cooperation of two slabs in carrying live load, which often increased the load capacity of the bridge. In the new slab extra reinforcement was embedded, transverse and longitudinal falls were shaped and new gulleys fastened. Over the gap between the span and the abutment, the new deck slab was lengthened behind the back wall using brackets, thus eliminating expansion joints.

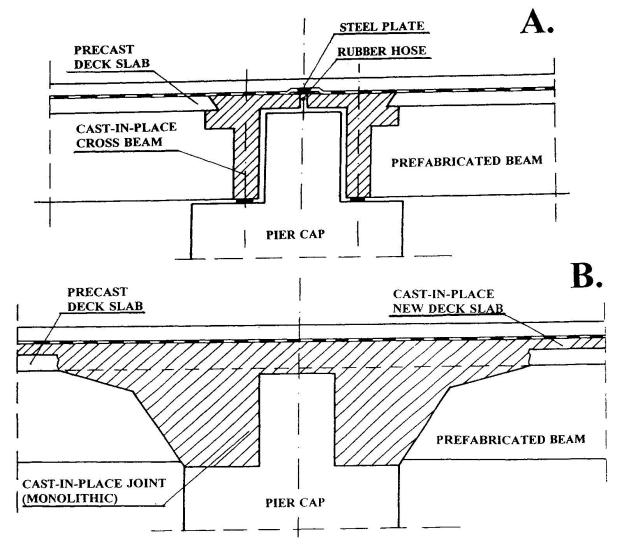
The caps of piers were the most damaged elements of the bridge structure. Leaky expansion joints and also lack of efficient drainage of the pavement caused extensive and deep losses in the concrete, loosening of the cover to the level of the reinforcement, exposure of the corroding rebars, scalling on the whole surface, etc. Besides, hammerhead piers with such a wide cap form too flexible support for bridge structures. The flexibility could easily be felt when heavy lorries were crossing the bridge. The main rehabilitation stages were the following:

Fig.2. Modernization of the supporting area of piers: a) before reconstruction; b) after reconstruction. Curbless cross-section was replaced by new one with curbs separating pedestrian lanes from those for the traffic. Total structure and service width does not change. Sidewalk was designed as reinforced concrete put-on slab separated from the carriageway by stone curbs. All hollows, pipes and empty chambers were removed.

The main goal of making continuity of spans was the upgrading the longitudinal and transverse rigidity of the structure and the elimination of expansion joints, which meant sealing the structure. Concrete cast-in-place joints over the piers create a frame structure. A strongly reinforced joint of considerable size stiffens also the cap of the pier (fig.2).

The new deck slab was composite with the hitherto existing one by means of special steel studs. The new slab sealed the deck, increased the load capacity of the span and enabled to properly anchor rebars of the joints over the piers.
