Repair and Consolidation of the Masonry Structure of a Building

Sevastean Ioan IANCA

The paper presents a study of a case about the damages caused by the 1977 earthquake to the structure of a building in Craiova, Romania, as well as repairing and consolidation solutions for this structure. The proposed solutions intend to restore the initial bearing capacity of the structure and its safety.

One of these old buildings, damaged during the earthquake from March 4, 1977 with the epicentre in Vrancea - Romania, is the building of the Faculty of Agronomy from Craiova - Romania.

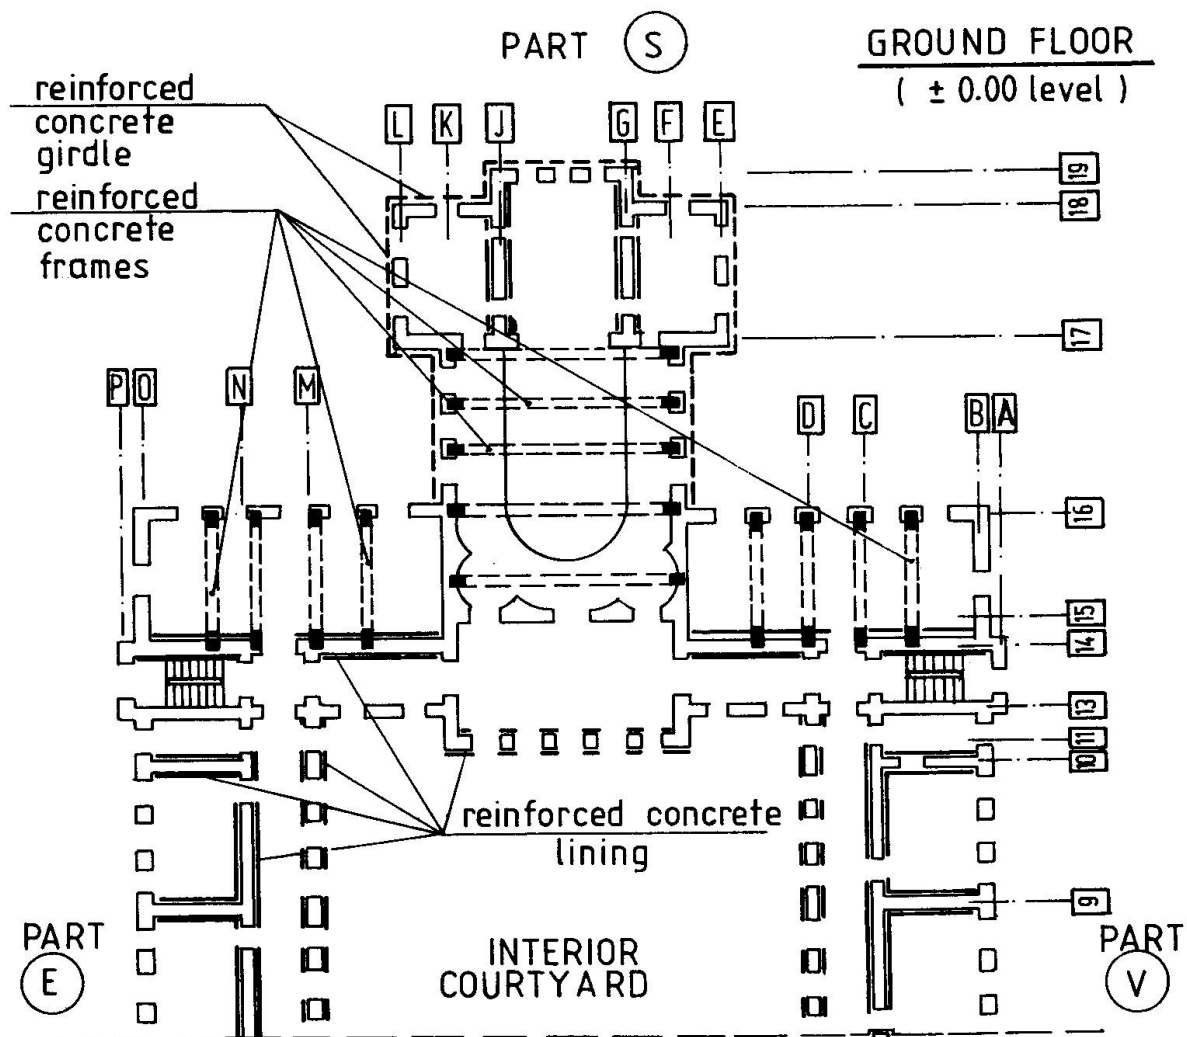
Fig. 4 The consolidation of the South wing of the building

- the making of eight reinforced concrete transversal frames in the South wing linked to the masonry walls and the existing floors (see Figure 4). The beams of these frames can be made including the existing monolith reinforced concrete beams of the floor, in the new beams of the frames and the monolith reinforced concrete columns can be made inside the two large rooms having their own foundations linked to the existing foundations of the walls.

- the consolidation of the amphitheatre by introducing the reinforced concrete transversal frames on the height of the basement, ground floor and first storey (see Figure 4). These frames will be linked with the exterior walls and with the existing transversal beams of the reinforced concrete floor above the amphitheatre;
