Stone restoration at the Houses of Parliament in London

Stone Restoration at the Houses of Parliament in London
Rénovation de la maçonnerie en pierre du Parlement de Londres
Steinrestaurierung am House of Parliament in London

Henry WEBBER
Director
Parliamentary Works
London, England

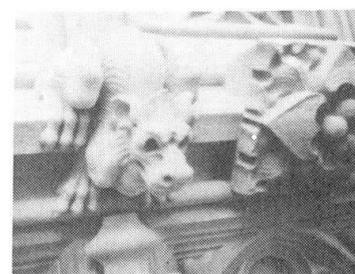
Fig.3 New Carvings

5.1 After cleaning, each area was reinspected and a detailed schedule of repairs was prepared. Defects included sulphate attack, stone spalling, clay beds and faults within the stone, missing pieces and water traps. The aim was to retain as much of the original stonework as possible, accepting weathered profiles. Repairs were undertaken where failure was likely during the 40 year maintenance cycle, to prevent water traps, to reduce the rate of decay and to reinstate important architectural details.

5.2 The stone repairs ranged from repointing, to dressing out water traps, repairing with stone dust mortar, piecing in small areas, the renewal of ashlar blocks and the replacement of elaborate carvings. For the Victoria Tower, which was by far the largest phase and included particularly rich ornamentation, a stone carving workshop was established on site staffed by masons and stone carvers who were able to recreate accurately the decayed decorative carvings, heraldic devices, statues and building details which it was necessary to cut out and replace.

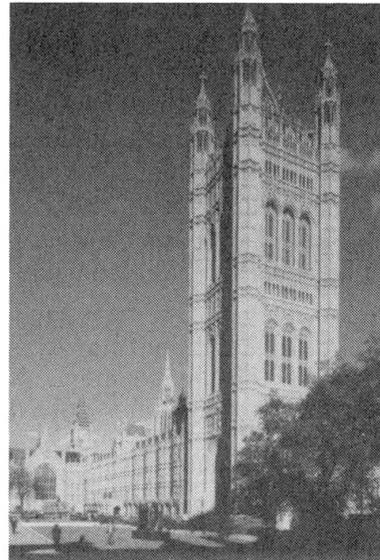
Fig.5 Restoration Complete

6.2.1 The Victoria Tower is roofed with large cast iron tiles on a trussed framework of cast and wrought iron. This is surmounted by a 28m high flag mast supported by ornate ironwork. Originally the tiles had a zinc anti-corrosion treatment which had failed very quickly in the acid Victorian city air and had been overcoated with a patent treatment. Research showed that many layers of lead based paint had also been applied over the years.

6.2.2 The aim was to put the roof in repair and provide a protective treatment which would last some 40 years. The accumulated layers of dirt and paint were removed back to bare metal by air abrasive blasting. Lead precautions included a full working enclosure, protective suits with air supply, air sampling outside the enclosure, disposal of the spent grit and dirt under controlled conditions and a decontamination unit for workmen. Broken cast iron tiles and jointing rolls were repaired by stitching, cold cast welding and off-site welding in an oven with controlled heating and cooling. Some new iron tiles, rolls and missing decorative features were cast, and after reassembly the roof surface was shot blasted and hot zinc sprayed. Pitting in the metal surface was stopped with an epoxy filler, followed by a sealing coat and finally a colour finish of vinyl co-polymer paint.

From analysis of paint scrapings, research in the Public Record Office, old photographs and contemporary descriptions it became clear that the gilding had originally been much more extensive and it was decided to restore the original decorative scheme. The gilding design was faithfully restored using 4,000 sheets of gold leaf and the completed scheme achieves a balance with the restored clock tower at the opposite end of the building, as Barry and Pugin originally intended.
