Zeitschrift: **IABSE reports = Rapports AIPC = IVBH Berichte**

Repair Methods for Deteriorated Sandstone Facades

Carolyn L. SEARLS

Daniel EILBECK

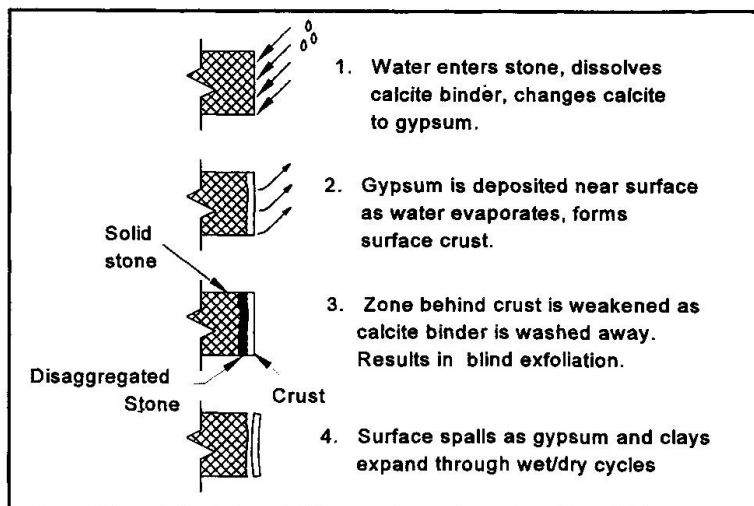
Figure 2: Deterioration Mechanism

The deterioration mechanism, shown in Figure 2, begins when water enters the stone. The water dissolves elements in the binding matrix while acidic pollutants in the water alter the calcite portion of the binder into gypsum. As the water evaporates during repeated wet-dry cycling, the gypsum is deposited at the surface of the stone and forms a surface crust approximately 2 mm thick. The process of forming the surface crust is known as "surface induration." Behind the crust, a layer of disaggregated stone is formed as the calcite binder is lost. Once formed, the crust will expand in all directions due to two mechanisms: -1 the gypsum expands as it incorporates water into its crystal structure, and -2 the montmorillinite clay expands in the presence of water. The crust is not as hard as the original stone, but it is much harder than the layer of disaggregated stone. Expansion of the crust cannot be restrained by the stone and eventually the crust exfoliates, and falls away from the body of the stone.
