Strengthening beams in the shear zone

Strengthening Beams in the Shear Zone

Anna KOSINSKA
Dr. Engineer
Technical University of Lodz
Lodz, Poland

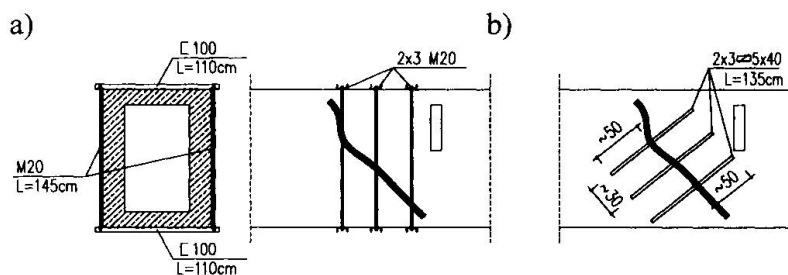
Fig. 1. Designed alternatives of strengthening

Two of all two-span box-girdes of the saw-tooth roof konstruktion of the spinning mill building were significantly cracked, closed to the intermediate support. The roof consists of triangular concrete prefabricated frames supported on these girders and covered with bearing bush plates. The main beams have the cross-section dimensions of $1.00 \times 1.35\text{m}$ and the spans of 18.0m. Their inner spaces are used to pull out air from the air-conditioning. Structural, statical and limit state analysis has been done, based on the investigation carried out in the building. There are few diagonal cracks on the side surfaces of the girders with the widths of 0.3 to 1.0mm, exceeding the limit values. The study of this case shows, that diagonal cross-section with the maximum crack width works in the worse conditions of the combined shear and bending. There are also effects of stresses due to shrinkage caused by the pull out air inside the girders and dry of the concrete. Ultimate shear capacity of the craced sections was calculated by the Polish Code method. The design shear resistance exceeds the shear force due to load, but with respect to serviceability limit state, two alternatives of strengthening the craced region were design as shown in fig. 1. Alternative b) represents the plate bonding technique and alternative a) is the traditional method of mechanical bonded externall stirrups.

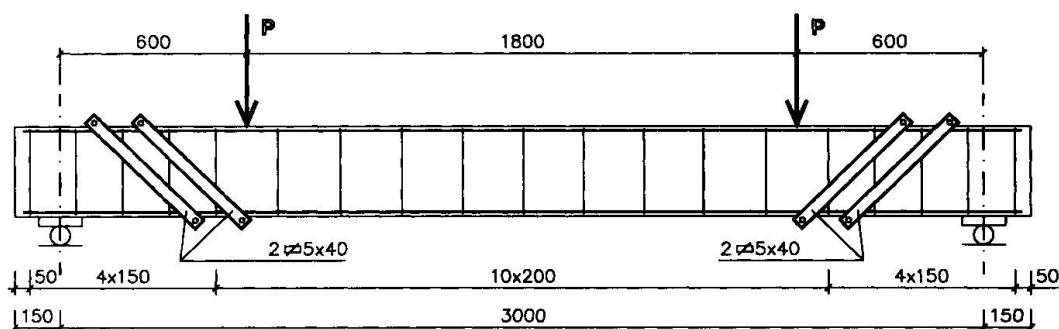
Fig. 2. Beam BS-2

Two beams ($b=0.20\text{m}$, $h=0.30\text{m}$) were made as underreinforced in the shear zone. The control beam BS-0 was not repaired and the beam BS-2 was first preloaded to about 65% of its ultimate load and precracked. Next it was strengthened by steel plates $5\times 40\text{mm}$, bonded and anchored to side faces in the support region using epoxy resins. Both beams failed as the result of diagonal tension cracking in the shear span regions. The effectiveness of the strengthening was 19 percent. The strengthened beam BS-2 failed prematurely by tearing off the concrete and plates before yielding of the external reinforcement. The stresses in the steel plates at failure were only $0.19f_y$. Their full ultimate capacity was not developed. But the stirrups were significantly unloaded (about 70%) by the external reinforcement comparing with the control beam, short before failure - see fig 3. It appeared to be important problem how to design the strengthening to avoid the premature failure of the beam. The strength of repaired concrete should be high enough and the maximum shear and peeling stresses at the interface should not exceed the limiting values at which tearing of the concrete takes place.
