Emergency Rehabilitation of the Zárate-Brazo Largo Bridges, Argentina

In November 1996 a cable ruptured on the Guazú Bridge across the Paraná River in Argentina, one of the two almost identical Zárate-Brazo Largo Bridges. COWI was immediately after retained as consultant by the bridge owner Dirección Nacional de Vialidad in order to ensure and document the safety of the bridges and to investigate the causes of the cable failure.

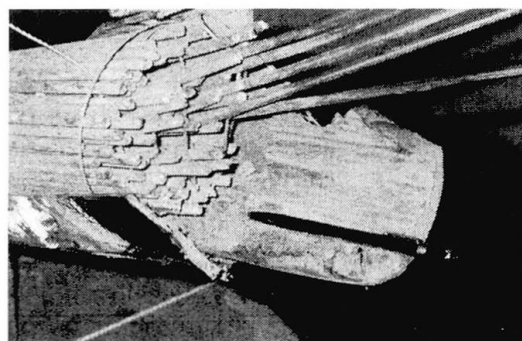
The evaluations revealed that a combination of corrosion and fatigue damage caused the failure of one cable, see Fig. 2, and large damages to a number of other cables. The corrosion was due to insufficient performance of the corrosion protection of the original cables. The cement grout, which was supposed to be the main active corrosion protection, was insufficient in the anchorage zone due to the presence of a non-protecting epoxy tar.

The fatigue damage has been severe due to larger traffic loads than accounted for in the original design, but not least due to large amplitude cable vibrations.

These amplitudes of the vibrations have been in the order of up to 1 m, which theoretically causes stress ranges well above the endurance limit of the wires. The corrosion has furthermore increased the fatigue stresses locally due to stress concentration.

Fig. 2 Ruptured cable

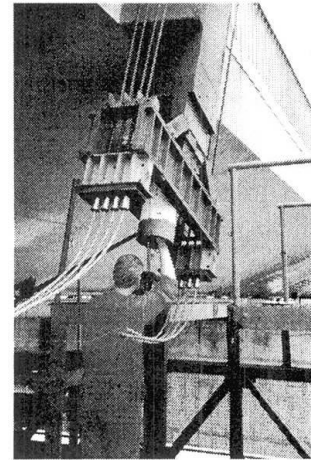
Fig. 3 Ultrasonic inspection of original cable. Temporary strengthening also shown.

The present condition of the cables were investigated through ultrasonic inspection as shown in Fig. 3. The investigations revealed that a number of cables were deteriorated with up to 62% damage of the original cable cross section. The material properties of the wires were established from tensile and fatigue tests carried out on specimens from the cables replaced first. The tests revealed that the tensile strength of the tested wires were below the original design values and that severe fatigue damage had taken place. The wires did no longer have an endurance limit.

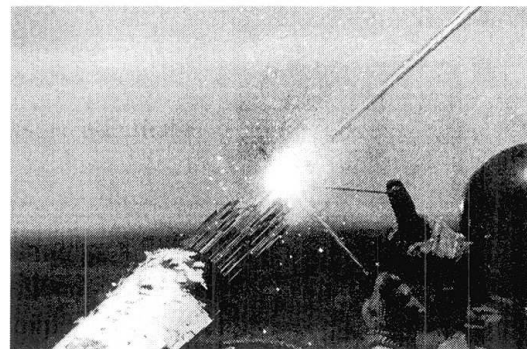
Fig. 4 Removal of existing cable by cutting of individual wires

A total of 13 cables were replaced during the emergency rehabilitation. The existing cables have been removed by cutting of the individual wires as seen in Fig. 4. It has been recommended to provide temporary wind ropes between the cables in order to limit the large amplitude cable vibrations. Furthermore, installation of guide deviators has been recommended in order to reduce the bending stresses in the anchorage zone.
