Emergency rehabilitation of the Zárate-Brazo Largo Bridges, Argentina

Emergency Rehabilitation of the Zárate-Brazo Largo Bridges, Argentina

In November 1996 a cable ruptured on the Guazú Bridge across the Paraná River in Argentina, one of the two almost identical Zárate-Brazo Largo Bridges. COWI was immediately after retained as consultant by the bridge owner Dirección Nacional de Vialidad in order to ensure and document the safety of the bridges and to investigate the causes of the cable failure.

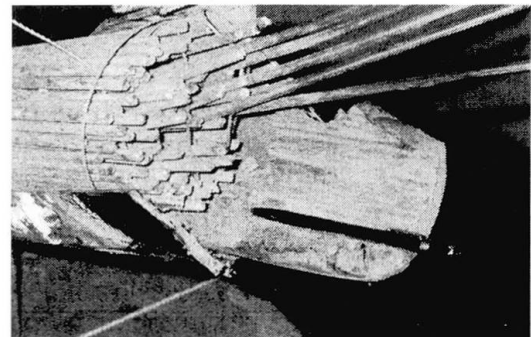
The evaluations revealed that a combination of corrosion and fatigue damage caused the failure of one cable, see Fig. 2, and large damages to a number of other cables. The corrosion was due to insufficient performance of the corrosion protection of the original cables. The cement grout, which was supposed to be the main active corrosion protection, was insufficient in the anchorage zone due to the presence of a non-protecting epoxy tar.

The fatigue damage has been severe due to larger traffic loads than accounted for in the original design, but not least due to large amplitude cable vibrations.

These amplitudes of the vibrations have been in the order of up to 1 m, which theoretically causes stress ranges well above the endurance limit of the wires. The corrosion has furthermore increased the fatigue stresses locally due to stress concentration.

Fig. 2 Ruptured cable
