**Structures to Withstand Natural Disasters:
Experiences and Applications**

Seismic Damage and Retrofit to California's Urban Concrete Bridge Structures

Frieder SEIBLE

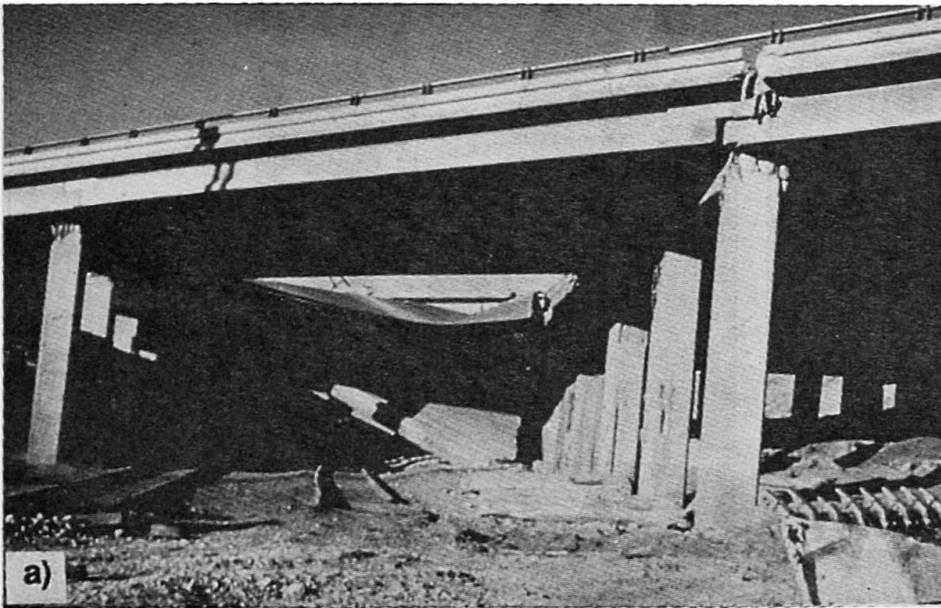
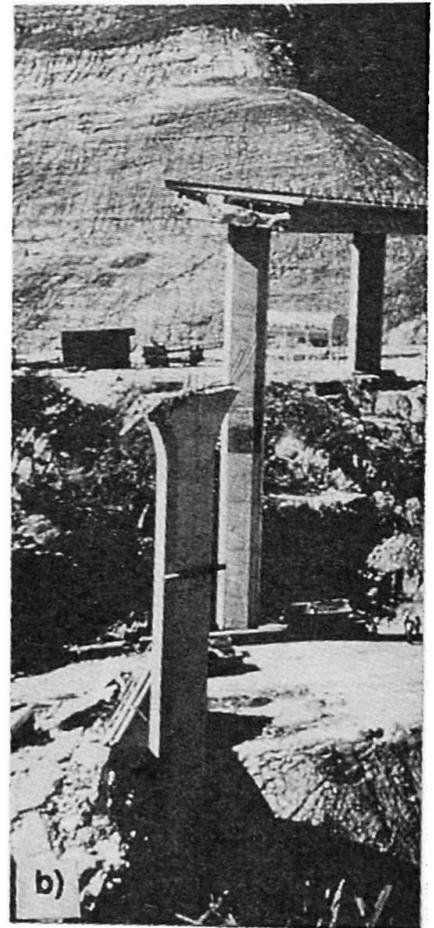
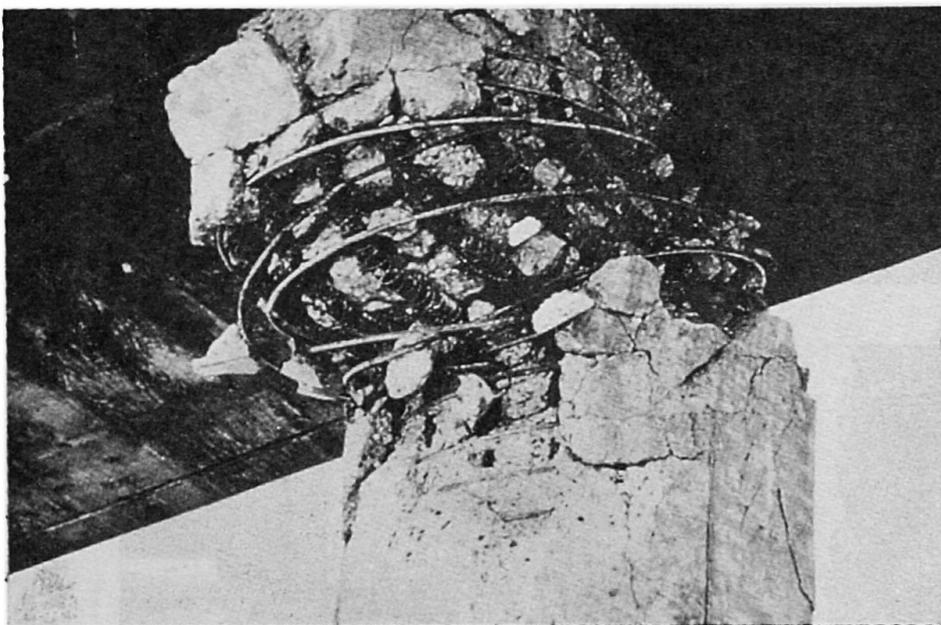
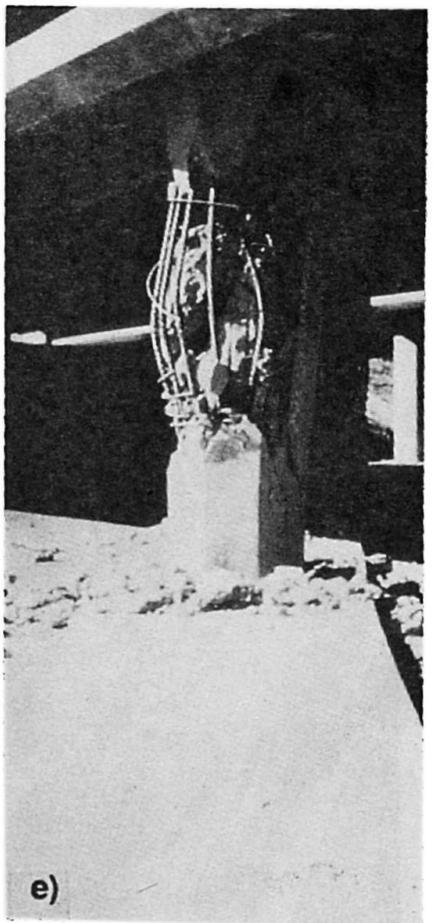
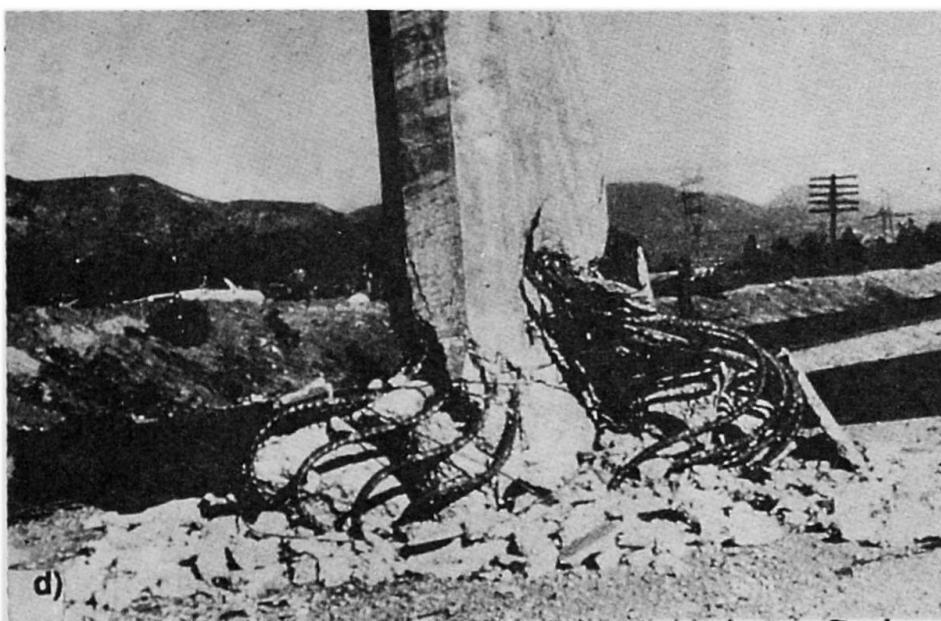
Fig 1. Bridge Damage During the 1971 San Fernando Earthquake

The 1971 San Fernando earthquake caused significant bridge damage, particularly to newly constructed interstate bridges. Key problems identified ranged from excessive seismic displacements and subsequent unseating of complete bridge spans at movement joints, see Figs. 1a and b, inadequate confinement of flexural plastic hinge regions in columns, see Figs. 1c and d, and Figs. 2a and b, anchorage problems with large diameter \varnothing 57 mm (#18) column reinforcement into the footing, see Fig. 2d, brittle shear failure of short columns with insufficient shear reinforcement, see Fig. 1e, and joint failures of knee joints due to the lack of joint shear reinforcement, see Fig. 2c. It is of interest to note that subsequent earthquakes such as Whittier (1987) and Loma Prieta (1989) did not uncover completely new problem areas which were not already identified in San Fernando (1971) but rather reemphasized some of the above mentioned problems.

While design guidelines for new bridge structures were immediately changed to reflect higher seismic force levels, confinement of column concrete particularly in potential plastic hinge regions and increased force and displacement requirements for movement joints, seismic retrofitting of existing bridge structures focussed initially on movement joint restrainers to prevent unseating and span collapse.

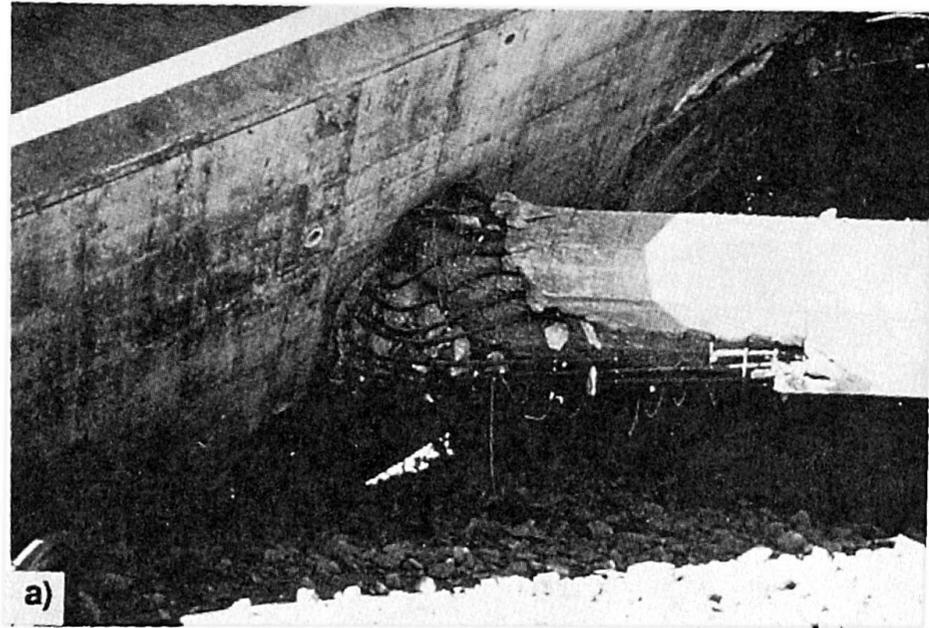
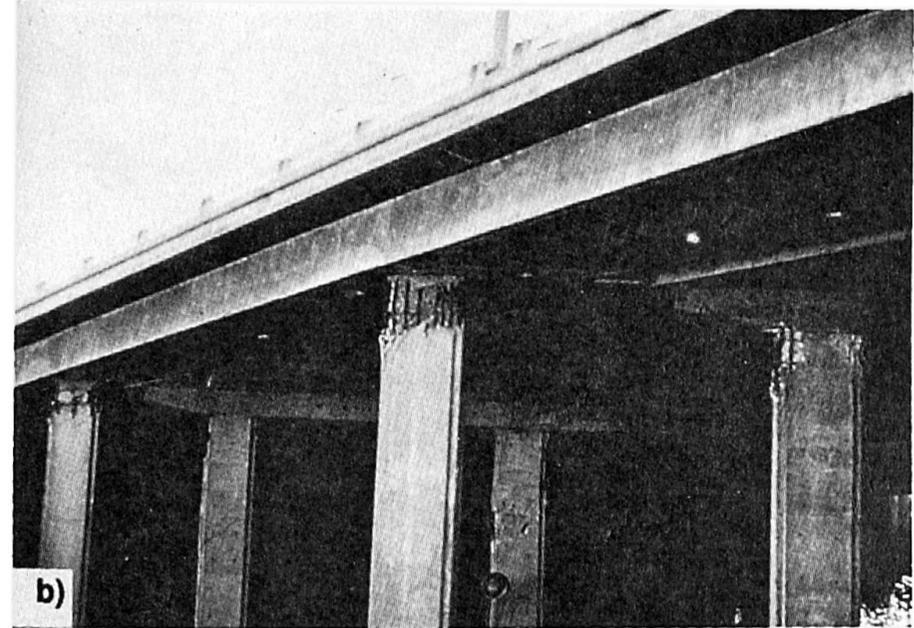
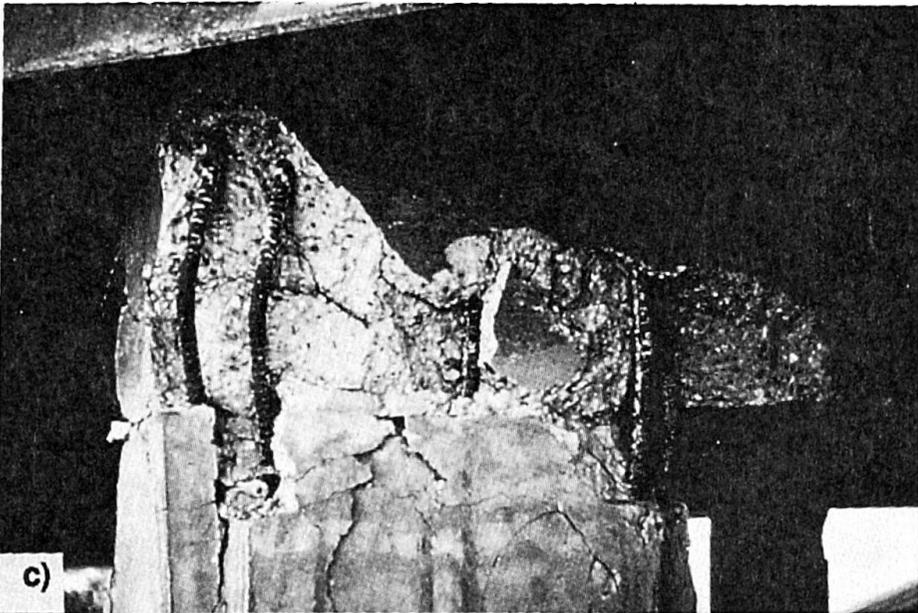
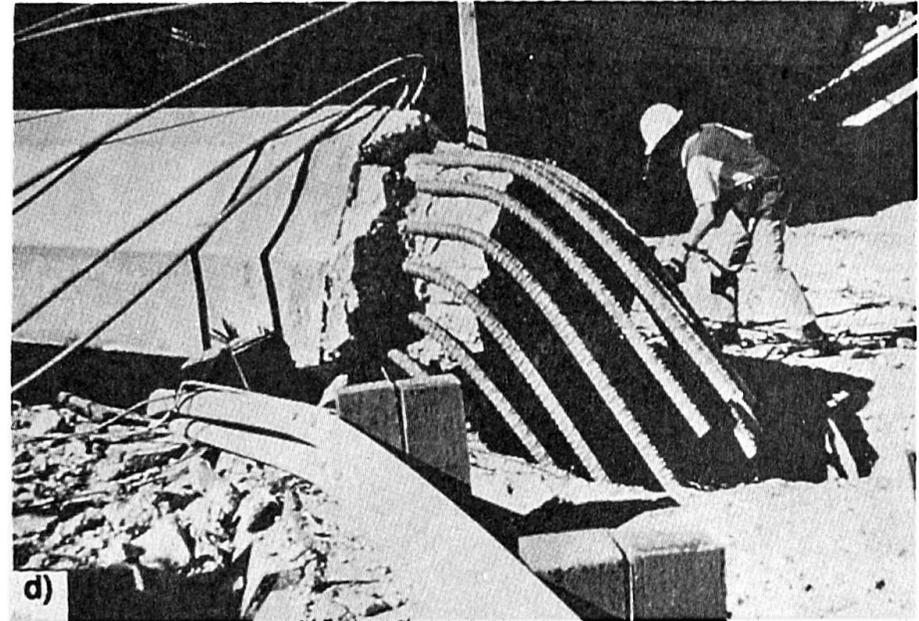
Fig 2. San Fernando Earthquake Bridge Damage (continued)

The Whittier earthquake (1987) caused significant damage only to one urban concrete bridge structure, the I-5/605 crossing where short piers of a skew multi column-bent bridge structure failed in shear. The large number of existing freeway overheads which feature these short piers, designed and constructed prior to 1971, pose probably the most severe seismic bridge hazard in

urban concrete freeway systems since transverse pier reinforcement typically consisted of nominal 12 mm \varnothing bars @ 300 mm (#4 @ 12 in.) and was not designed for the plastic shear which can be developed by the flexural column capacity, based on current seismic capacity design principles [5].

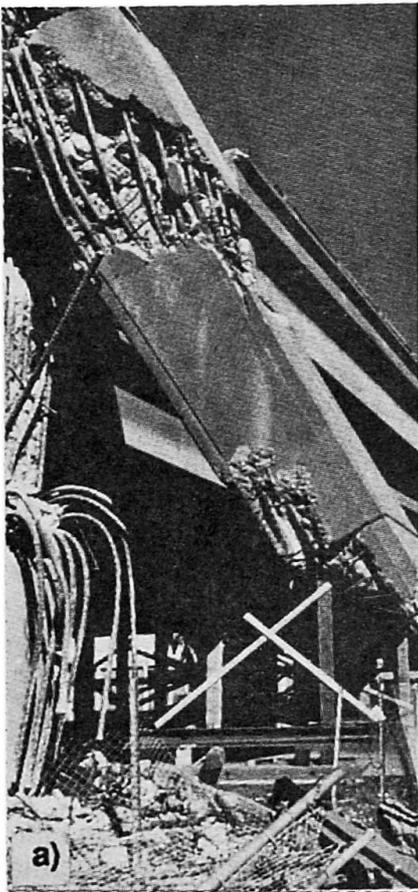
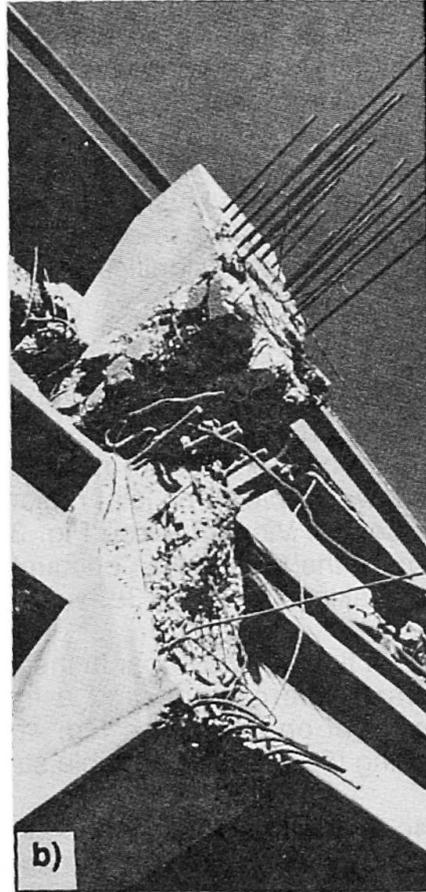
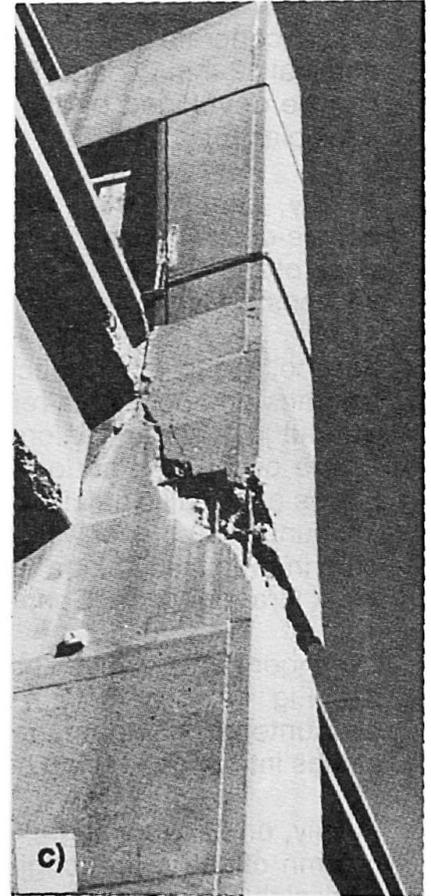
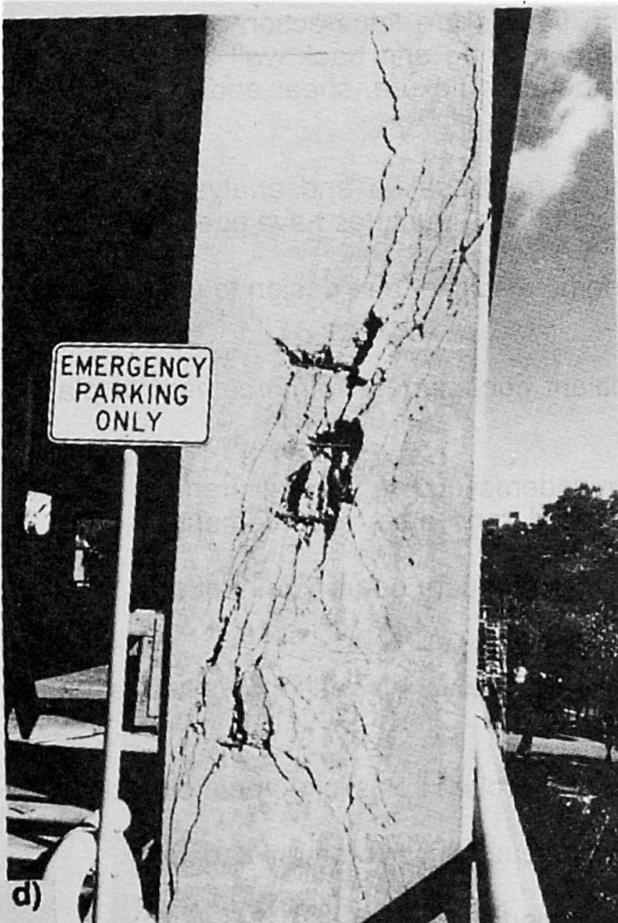
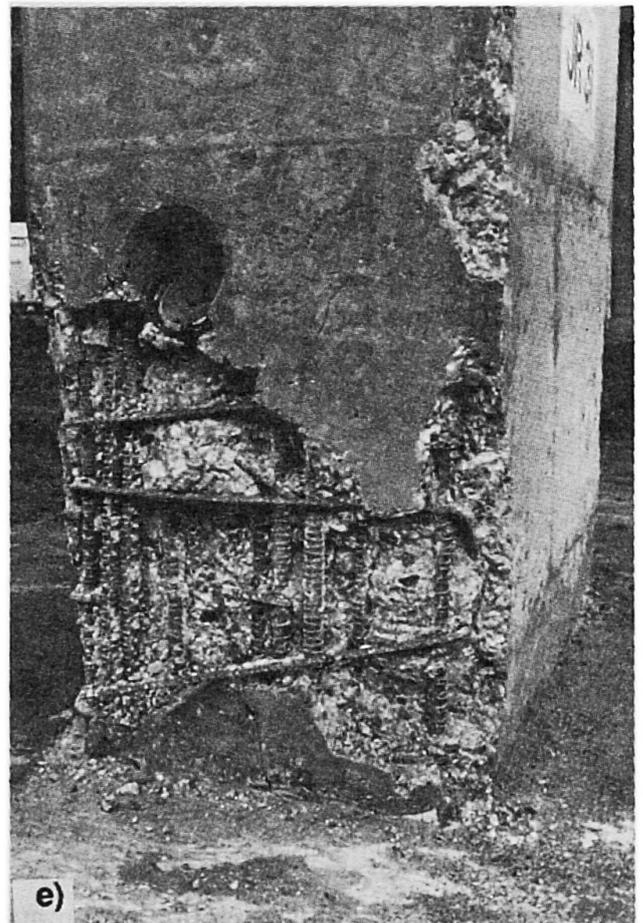
Fig 3. Bridge Damage, Loma Prieta 1989 (M7.1)

Finally, Loma Prieta (1989) revisited all previously encountered problems with emphasis on double-deck viaduct structures through the collapse of a 1 km (0.7 mile) long section of the upper deck of the Cypress Viaduct in Oakland, and significant damage to other double-deck viaduct sections in San Francisco.

The collapsed upper deck of the Cypress Viaduct in Oakland is shown in Fig. 3a, featuring columns and pedestals reinforced with 12 mm \varnothing ties @ 300 mm (#4 @ 12 in.) and joint regions without joint shear reinforcement. Figure 3b depicts a lower cap/column connection with pullout failure of top and bottom cap reinforcement due to inadequate anchorage length and Fig. 3c shows a typical joint failure of the lower cap/column joint region. Typical column shear failure was encountered on Highway 101 – Central Viaduct – see Fig. 3d, and lap-splice failure of column bars in the plastic hinge at the top of the footing was encountered in single-column bents on the West Grand Avenue Connector in Oakland, see Fig. 3e.

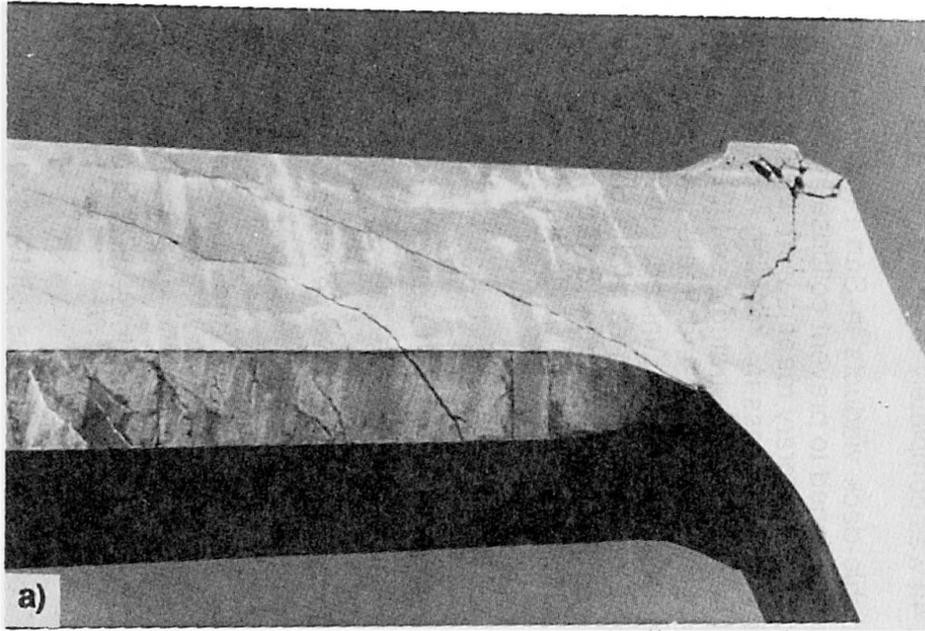
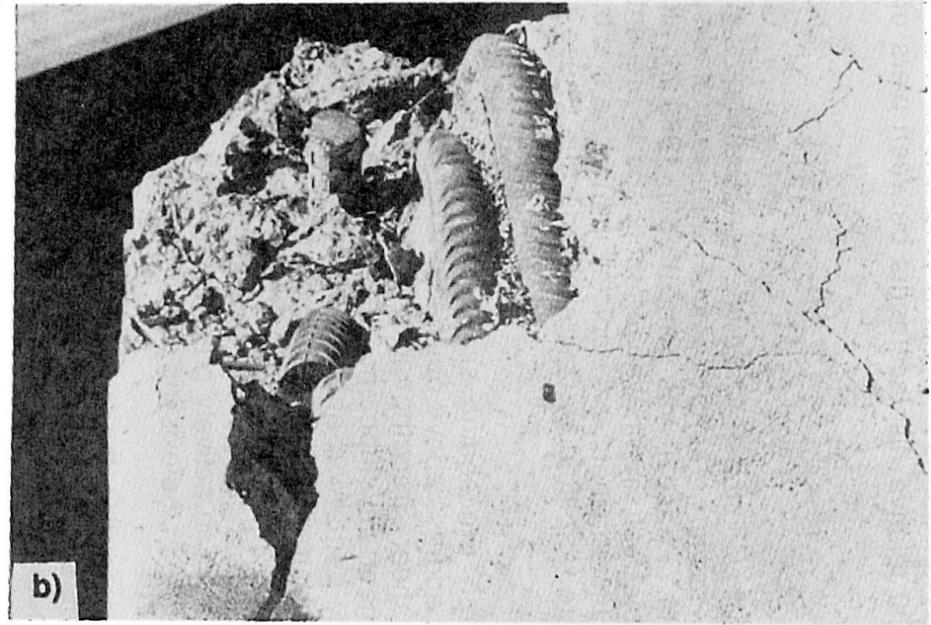
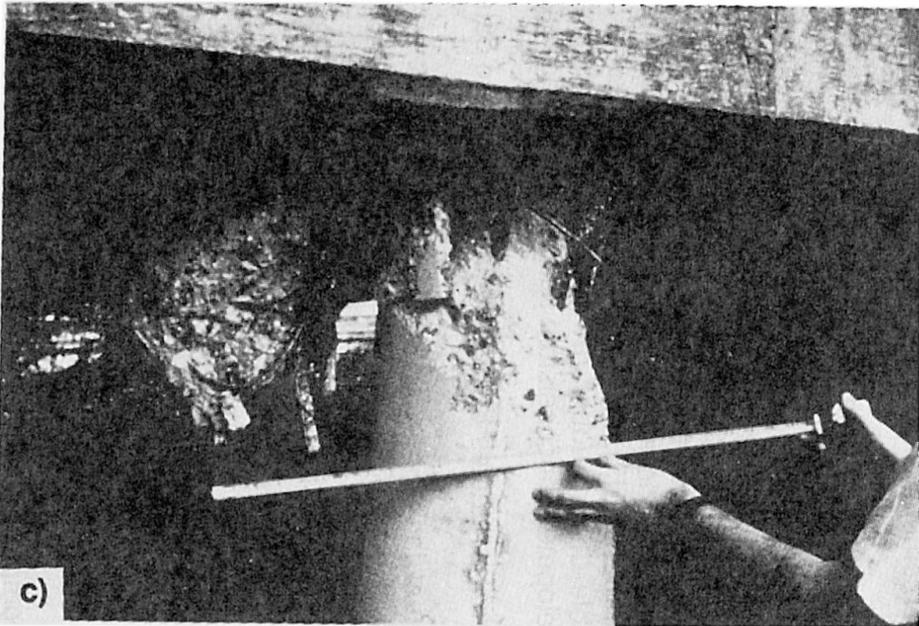
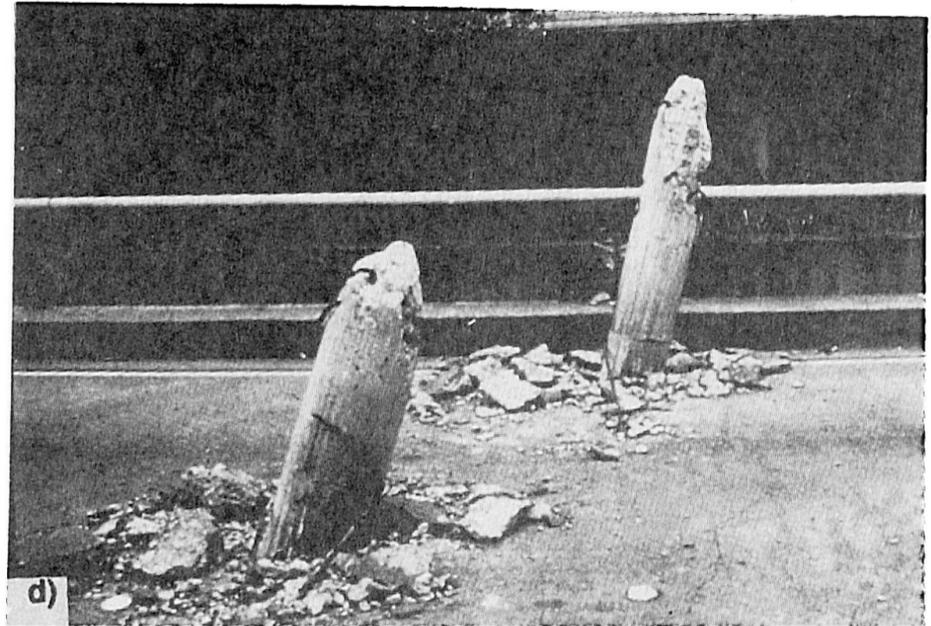
Fig 4. Knee Joint and Plastic Hinge Failure, Loma Prieta 1989

Outrigger bents showed problems in flexure and shear in the cap and shear failure of knee joints, see Fig. 4a, due to lack of shear reinforcement, and a fractured 57 mm \varnothing (#18) bar was encountered in a damaged knee joint on I-980, see Fig. 4b, which can be attributed to large strains introduced during bar bending (6.25%) and possible strain aging effects.

Finally, on struve slough, Figs. 4c and d, the plastic hinge at the column top sheared off and the column offset in the longitudinal bridge direction and punched through the reinforced concrete deck slab.

A flared pier wall which experienced shear distress during the Loma Prieta earthquake was repaired and retrofitted with a full height steel jacket, see Fig. 5c, for increased shear capacity. The previously discussed joint shear failure in an outrigger knee joint of I-980, see Fig. 4b was repaired by full replacement of the joint concrete, see Fig. 6d, and added joint shear reinforcement, while the outrigger bent shown in Fig. 4a was completely replaced, see Fig. 5e.
