Seismic Damage and Retrofit to California's Urban Concrete Bridge Structures

Frieder SEIBLE
Prof. of Struct. Eng.
Univ. of California
San Diego La Jolla, CA, USA

The Loma Prieta earthquake of October 1989 has re-emphasized the vulnerability and failure consequences of urban freeway bridges in a major seismic event. An overview of encountered urban bridge damage in recent earthquakes in California, is presented together with retrofit strategies to mitigate seismic bridge hazards in future earthquakes. Photo documentation of encountered damage and implemented temporary and permanent retrofit measures is provided.

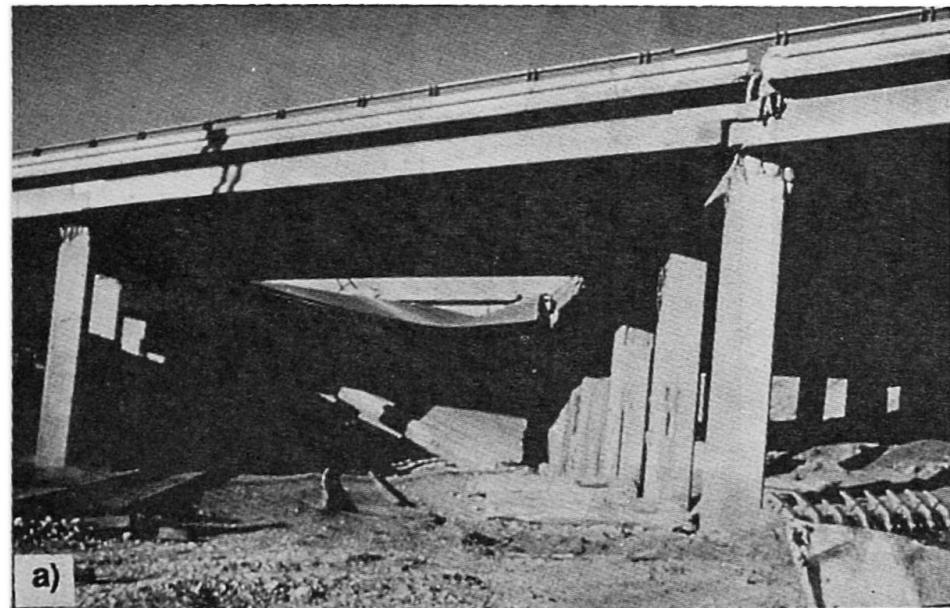
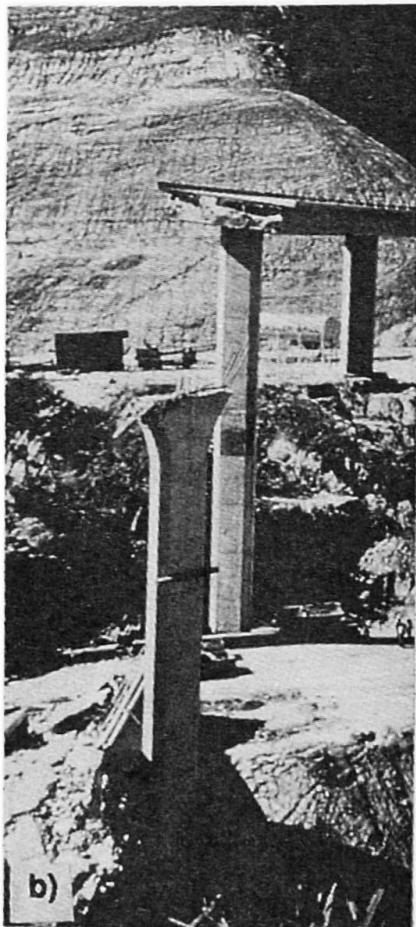
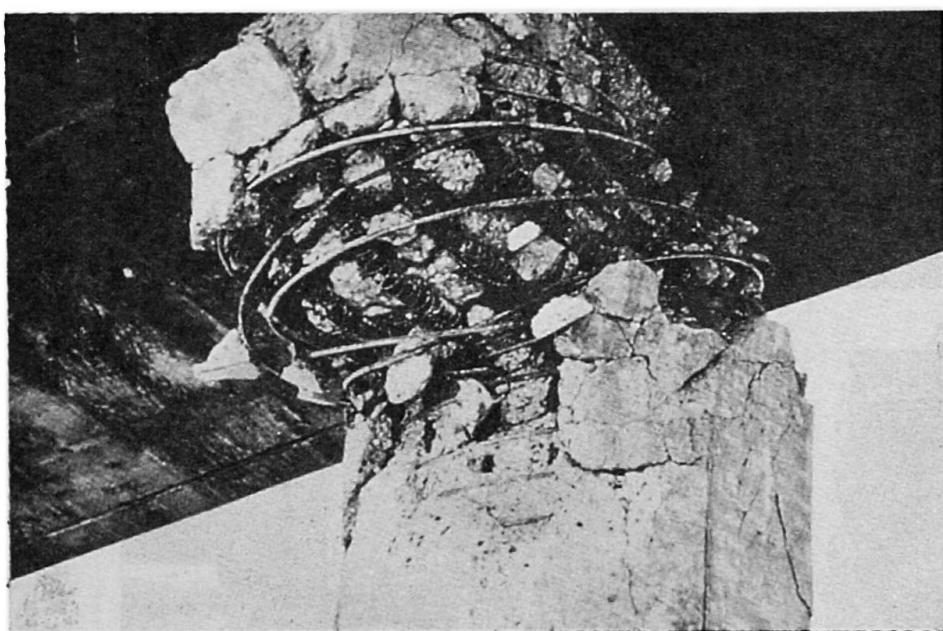
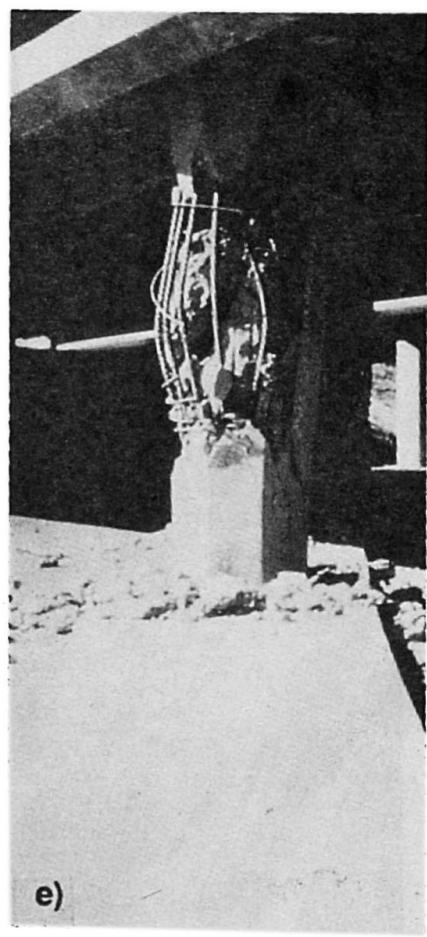
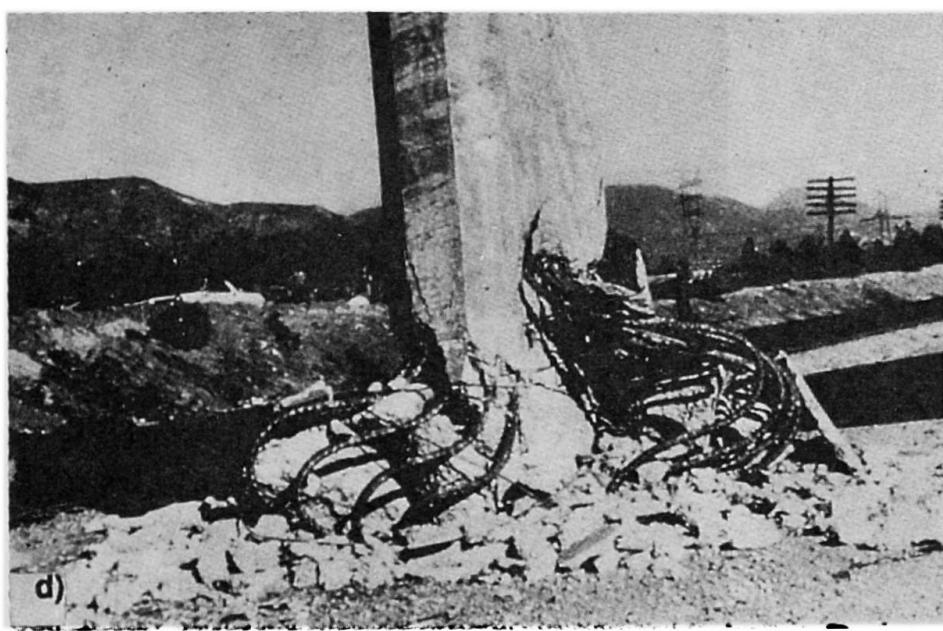
Fig 1. Bridge Damage During the 1971 San Fernando Earthquake

The 1971 San Fernando earthquake caused significant bridge damage, particularly to newly constructed interstate bridges. Key problems identified ranged from excessive seismic displacements and subsequent unseating of complete bridge spans at movement joints, see Figs. 1a and b, inadequate confinement of flexural plastic hinge regions in columns, see Figs. 1c and d, and Figs. 2a and b, anchorage problems with large diameter \varnothing 57 mm (#18) column reinforcement into the footing, see Fig. 2d, brittle shear failure of short columns with insufficient shear reinforcement, see Fig. 1e, and joint failures of knee joints due to the lack of joint shear reinforcement, see Fig. 2c. It is of interest to note that subsequent earthquakes such as Whittier (1987) and Loma Prieta (1989) did not uncover completely new problem areas which were not already identified in San Fernando (1971) but rather reemphasized some of the above mentioned problems.

While design guidelines for new bridge structures were immediately changed to reflect higher seismic force levels, confinement of column concrete particularly in potential plastic hinge regions and increased force and displacement requirements for movement joints, seismic retrofitting of existing bridge structures focussed initially on movement joint restrainers to prevent unseating and span collapse.

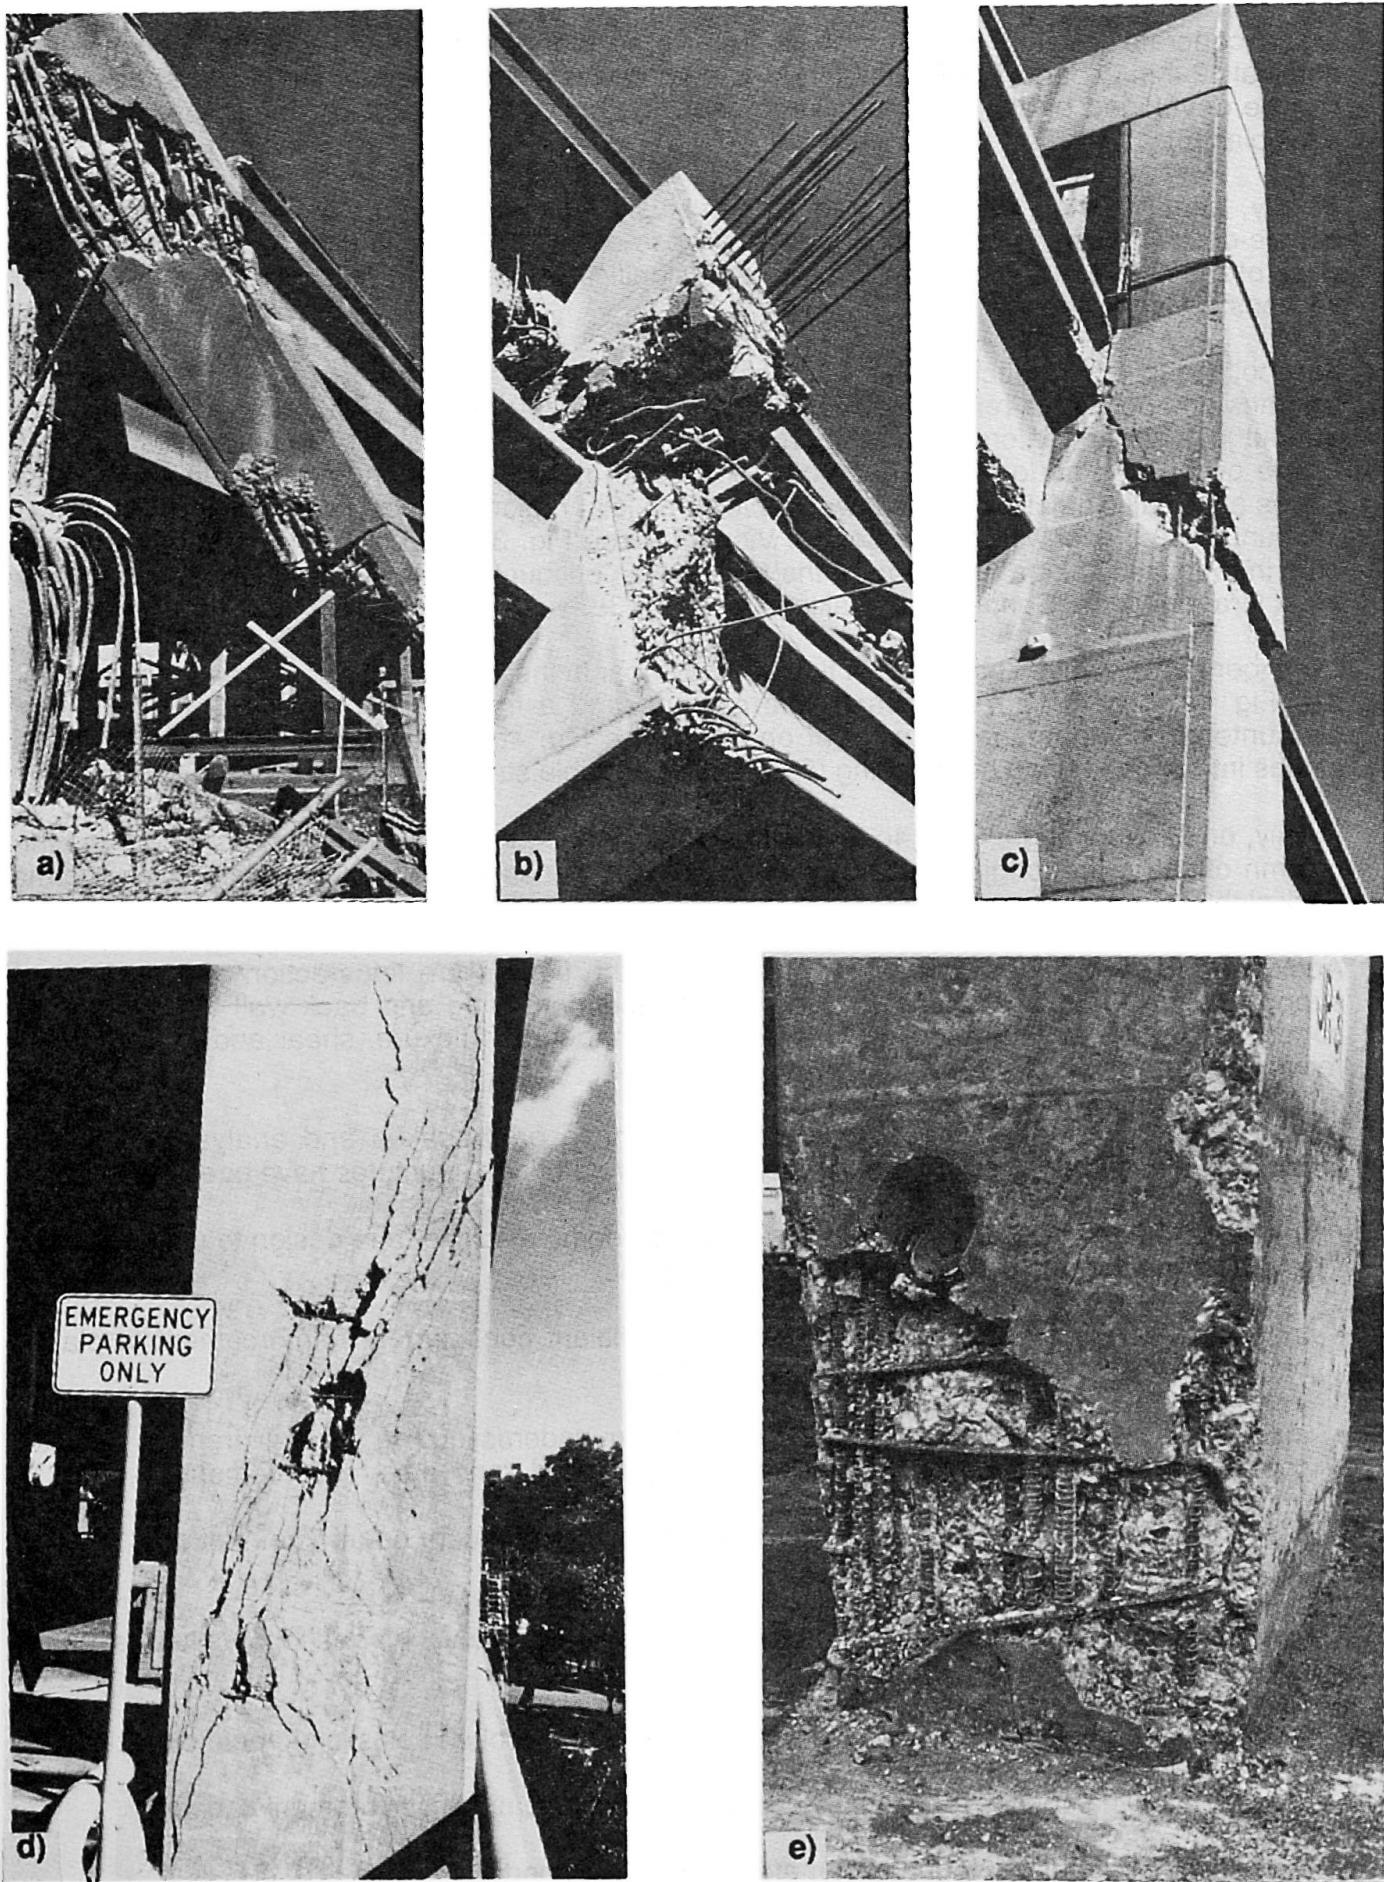
Fig 3. Bridge Damage, Loma Prieta 1989 (M7.1)

Finally, Loma Prieta (1989) revisited all previously encountered problems with emphasis on double-deck viaduct structures through the collapse of a 1 km (0.7 mile) long section of the upper deck of the Cypress Viaduct in Oakland, and significant damage to other double-deck viaduct sections in San Francisco.

The collapsed upper deck of the Cypress Viaduct in Oakland is shown in Fig. 3a, featuring columns and pedestals reinforced with 12 mm Ø ties @ 300 mm (#4 @ 12 in.) and joint regions without joint shear reinforcement. Figure 3b depicts a lower cap/column connection with pullout failure of top and bottom cap reinforcement due to inadequate anchorage length and Fig. 3c shows a typical joint failure of the lower cap/column joint region. Typical column shear failure was encountered on Highway 101 – Central Viaduct – see Fig. 3d, and lap-splice failure of column bars in the plastic hinge at the top of the footing was encountered in single-column bents on the West Grand Avenue Connector in Oakland, see Fig. 3e.

Following the Loma Prieta earthquake, several double-deck viaducts in San Francisco were closed to traffic and temporary retrofit strategies were designed to prevent collapse in the case of additional seismic activity in the near future. Some of the temporary retrofits were fully or partially implemented, see Figs. 6a, b and c. However, their ineffectiveness in providing required lateral confinement levels and their lack of global structural seismic retrofit strategy, see [3], prompted a reevaluation of these temporary retrofit schemes and resulted in the immediate design of permanent and final retrofit measures, which are currently being scrutinized, proof tested and implemented [3]. The difficulties encountered during the design process of the San Francisco double-deck viaduct retrofits and other ongoing retrofit projects showed the need for the development of consistent seismic assessment and retrofit strategies for bridge structures.

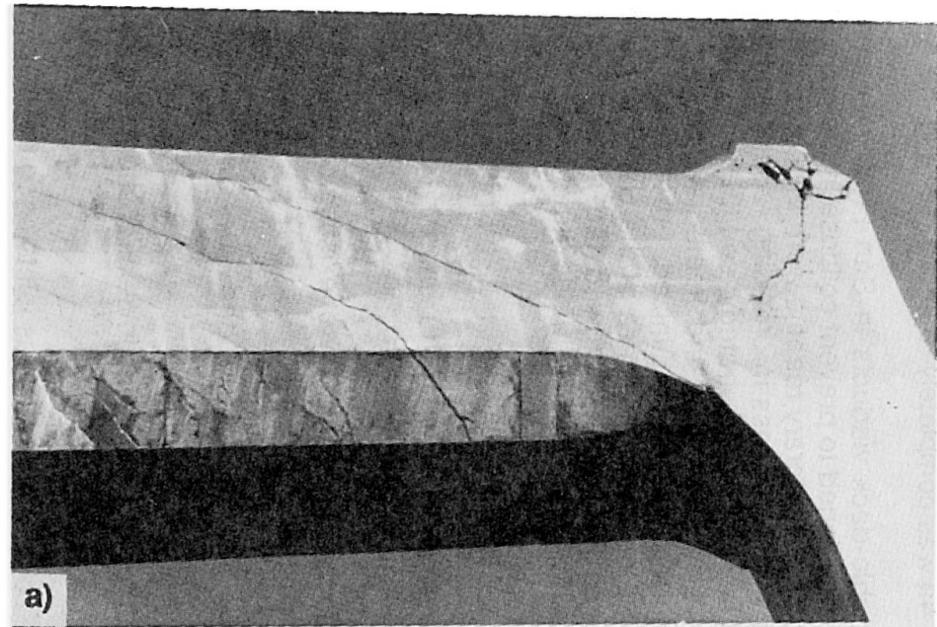
a)

Outrigger bents showed problems in flexure and shear in the cap and shear failure of knee joints, see Fig. 4a, due to lack of shear reinforcement, and a fractured 57 mm Ø (#18) bar was encountered in a damaged knee joint on I-980, see Fig. 4b, which can be attributed to large strains introduced during bar bending (6.25%) and possible strain aging effects.

A flared pier wall which experienced shear distress during the Loma Prieta earthquake was repaired and retrofitted with a full height steel jacket, see Fig. 5c, for increased shear capacity. The previously discussed joint shear failure in an outrigger knee joint of I-980, see Fig. 4b was repaired by full replacement of the joint concrete, see Fig. 6d, and added joint shear reinforcement, while the outrigger bent shown in Fig. 4a was completely replaced, see Fig. 5e.

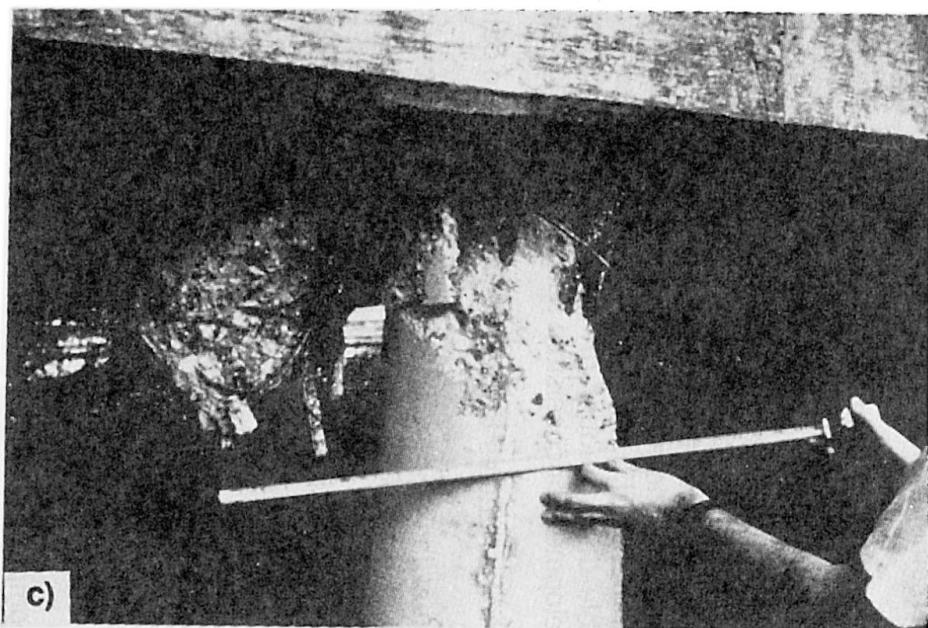
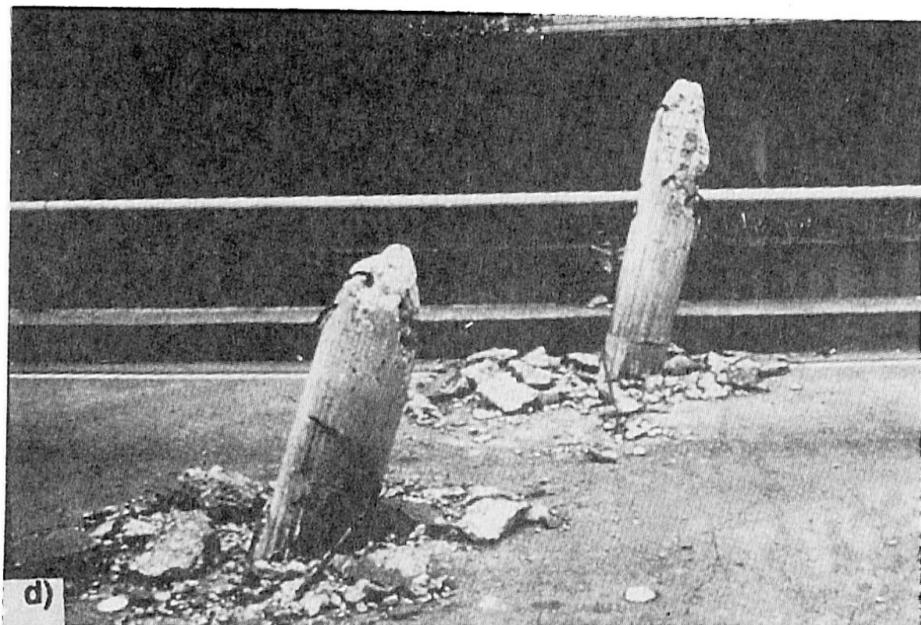
Fig 4. Knee Joint and Plastic Hinge Failure, Loma Prieta 1989

Finally, on struve slough, Figs. 4c and d, the plastic hinge at the column top sheared off and the column offset in the longitudinal bridge direction and punched through the reinforced concrete deck slab.
