**Rubrik:** Seminar 3: Structures to withstand natural disasters: experiences and applications

## **Seismic Damage and Retrofit to California's Urban Concrete Bridge Structures**

### **Frieder SEIBLE**

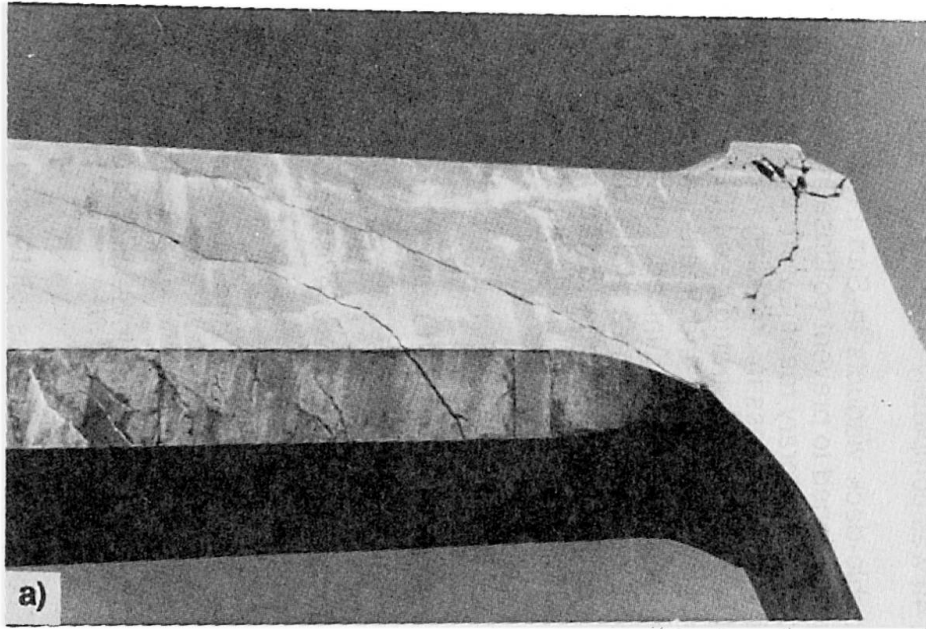
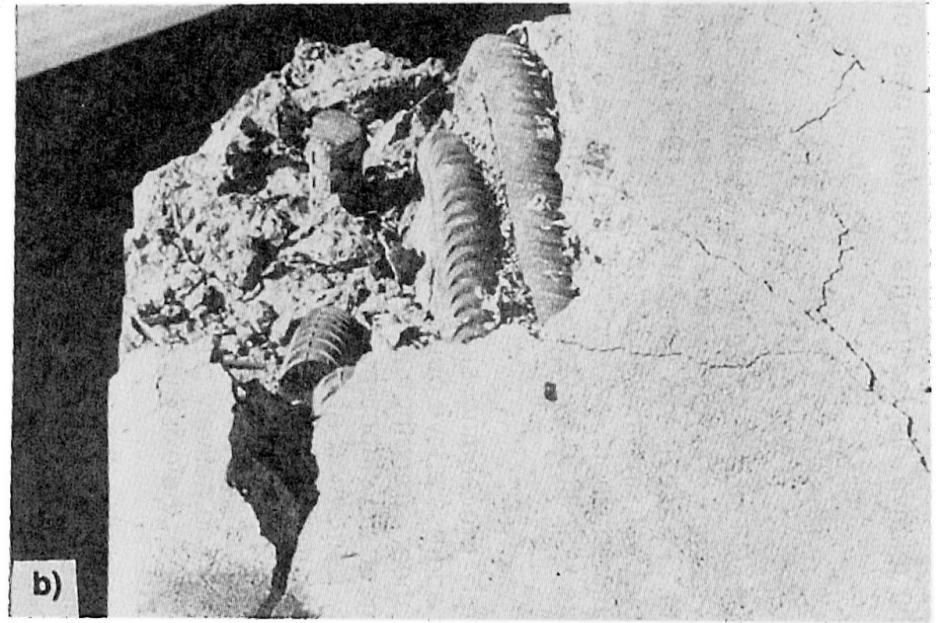
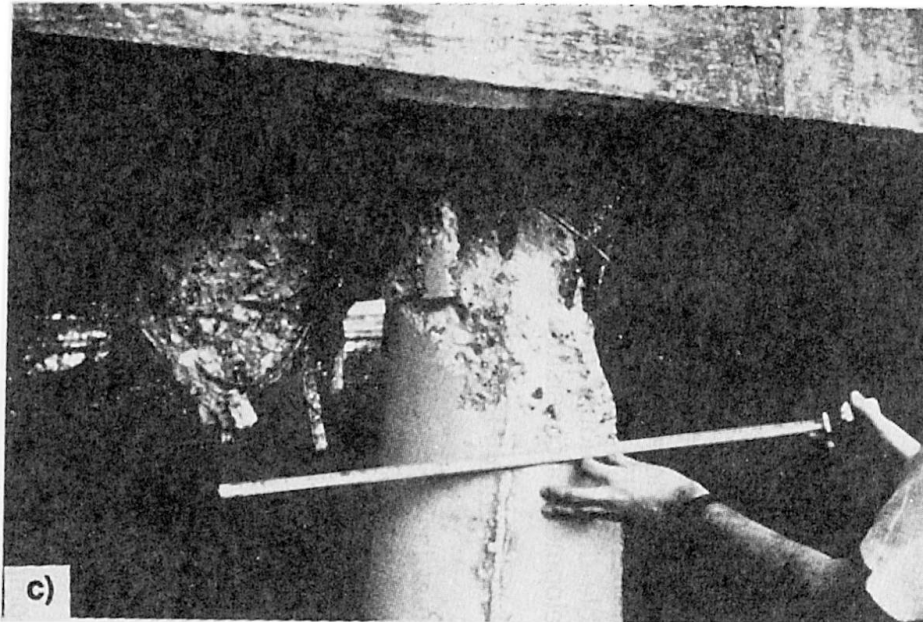
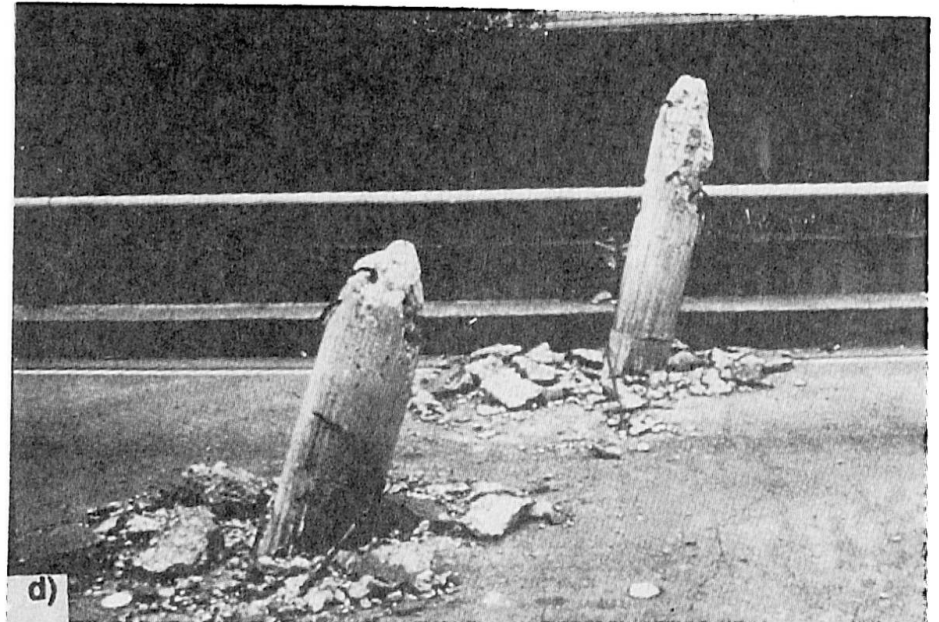
**Fig 4. Knee Joint and Plastic Hinge Failure, Loma Prieta 1989**

Outrigger bents showed problems in flexure and shear in the cap and shear failure of knee joints, see Fig. 4a, due to lack of shear reinforcement, and a fractured 57 mm  $\varnothing$  (#18) bar was encountered in a damaged knee joint on I-980, see Fig. 4b, which can be attributed to large strains introduced during bar bending (6.25%) and possible strain aging effects.

Finally, on struve slough, Figs. 4c and d, the plastic hinge at the column top sheared off and the column offset in the longitudinal bridge direction and punched through the reinforced concrete deck slab.

A flared pier wall which experienced shear distress during the Loma Prieta earthquake was repaired and retrofitted with a full height steel jacket, see Fig. 5c, for increased shear capacity. The previously discussed joint shear failure in an outrigger knee joint of I-980, see Fig. 4b was repaired by full replacement of the joint concrete, see Fig. 6d, and added joint shear reinforcement, while the outrigger bent shown in Fig. 4a was completely replaced, see Fig. 5e.
