Seminar 3: Structures to withstand natural disasters: experiences and applications

Zeitschrift: **IABSE congress report = Rapport du congrès AIPC = IVBH
Kongressbericht**

Seismic Damage and Retrofit to California's Urban Concrete Bridge Structures

Frieder SEIBLE

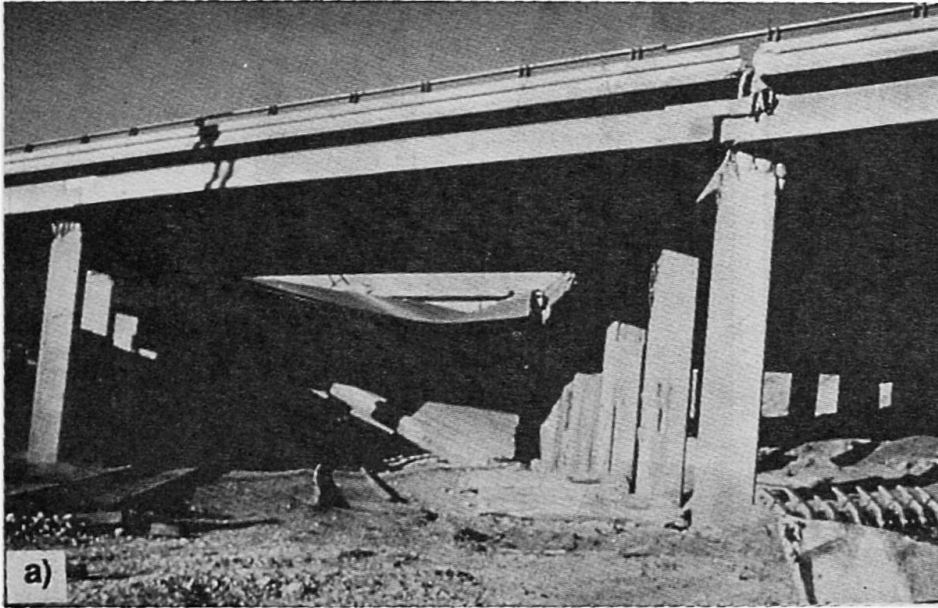
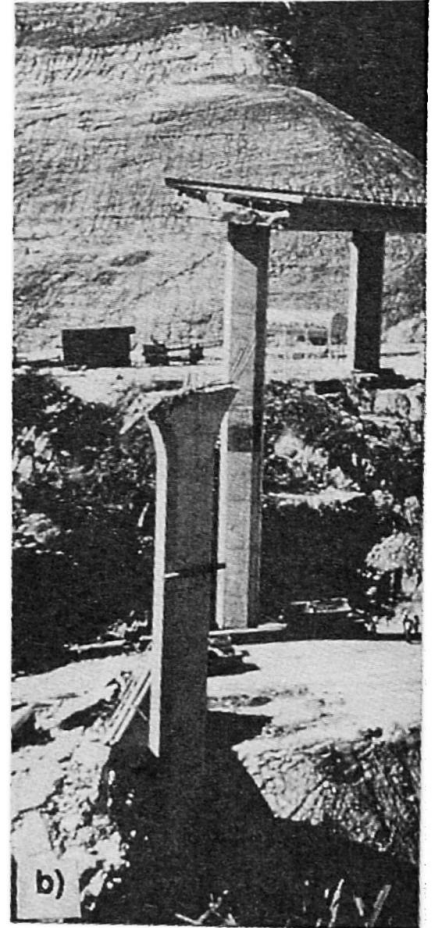
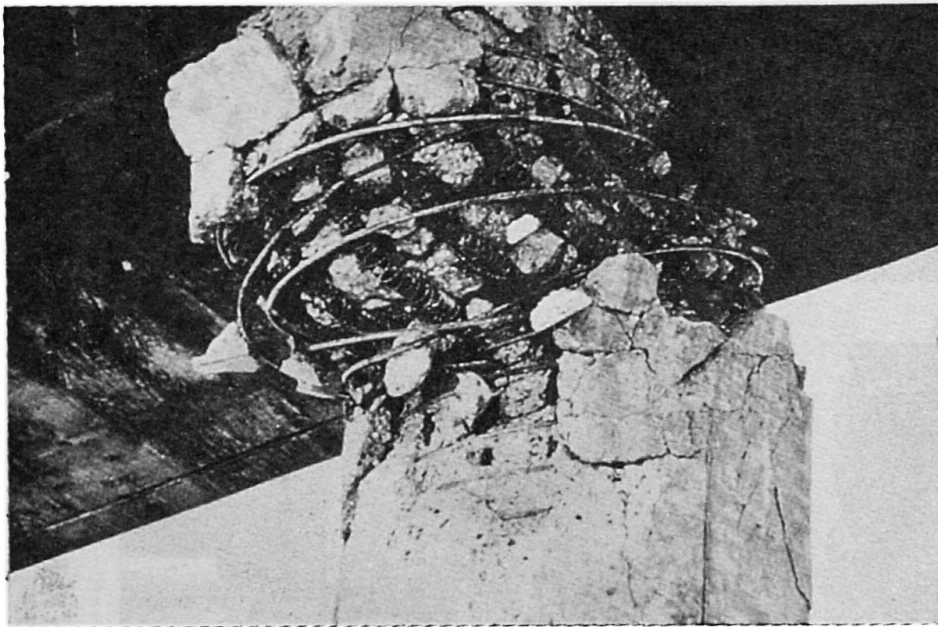
Fig 1. Bridge Damage During the 1971 San Fernando Earthquake

The 1971 San Fernando earthquake caused significant bridge damage, particularly to newly constructed interstate bridges. Key problems identified ranged from excessive seismic displacements and subsequent unseating of complete bridge spans at movement joints, see Figs. 1a and b, inadequate confinement of flexural plastic hinge regions in columns, see Figs. 1c and d, and Figs. 2a and b, anchorage problems with large diameter \varnothing 57 mm (#18) column reinforcement into the footing, see Fig. 2d, brittle shear failure of short columns with insufficient shear reinforcement, see Fig. 1e, and joint failures of knee joints due to the lack of joint shear reinforcement, see Fig. 2c. It is of interest to note that subsequent earthquakes such as Whittier (1987) and Loma Prieta (1989) did not uncover completely new problem areas which were not already identified in San Fernando (1971) but rather reemphasized some of the above mentioned problems.

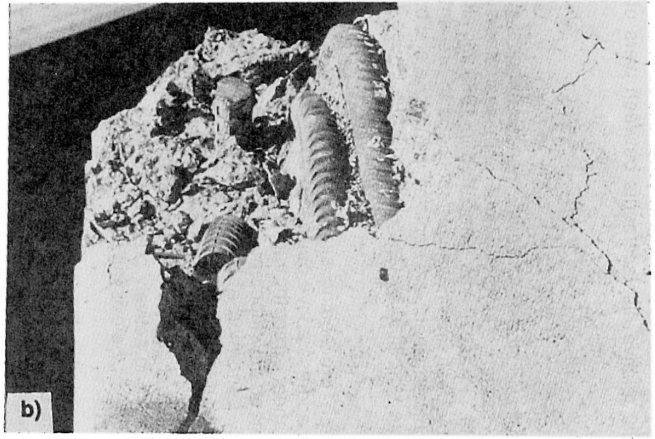
Fig 4. Knee Joint and Plastic Hinge Failure, Loma Prieta 1989

Outrigger bents showed problems in flexure and shear in the cap and shear failure of knee joints, see Fig. 4a, due to lack of shear reinforcement, and a fractured 57 mm \varnothing (#18) bar was encountered in a damaged knee joint on I-980, see Fig. 4b, which can be attributed to large strains introduced during bar bending (6.25%) and possible strain aging effects.

A flared pier wall which experienced shear distress during the Loma Prieta earthquake was repaired and retrofitted with a full height steel jacket, see Fig. 5c, for increased shear capacity. The previously discussed joint shear failure in an outrigger knee joint of I-980, see Fig. 4b was repaired by full replacement of the joint concrete, see Fig. 6d, and added joint shear reinforcement, while the outrigger bent shown in Fig. 4a was completely replaced, see Fig. 5e.
