**Artikel:** Seismic damage and retrofit to California's urban concrete bridge  
structures

**Autor:** Seible, Frieder

## **Seismic Damage and Retrofit to California's Urban Concrete Bridge Structures**

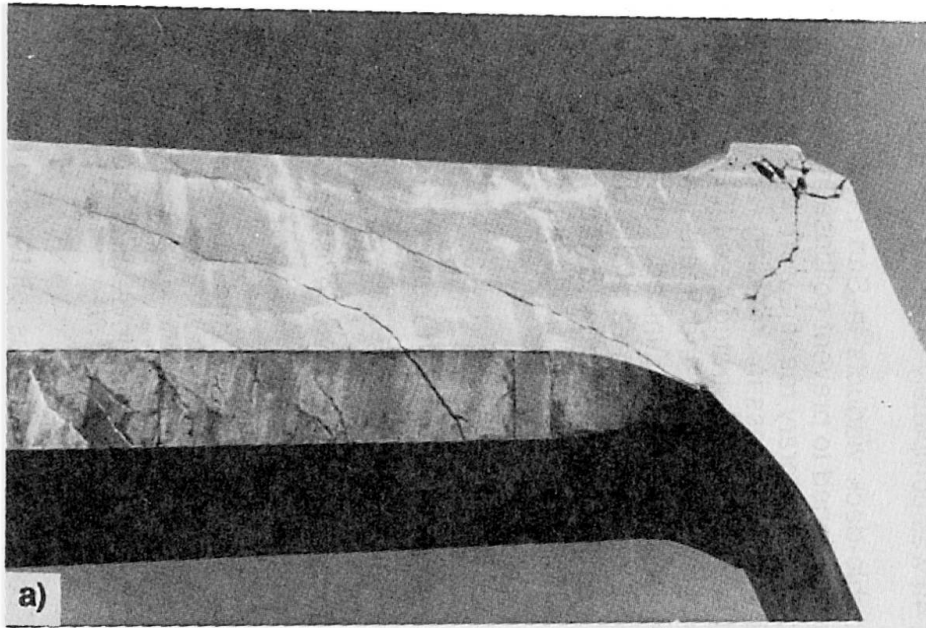
Outrigger bents showed problems in flexure and shear in the cap and shear failure of knee joints, see Fig. 4a, due to lack of shear reinforcement, and a fractured 57 mm  $\varnothing$  (#18) bar was encountered in a damaged knee joint on I-980, see Fig. 4b, which can be attributed to large strains introduced during bar bending (6.25%) and possible strain aging effects.

A flared pier wall which experienced shear distress during the Loma Prieta earthquake was repaired and retrofitted with a full height steel jacket, see Fig. 5c, for increased shear capacity. The previously discussed joint shear failure in an outrigger knee joint of I-980, see Fig. 4b was repaired by full replacement of the joint concrete, see Fig. 6d, and added joint shear reinforcement, while the outrigger bent shown in Fig. 4a was completely replaced, see Fig. 5e.

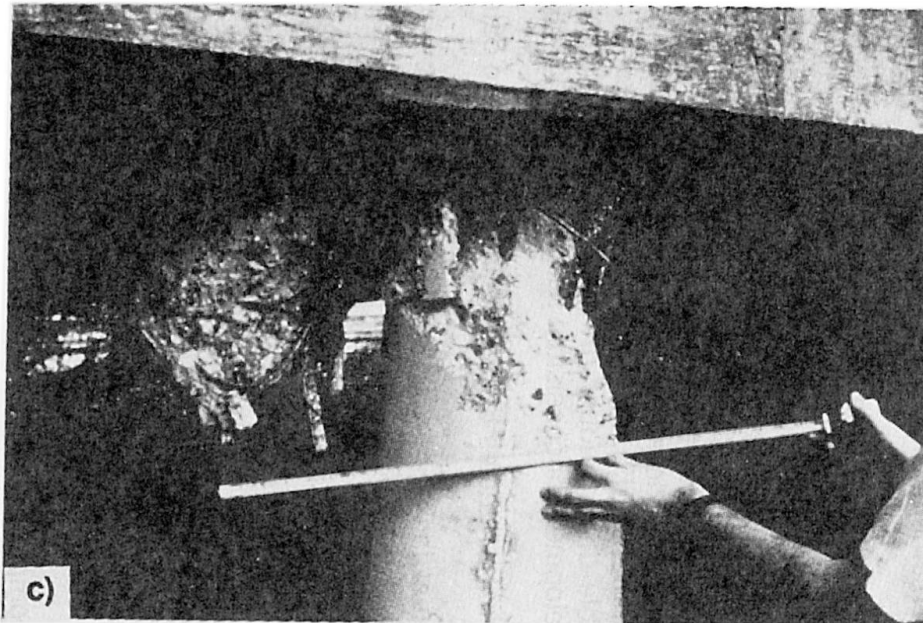
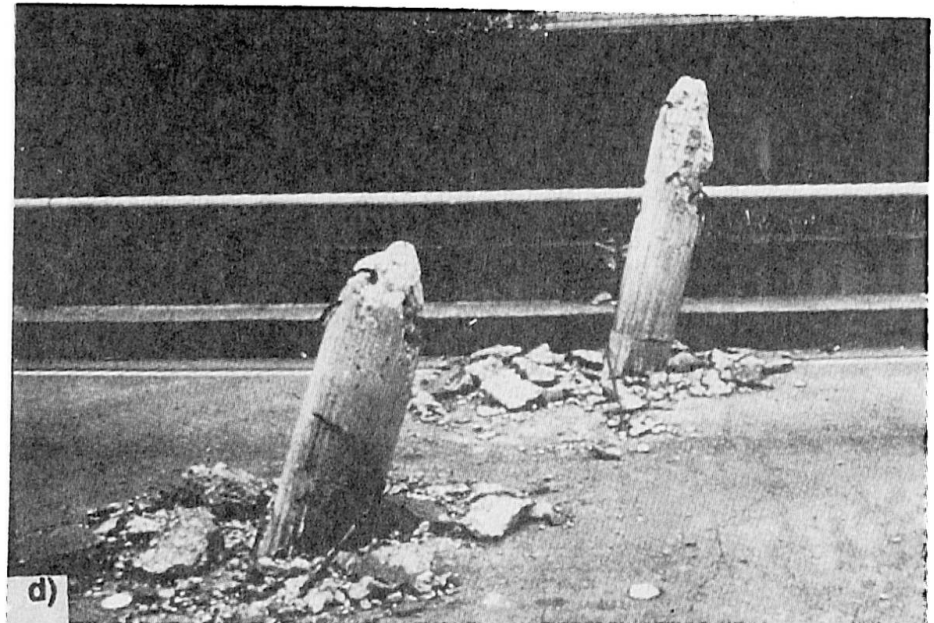
Finally, on struve slough, Figs. 4c and d, the plastic hinge at the column top sheared off and the column offset in the longitudinal bridge direction and punched through the reinforced concrete deck slab.
