Artikel: Seismic damage and retrofit to California's urban concrete bridge
structures

Seismic Damage and Retrofit to California's Urban Concrete Bridge Structures

Frieder SEIBLE

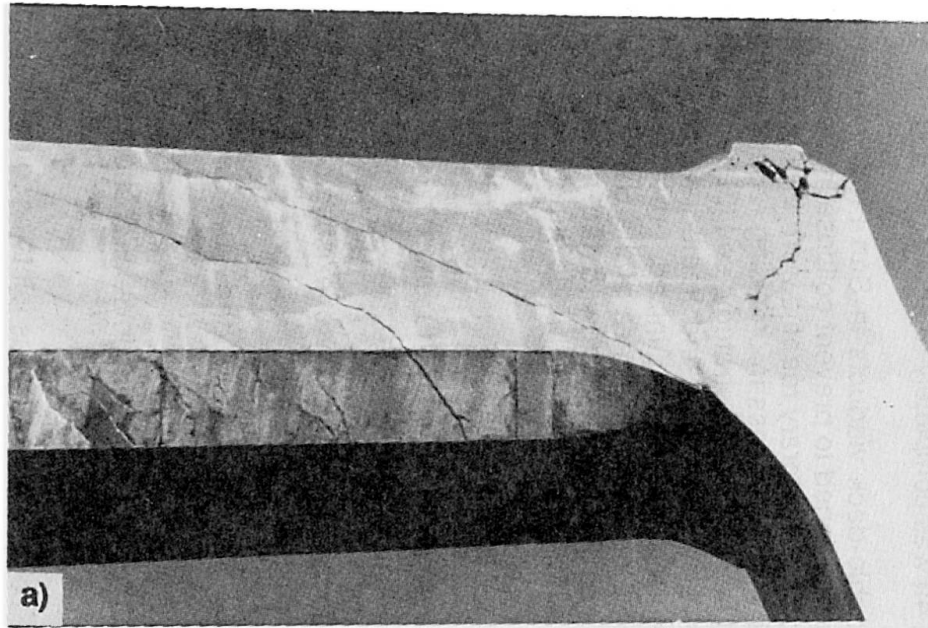
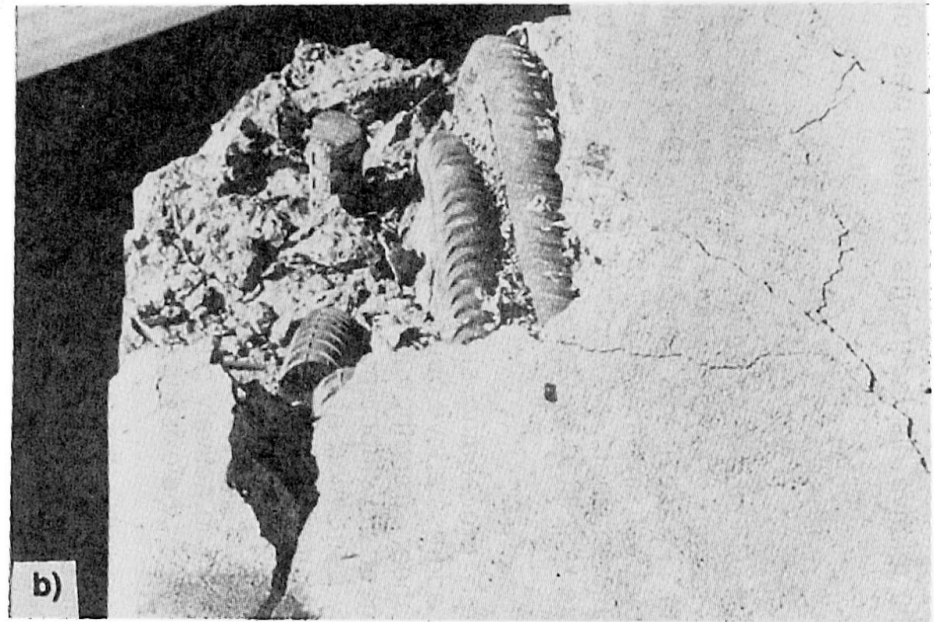
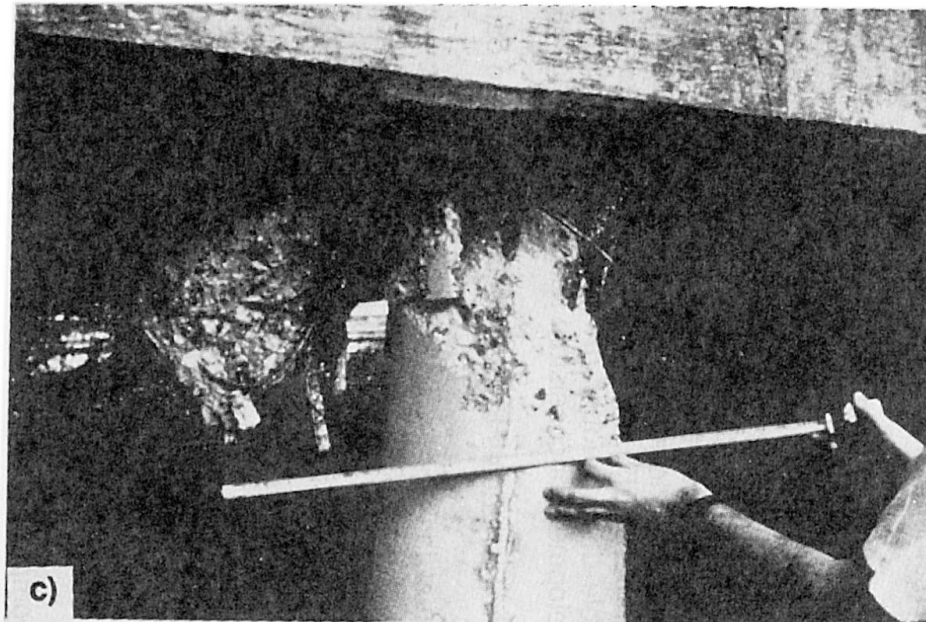
Fig 4. Knee Joint and Plastic Hinge Failure, Loma Prieta 1989

Outrigger bents showed problems in flexure and shear in the cap and shear failure of knee joints, see Fig. 4a, due to lack of shear reinforcement, and a fractured 57 mm \varnothing (#18) bar was encountered in a damaged knee joint on I-980, see Fig. 4b, which can be attributed to large strains introduced during bar bending (6.25%) and possible strain aging effects.

Finally, on struve slough, Figs. 4c and d, the plastic hinge at the column top sheared off and the column offset in the longitudinal bridge direction and punched through the reinforced concrete deck slab.

A flared pier wall which experienced shear distress during the Loma Prieta earthquake was repaired and retrofitted with a full height steel jacket, see Fig. 5c, for increased shear capacity. The previously discussed joint shear failure in an outrigger knee joint of I-980, see Fig. 4b was repaired by full replacement of the joint concrete, see Fig. 6d, and added joint shear reinforcement, while the outrigger bent shown in Fig. 4a was completely replaced, see Fig. 5e.
