Recorded Failures of Electrically Welded Wrought Iron and Mild Steel Bridges.

H. J. L. Bruff,

Bridge Engineer, North Eastern Area, London & North Eastern Railway. York.

The failures occurred in the course of carrying out the repairs to an old Wrought Iron plate girder bridge in the City of Leeds, which, apart from having suffered very badly from corrosion needed to be strengthened, as it was considered of inadequate strength to carry modern traffic.

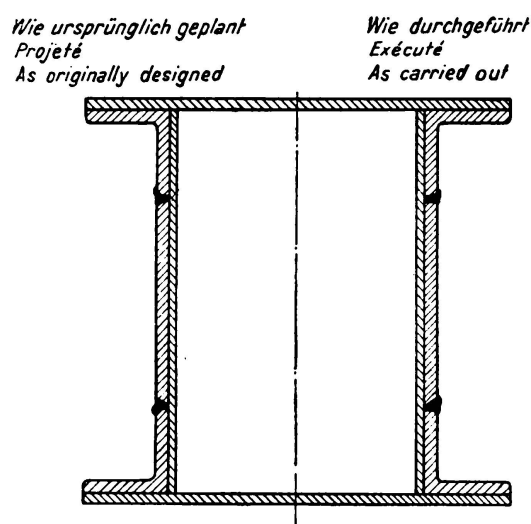
Fig. 1.

The observed failures of the welding occurred in the cross girders, which were of box type construction. They were badly corroded and had also suffered distortion of the webs due to overloading. This was caused by the removal, at some time, of certain rivets and their substitution with bolts which had rusted

Section of Cross Girder.

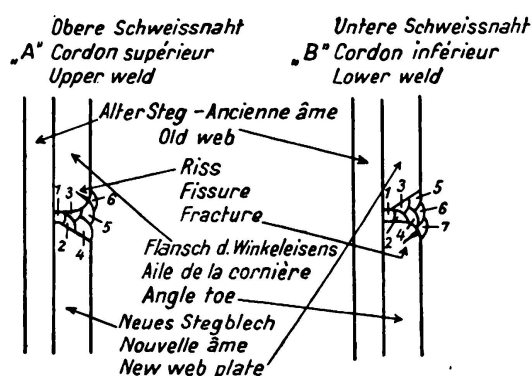
Fig. 2.

Details of Web Butt Welds as designed.

The most difficult portion of the work was the welding in of new web plates, as these had to be fitted in between the vertical flanges of the cross girder angles, which necessitated using fairly large butt welds. The procedure of carrying out this work was to tack weld the new web plates to the angle toes and then to weld alternately the top and bottom butts in runs of six inches, the number of runs being in some cases as many as seven. The butts when prepared were of the usual form adopted by my Chief for welds of this kind and the welding was as indicated in Fig. 2, A and B.

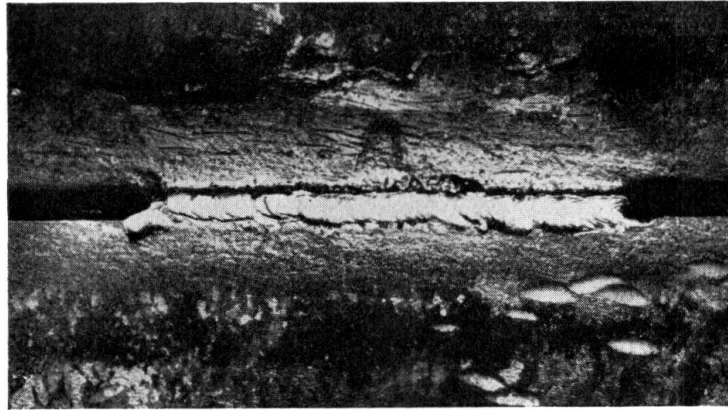
Fig. 3.

It was found that when the final weld had been deposited, a fracture developed along the parallel to it, as shown on the photograph (Fig. 3). It was considered that the deposition of further welds (Fig. 2, A 6 and B 7) would not of necessity guarantee that these would reach sound metal at the root of the fractures.

Fracture in angle parallel Weld.

The fractures seem to be caused by the contraction of the metal at right angles to the rolling direction extending as the welding proceeded. A piece of the

angle cut out disclosed a fibrous structure parallel with the length of the bar, such as wrought iron of good quality invariably shows.

After a number of experiments it was found that the method indicated in Fig. 4 was most satisfactory.

The idea underlying the method finally adopted was to provide a coating weld (Fig. 4: C 2 and D 4) which would offer greater resistance to the contraction set up by the shrinkage of the welds (Fig. 4: C 3 and C 4 and D 5) than the W. I. of the angles. After adopting the method described, no fractures have taken place when the welds were made, nor have any fractures developed since.

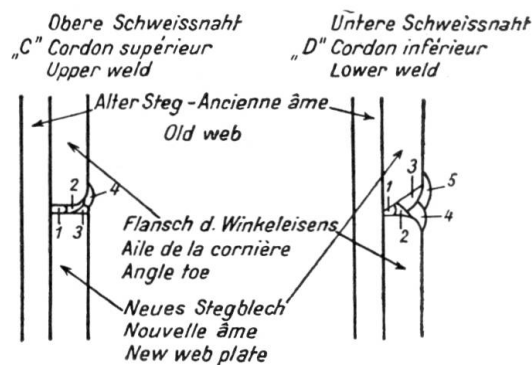
Fig. 4.

Web Butt Welds as carried out.

The lower or bottom weld was run first the full length of the web and then the upper or top weld. As will be noted, there was no chamfer in the case of the top weld, and in the case of the bottom weld, there was no face to the chamfer, which was run to a sharp edge. The sharp edged type of chamfer has
