Recorded Failures of Electrically Welded Wrought Iron and Mild Steel Bridges.

H. J. L. Bruff,

Bridge Engineer, North Eastern Area, London & North Eastern Railway. York.

The failures occurred in the course of carrying out the repairs to an old Wrought Iron plate girder bridge in the City of Leeds, which, apart from having suffered very badly from corrosion needed to be strengthened, as it was considered of inadequate strength to carry modern traffic.

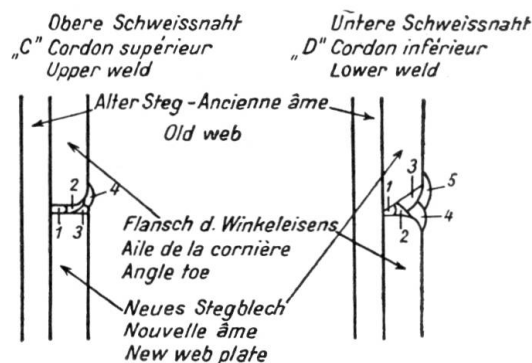
Fig. 4.

Web Butt Welds as carried out.

After a number of experiments it was found that the method indicated in Fig. 4 was most satisfactory.

The lower or bottom weld was run first the full length of the web and then the upper or top weld. As will be noted, there was no chamfer in the case of the top weld, and in the case of the bottom weld, there was no face to the chamfer, which was run to a sharp edge. The sharp edged type of chamfer has

The idea underlying the method finally adopted was to provide a coating weld (Fig. 4: C 2 and D 4) which would offer greater resistance to the contraction set up by the shrinkage of the welds (Fig. 4: C 3 and C 4 and D 5) than the W. I. of the angles. After adopting the method described, no fractures have taken place when the welds were made, nor have any fractures developed since.
