### Recorded Failures of Electrically Welded Wrought Iron and Mild Steel Bridges.

H. J. L. Bruff,

Bridge Engineer, North Eastern Area, London & North Eastern Railway. York.

The failures occurred in the course of carrying out the repairs to an old Wrought Iron plate girder bridge in the City of Leeds, which, apart from having suffered very badly from corrosion needed to be strengthened, as it was considered of inadequate strength to carry modern traffic.

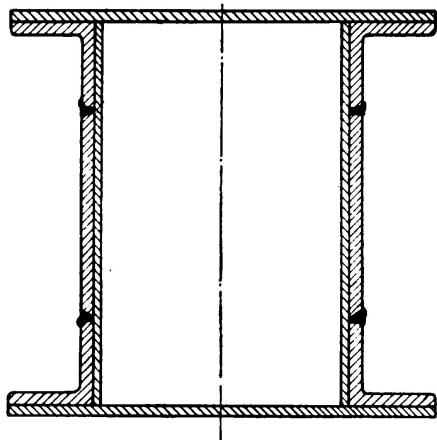
Fig. 1.

The observed failures of the welding occurred in the cross girders, which were of box type construction. They were badly corroded and had also suffered distortion of the webs due to overloading. This was caused by the removal, at some time, of certain rivets and their substitution with bolts which had rusted

Section of Cross Girder.

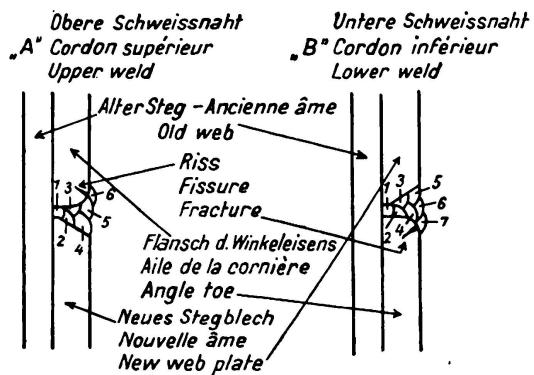
Fig. 2.

Details of Web Butt Welds as designed.

The most difficult portion of the work was the welding in of new web plates, as these had to be fitted in between the vertical flanges of the cross girder angles, which necessitated using fairly large butt welds. The procedure of carrying out this work was to tack weld the new web plates to the angle toes and then to weld alternately the top and bottom butts in runs of six inches, the number of runs being in some cases as many as seven. The butts when prepared were of the usual form adopted by my Chief for welds of this kind and the welding was as indicated in Fig. 2, A and B.

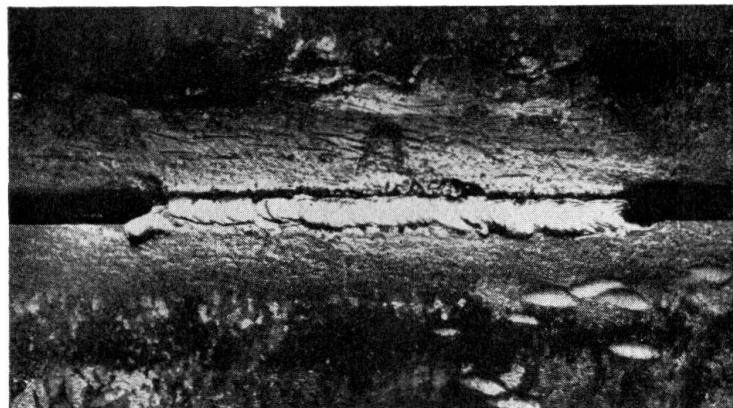
Fig. 3.  
Fracture in angle parallel Weld.

It was found that when the final weld had been deposited, a fracture developed along the parallel to it, as shown on the photograph (Fig. 3). It was considered that the deposition of further welds (Fig. 2, A 6 and B 7) would not of necessity guarantee that these would reach sound metal at the root of the fractures.

The fractures seem to be caused by the contraction of the metal at right angles to the rolling direction extending as the welding proceeded. A piece of the

angle cut out disclosed a fibrous structure parallel with the length of the bar, such as wrought iron of good quality invariably shows.

The idea underlying the method finally adopted was to provide a coating weld (Fig. 4: C 2 and D 4) which would offer greater resistance to the contraction set up by the shrinkage of the welds (Fig. 4: C 3 and C 4 and D 5) than the W. I. of the angles. After adopting the method described, no fractures have taken place when the welds were made, nor have any fractures developed since.

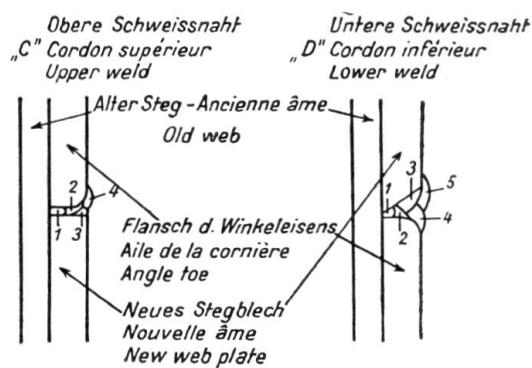
Fig. 4.  
Web Butt Welds as carried out.

After a number of experiments it was found that the method indicated in Fig. 4 was most satisfactory.

The lower or bottom weld was run first the full length of the web and then the upper or top weld. As will be noted, there was no chamfer in the case of the top weld, and in the case of the bottom weld, there was no face to the chamfer, which was run to a sharp edge. The sharp edged type of chamfer has
