**Artikel:** Maintenance of steel structures

## **IV d 2**

### **Maintenance of steel structures**

**M. F. PALMER**

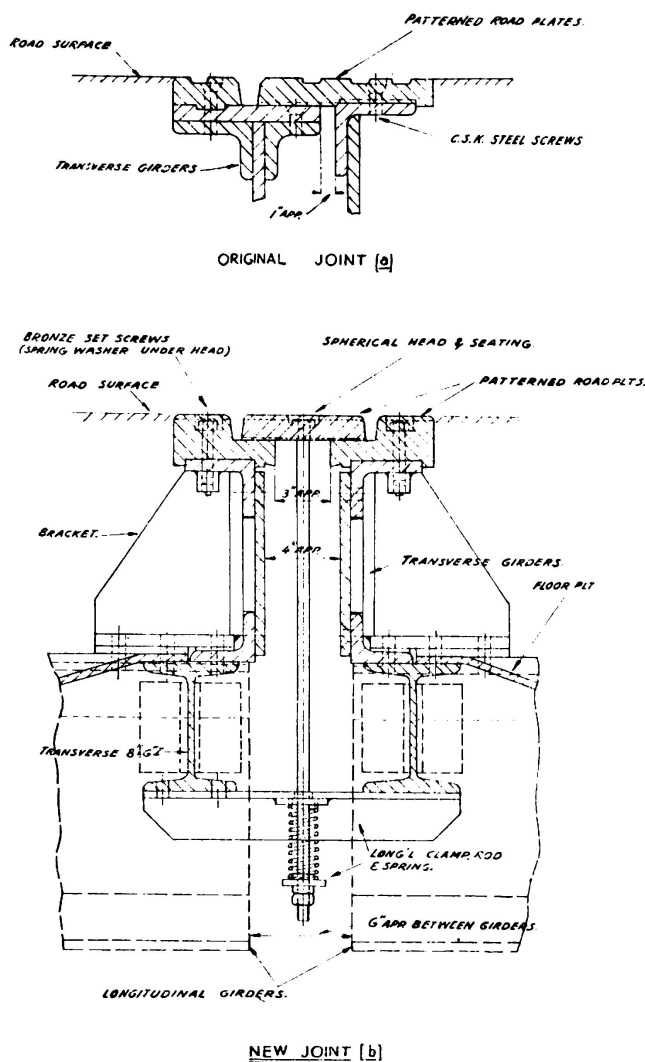
Expansion joints in decks of road bridges require careful consideration. Fig. 4 (a) shows a detail of one of the original joints on Rochester Bridge. The overhanging plates which were held down by countersunk screws were continually working loose. Owing to a slight movement of one of the abutments over a period of years, the expansion gap was gradually reduced and it became necessary to renew the joint. The detail shown in Fig. 4 (b) was adopted. It will be seen that the plate bridging the gap is loose, apart from being held down by springs which are adjustable from the underside of the bridge. This reconstructed joint has been in existence now for a few years and has proved successful.

FIG. 4. Rochester bridge. Section Through expansion joints
