**Artikel:** Maintenance of steel structures

## **IV d 2**

### **Maintenance of steel structures**

**M. F. PALMER**

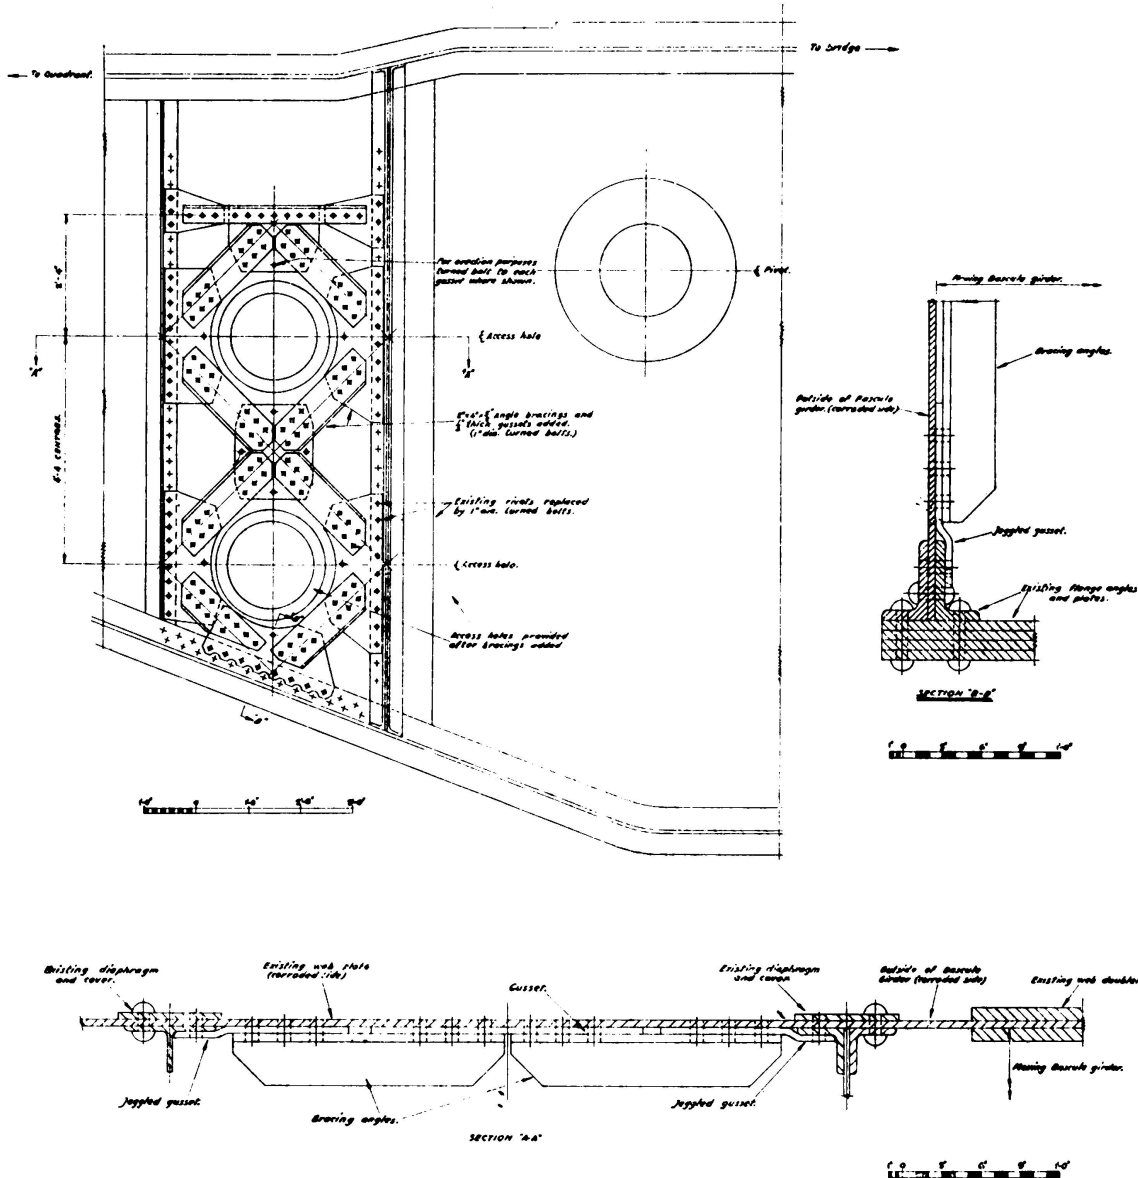
At the start of the last war, as a safety precaution, the heavy cast iron ornamentations were removed from the overhead girders of the opening span, and this revealed corrosion which had taken place in the webs of the mild steel outer channels forming the bottom boom of the

Other places needing attention were the four outer corners of the opening span near the pivots of the bascules. The space between the bascules and the fixed steelwork at these points was only about 9 inches wide, and as a consequence, the steel surfaces which shadowed each other had not been painted since the bridge was erected. It was possible to see, however, that considerable corrosion had taken place on some of the web plates where water had run down from the road surface; also that some of the rivet heads had practically corroded away, while others had conical heads of various sizes.

FIG. 1. Tower Bridge repairs. Arrangement of new steelwork for repair of corroded webs of moving bascule girders

lattice girders. These channels were repaired by burning out sections of the web 12" long and 4" deep and butt welding in new plates, working along the boom until the total length of repair was sufficient to replace the corroded area.

To strengthen the girders, a system of web latticing was added as shown in Fig. 1, thus making the web plates more or less superfluous at these points. Manholes were then constructed as shown. By placing these manholes in suitable positions and rotating the bascules it was found possible to gain access to all parts which were previously inaccessible. When the manholes were not in use, cover plates were screwed on, in order to reduce draughts.

Rivets with badly corroded heads were cut out and replaced with high tensile steel turned and fitted bolts, the holes being reamed out to suit. In all cases, the working space was very confined, and replacing with rivets was not a practical proposition.

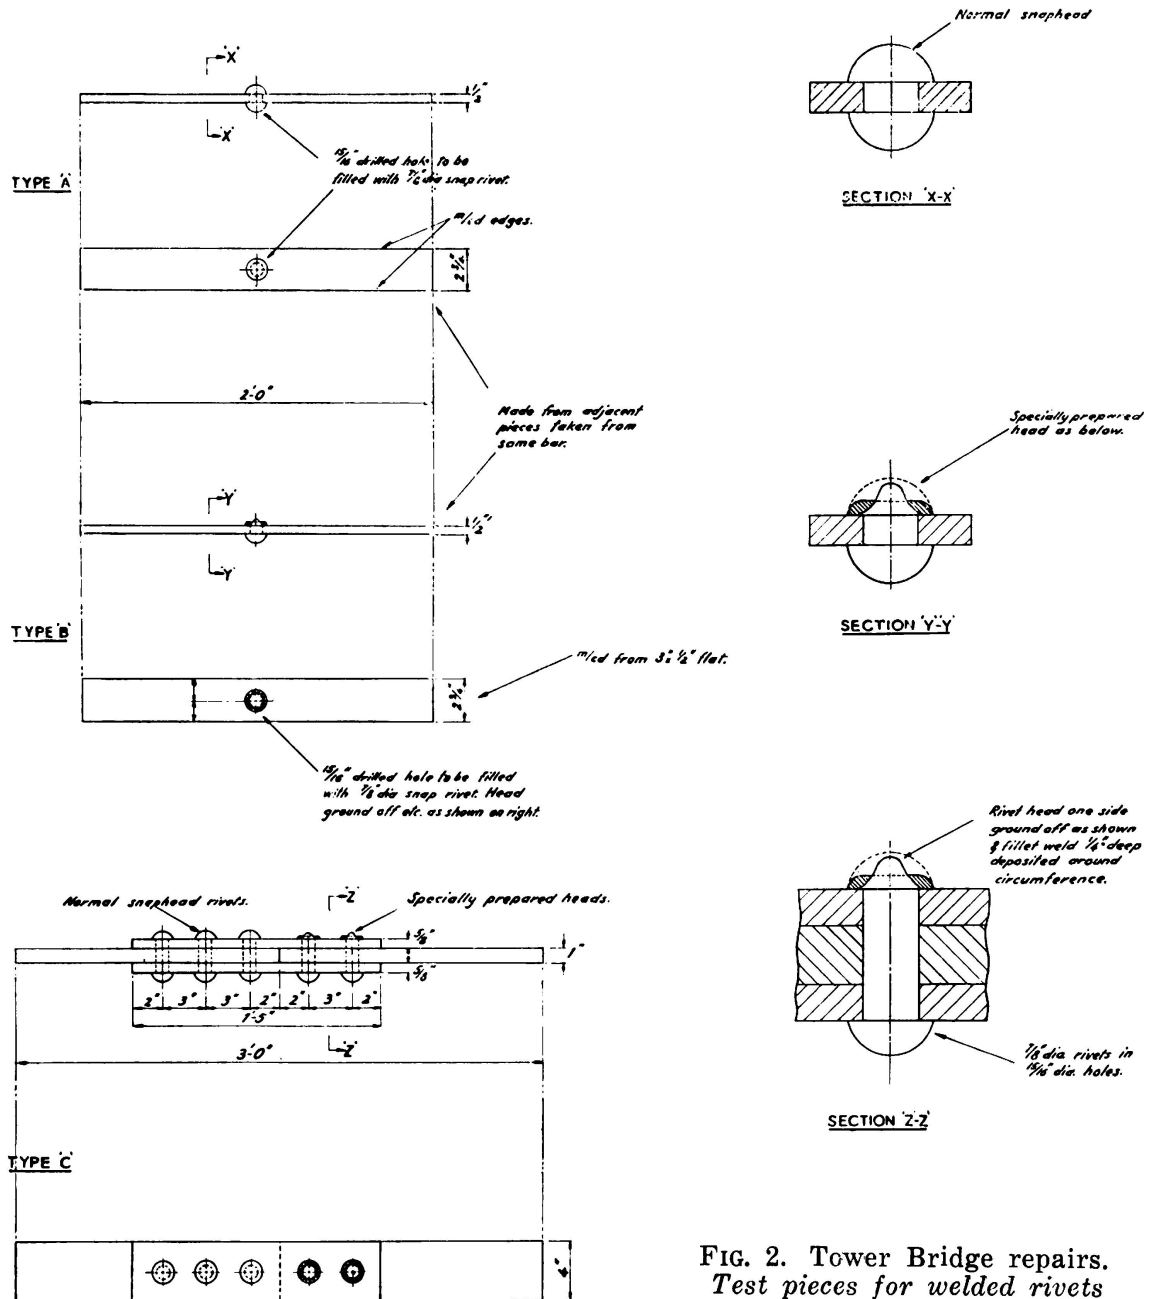
During the progress of the work, an investigation was made into the feasibility of welding round corroded rivet heads so as to avoid the work involved in cutting out the rivets and replacing with bolts. Test pieces were prepared as shown in Fig. 2.

Test piece (a) was a  $2\frac{3}{4}" \times \frac{1}{2}"$  flat drilled centrally with a  $\frac{15}{16}"$  diameter hole and filled with a  $\frac{7}{8}"$  diameter rivet.

Test piece (b) was similar, except that the head of the rivet was ground to simulate a corroded head such as existed on the bridge. This head was then welded round as shown.

Test piece (c) was made with the object of testing whether the rivets were liable to pull out when tested in double shear.

<i>Test Piece (a).</i>	No. 1 Tons	No. 2 Tons	Average Tons
Actual load to cause yield ... ..	25.14	25.83	25.48
Actual load to cause failure ... ..	31.40	30.74	31.07
<i>Test Piece (b).</i>	No. 1 Tons	No. 2 Tons	Average Tons
Actual load to cause yield ... ..	26.12	25.60	25.86
Actual load to cause failure ... ..	38.55	38.21	38.38

In the first test (b), the piece fractured across the parent metal at the hole and round the throat of the weld on one side of the hole. In the second test, the piece fractured across the parent metal at the hole and through the weld.

By comparing test pieces (a) and (b), it will be seen that in repairing the rivet heads by welding round them, the ultimate strength of the plate at the weakest cross section, was increased by the value of the added weld metal. In this test, the increase was  $38.38 - 31.07 = 7.31$  tons or 23 %. This is a very valuable addition, especially as the web will have also corroded at this point.

The results given by test piece (c) show that after repair, the rivets were capable of taking their original shear load.

FIG. 2. Tower Bridge repairs.  
Test pieces for welded rivets

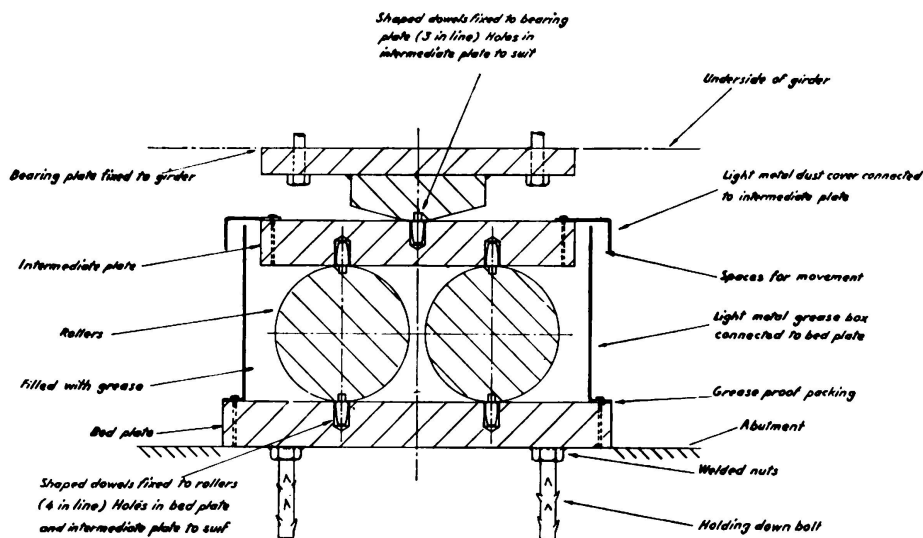
FIG. 3. Expansion bearings

In some cases, roller expansion bearings have not been easily accessible and have become completely corroded, and, in effect, fixed. It is now common practice to encase such bearings in grease boxes having dust covers, which ensures that no further attention is required for a number of years. This is exemplified by Rochester Bridge, which was reconstructed in 1912. The expansion bearings were left exposed, but

in 1930, owing to the troubles from dust and dirt, they were completely encased and packed with grease. No further attention has been necessary, and the bearings are working well. Fig. 3 gives an example of a simple enclosed bearing.

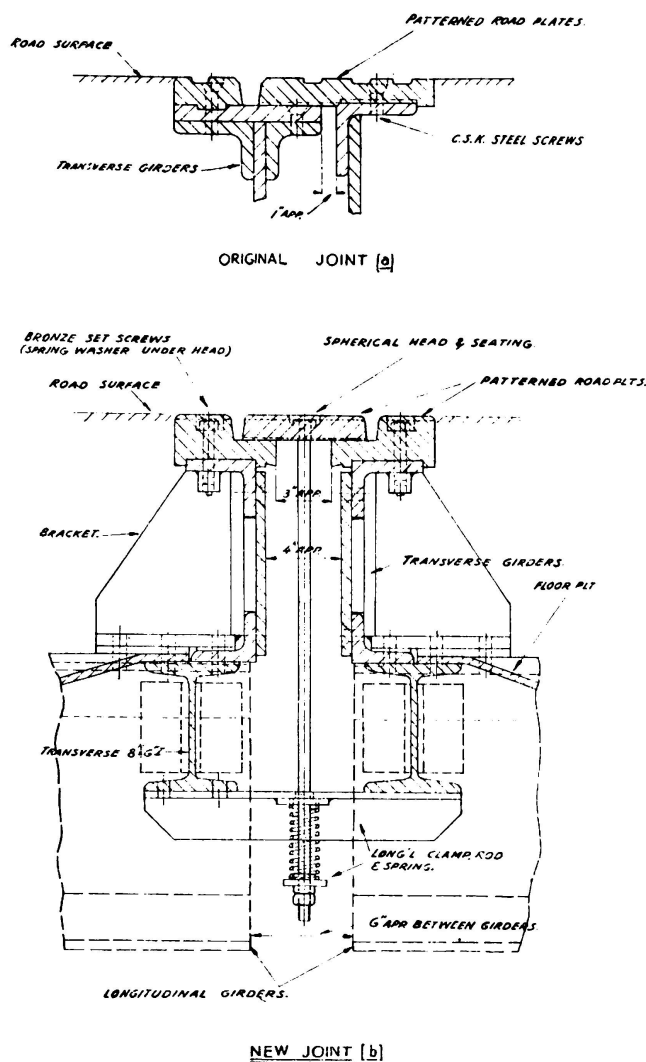
Expansion joints in decks of road bridges require careful consideration. Fig. 4 (a) shows a detail of one of the original joints on Rochester Bridge. The overhanging plates which were held down by countersunk screws were continually working loose. Owing to a slight movement of one of the abutments over a period of years, the expansion gap was gradually reduced and it became necessary to renew the joint. The detail shown in Fig. 4 (b) was adopted. It will be seen that the plate bridging the gap is loose, apart from being held down by springs which are adjustable from the underside of the bridge. This reconstructed joint has been in existence now for a few years and has proved successful.

FIG. 4. Rochester bridge. Section Through expansion joints
