The Development of Asphalt Surfacing for Steel Bridge Decking

J. J. TROTT

D. S. WILSON

Road Research Laboratory, Department of Scientific and Industrial Research,
United Kingdom

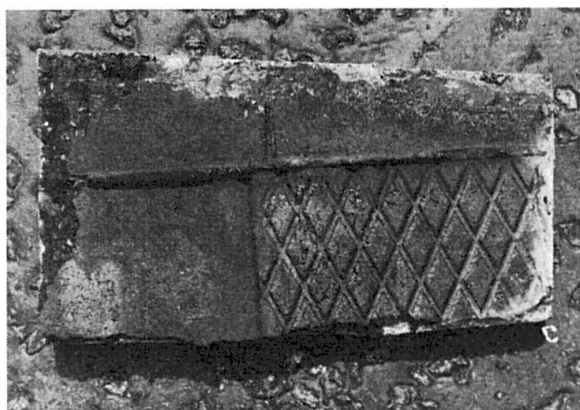
Fig. 3. The Underside of the $1\frac{1}{2}$ -in. Surfacing Removed From the Junction of the Smooth and Chequered Plate Panels.

paint and caused failure of the bond between the surfacing and the deck plate (see figs. 3 and 4). Where the bond had failed, traffic caused "pushing" of the asphalt (see fig. 5); the general appearance of the surfacing is shown in fig. 6.

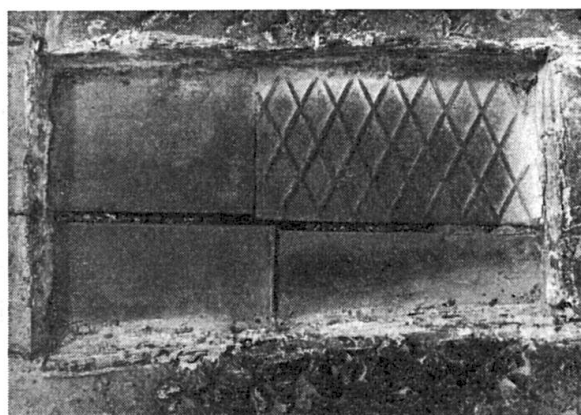
By January, 1950, three weeks after opening to traffic, cracks began to appear at the junction of the panels and the side plates, and, by April, 1950, the side plates on all the sections, except that with a 2-in. surfacing, were outlined by cracks. A crack also appeared between the 1-in. and $1\frac{1}{2}$ -in. sections, no cracks were detected in the surfacing proper, although on that with a 1-in. surfacing, cracks appeared to be working in from the edges. In June, 1950, patches were cut from all sections and showed that rusting was occurring at the edges of the plates near the cracks. This spread under the bituminous

Fig. 4. Deck Plate on the Smooth and Chequered Plate Panels After Removing the $1\frac{1}{2}$ -in. Surfacing. Rusting Can Be Seen Round the Edge of the Plates.

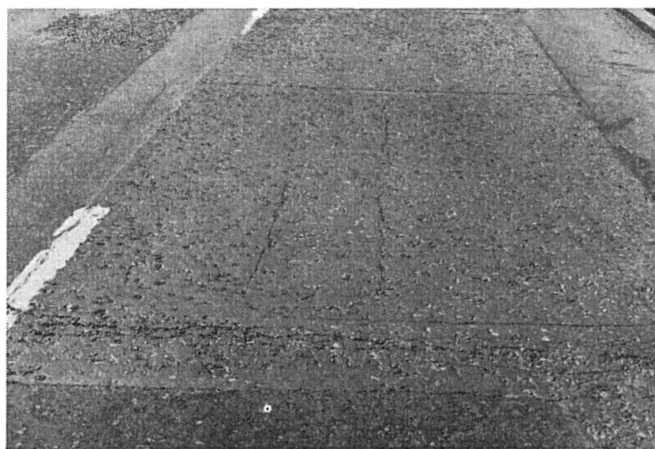
The cracks formed over the stiffeners are shown in fig. 8. On stripping the surfacing it was found to be cracked right through over the three central stiffeners for nearly the whole distance between the transverse supports. The

Fig. 8. General View of Bridge Panels After 2 $\frac{1}{2}$ yr. with 1-in. Surfacing in Foreground. Note the Pronounced Cracks Over the Three Central Stiffeners and Incipient Cracks Over the Outer Stiffeners.

cracks over the outer stiffeners were found to be in the form of a "vee", the point of the "vee" just touching the steel over a short distance. Where the cracks penetrated to the steel, and all around the edges of the panel, water had entered and caused considerable rusting. Fig. 9 shows the extent of this corrosion and also shows that, over the main area of the panel where the adhesion to the mastic had remained good, no penetration of water had occurred and hence no rusting. The considerable crack over the central transverse support did not extend through the surfacing and no water had penetrated to the steel.

1. A 1-in. thickness of stone-filled mastic asphalt would be too thin for use on the deck of the proposed bridge. Cracks would probably form over the longitudinal stiffeners and permit water to penetrate through to the steel plate.

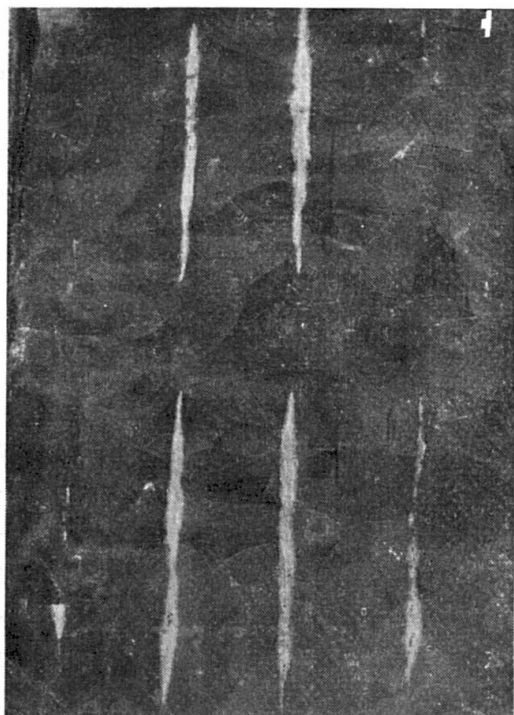
Fig. 9. The Steel Deck-Plate After Removal of 1-in. Surfacing. Note the Corrosion After $4\frac{1}{2}$ yr. Owing to Water Penetrating Through the Cracks Shown Above.
