Artikel: The development of asphalt surfacings for steel bridge decking

The Development of Asphalt Surfacings for Steel Bridge Decking

J. J. TROTT

Road Research Laboratory, Department of Scientific and Industrial Research, United Kingdom

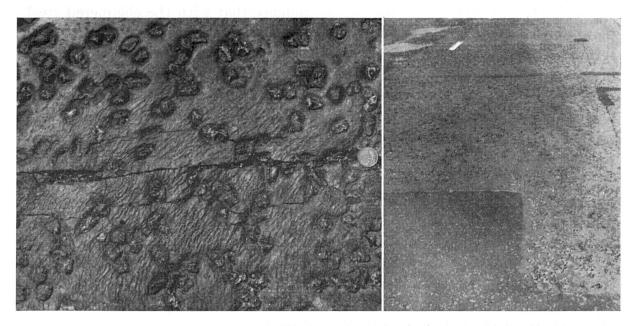
Fig. 5. Pushing of the 1-in. Mastic Asphalt Surfacing Fig. 6. View of the Surface on the on the Side Plate Due to the Bond Being Broken Panels, Showing the Cracking Between the Surface and the Steel.

Round the Side Plates.

paint and caused failure of the bond between the surfacing and the deck plate (see figs. 3 and 4). Where the bond had failed, traffic caused "pushing" of the asphalt (see fig. 5); the general appearance of the surfacing is shown in fig. 6.

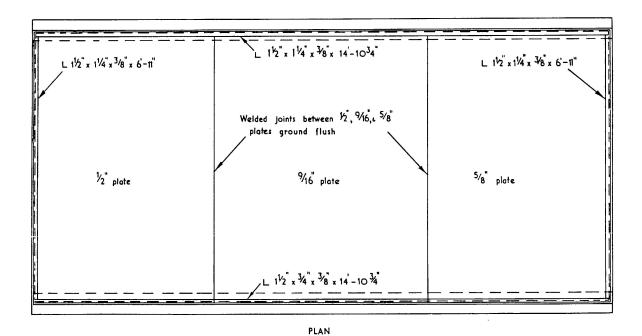
Fig. 7. Panel Used for Second Experiment.

The large panel was similar in construction to those described earlier. Angle-iron was welded along its edges as shown in fig. 7 in order to contain the asphalt. Two of the existing panels, namely that with the chequered steel plate and that carrying the 2-in. mastic asphalt surfacing, were taken out of service and replaced by the 15 ft. by 7 ft. plate in November 1950. Two methods of laying the surfacing were employed and the methods used to seal the edges are shown in fig. 7. The panel was subjected to traffic and weathering for $5^{1}/_{2}$ years and was removed for inspection in July, 1956. The surfacing was removed near to the corners to inspect the sealing and the results were as follows:

Corner A. The edge here was formed by $1^1/_2$ in. by $1^1/_4$ in. angle and was filled with a proprietary rubber/bitumen sealing compound. The joint was found to be perfect.

Corner B. The edge here was formed from either $1^1/2$ in. by $1^1/4$ in. or $1^1/2$ in. by 3/4 in. angles and filled with damp-proof mastic. There was an obvious construction joint between the two courses of mastic and this was filled with dust and dirt. Little adhesion occurred between the damp-proof mastic and the angle-iron: the latter showed signs of rusting.

Corner C. The construction was as for B. The joint between the two mastic layers was more pronounced and showed evidence of pushing. The adhesion

to the angle-iron was poor and water had entered, causing some corrosion of the angle. The steel deck plate was undamaged.

Corner D. The construction was as for A. The joint appeared perfect but droplets of water were found in three small pockets (1 to 2 sq.in.) under the mastic. They caused some discoloration but the zinc film was intact and the deck plate undamaged. There was no evidence to indicate how the water had reached the small pockets.

No rusting of the deck plate occurred at any of these points.

- 3. Special construction is necessary to keep water out of the edge joints. Angle-iron at the edges of the deck plates, filled with rubber/bitumen sealing compound together with a surfacing of $1^1/2$ in. of stone-filled mastic asphalt gave a joint that withstood heavy traffic for at least 6 years.

- 4. When angle-iron was used with a two-course surfacing consisting of stone-filled mastic asphalt overlying $^3/_8$ in. of damp-course mastic, the resistance to the ingress of water at the edges was not so good as that given by (3).

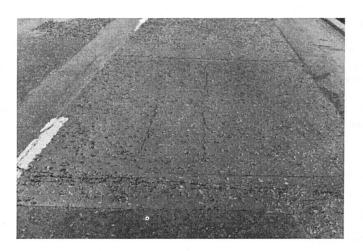
The cracks formed over the stiffeners are shown in fig. 8. On stripping the surfacing it was found to be cracked right through over the three central stiffeners for nearly the whole distance between the transverse supports. The

Fig. 8. General View of Bridge Panels After $2^{1}/_{2}$ yr. with 1-in. Surfacing in Foreground. Note the Pronounced Cracks Over the Three Central Stiffeners and Incipient Cracks Over the Outer Stiffeners.

cracks over the outer stiffeners were found to be in the form of a "vee", the point of the "vee" just touching the steel over a short distance. Where the cracks penetrated to the steel, and all around the edges of the panel, water had entered and caused considerable rusting. Fig. 9 shows the extent of this corrosion and also shows that, over the main area of the panel where the adhesion to the mastic had remained good, no penetration of water had occurred and hence no rusting. The considerable crack over the central transverse support did not extend through the surfacing and no water had penetrated to the steel.

- 1. A 1-in. thickness of stone-filled mastic asphalt would be too thin for use on the deck of the proposed bridge. Cracks would probably form over the longitudinal stiffeners and permit water to penetrate through to the steel plate.

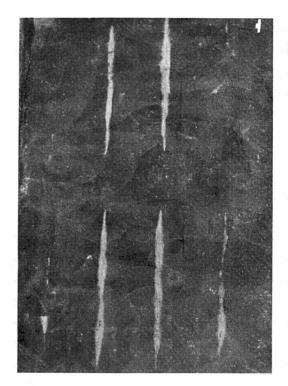
Fig. 9. The Steel Deck-Plate After Removal of 1-in. Surfacing. Note the Corrosion After 4¹/₂ yr. Owing to Water Penetrating Through the Cracks Shown Above.

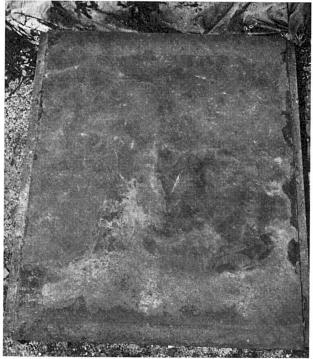
Fig. 10. The 9 ft. By 7 ft. Deck Plate After Removal of the 1¹/₂-in. Surfacing. Note Absence of Any Corrosion After 4¹/₂ yr., Due to Cracking; and Also the Very Considerable Corrosion Where the Mastic Asphalt Had Not Adhered Properly Over the Front and Centre Portions of the Plate.

There was a fairly well defined crack about $^{1}/_{16}$ in. wide over the central stiffener and a very short, faint crack over each of the two adjoining stiffeners. None of these cracks penetrated to the steel plate. As with the 1-in. surfacing, water entered all around the edges of the plate and caused considerable corrosion, particularly at the west end of the panel (on which traffic first runs). Approximately a quarter of the whole area had no adhesion between the

mastic asphalt and the steel. Here the plate was extensively rusted and the mastic asphalt was widely cracked over its underside. The cracks were filled with rust and slime, but did not penetrate to within $^{1}/_{2}$ in. of the top surface. No cracks were detected in the region where the adhesion to the steel was good. Fig. 10 shows a photograph of the steel plate after the $1^{1}/_{2}$ -in. surfacing had been removed.

- 2. A $1^1/_2$ -in. thickness of stone-filled mastic asphalt behaved satisfactorily for 5 years under heavy traffic. Cracks formed in it but did not penetrate through to the steel. These tests were made with a steel plate $1/_2$ in. thick; thus it is reasonable to expect that a $1^1/_2$ -in. surfacing would behave well on the plate proposed for the bridge.

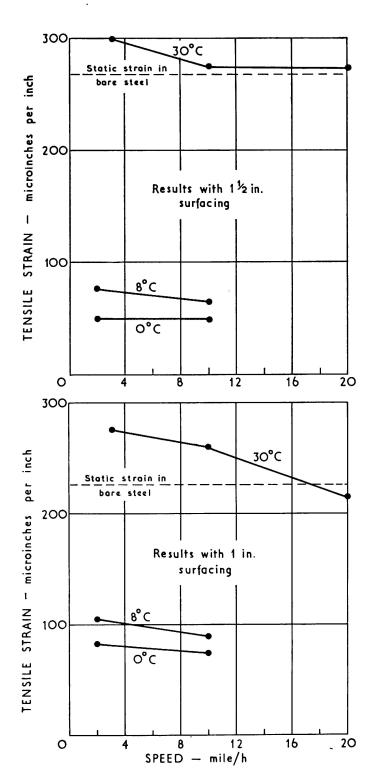
Fig. 15. Effect of Vehicle Speed and Temperature on the Dynamic Strains in Bridge Panels Caused By a Wheel Load of 11000 LB.

Values of the peak tensile strain recorded by gauge No. 6 in each test run are shown in fig. 15 plotted against the vehicle speed, separate curves being shown for the three surfacing temperatures studied. Separate sets of curves are shown for each panel, and each diagram shows the tensile strain deduced from the static tests at a load equal to that applied by the rear wheel of the moving lorry, i.e. 11,000 lb. The distribution of strain occurring under the load applied by the jack to a rubber disc 11 in. in diameter and that applied by the vehicle tyre having an elliptical contact area about 12 in. by 8 in. will not be identical. The static strains have been included in fig. 15 merely as a yardstick by which to judge the strains recorded under the moving vehicle. The fact that, at 30°C, the dynamic strain recorded with, say, a surfacing $1^{1}/_{2}$ in. thick, was actually greater than that recorded statically, with the load applied to the bare steel, therefore, has no significance.

Both sets of diagrams on fig. 15 show much larger strains in the steel when the surfacings were at a temperature of 30°C than at 0 and 8°C. The diagrams indicate that at 30°C, the surfacings made only minor contributions to the rigidity of the steel plate, whereas at the lower temperatures, their contributions were appreciable. If it is assumed that the strains measured in the static test were directly comparable with the dynamic values, it would appear that, at 0°C, the $1^{1}/_{2}$ -in. surfacing contributed about 80 per cent as much as the steel plate to the overall rigidity, while the contribution of the 1-in. surfacing was 60 per cent. If the mastic asphalt behaved elastically under the stresses and rates of loading applied by the moving vehicle, it would be expected that the elastic modulus would be higher at the low temperature than at 30°C. Tests on bituminous materials have indicated that the change of modulus corresponding with this temperature change may be of the order of three to four times greater and this would largely explain the recorded differences in strain at summer and winter temperatures.

The trafficking tests which lasted $4^{1}/_{2}$ years showed a difference in the performance of the 1-in. and $1^{1}/_{2}$ -in. surfacings. It is possible that summer temperatures only applied for a small proportion of the period of test and, at lower temperatures, as fig. 15 shows, there was a difference in the strains generated in the steel plates by vehicles travelling over the two thicknesses of surfacing.

The greater strains generated in the plate under the 1-in. surfacing may possibly account for its inferior performance, plus the fact that any crack generated in the surfacing had a smaller thickness to travel through than was the case with the $1^{1}/_{2}$ -in. layer.
