Artikel: The development of asphalt surfacings for steel bridge decking

The Development of Asphalt Surfacings for Steel Bridge Decking

Road Research Laboratory, Department of Scientific and Industrial Research,
United Kingdom

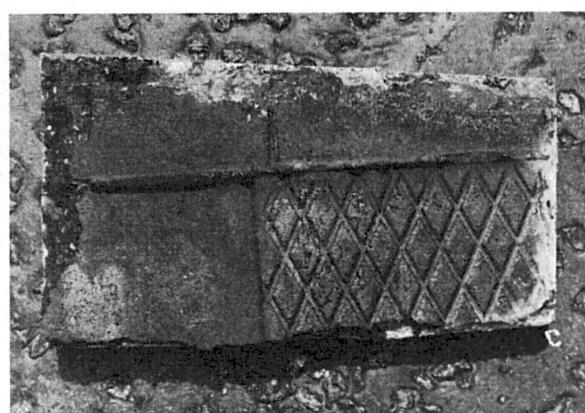
Fig. 3. The Underside of the $1\frac{1}{2}$ -in. Surfacing Removed From the Junction of the Smooth and Chequered Plate Panels.

By January, 1950, three weeks after opening to traffic, cracks began to appear at the junction of the panels and the side plates, and, by April, 1950, the side plates on all the sections, except that with a 2-in. surfacing, were outlined by cracks. A crack also appeared between the 1-in. and $1\frac{1}{2}$ -in. sections, no cracks were detected in the surfacing proper, although on that with a 1-in. surfacing, cracks appeared to be working in from the edges. In June, 1950, patches were cut from all sections and showed that rusting was occurring at the edges of the plates near the cracks. This spread under the bituminous

paint and caused failure of the bond between the surfacing and the deck plate (see figs. 3 and 4). Where the bond had failed, traffic caused "pushing" of the asphalt (see fig. 5); the general appearance of the surfacing is shown in fig. 6.

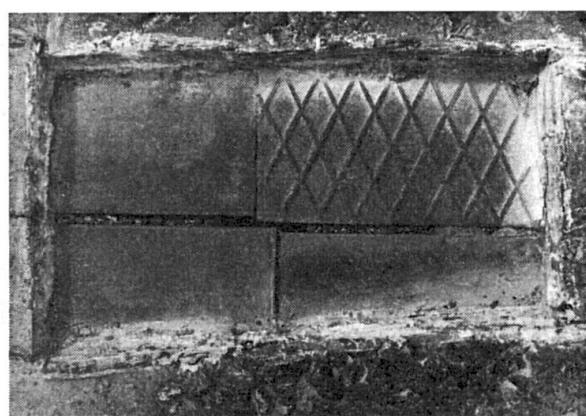
Fig. 4. Deck Plate on the Smooth and Chequered Plate Panels After Removing the $1\frac{1}{2}$ -in. Surfacing. Rusting Can Be Seen Round the Edge of the Plates.

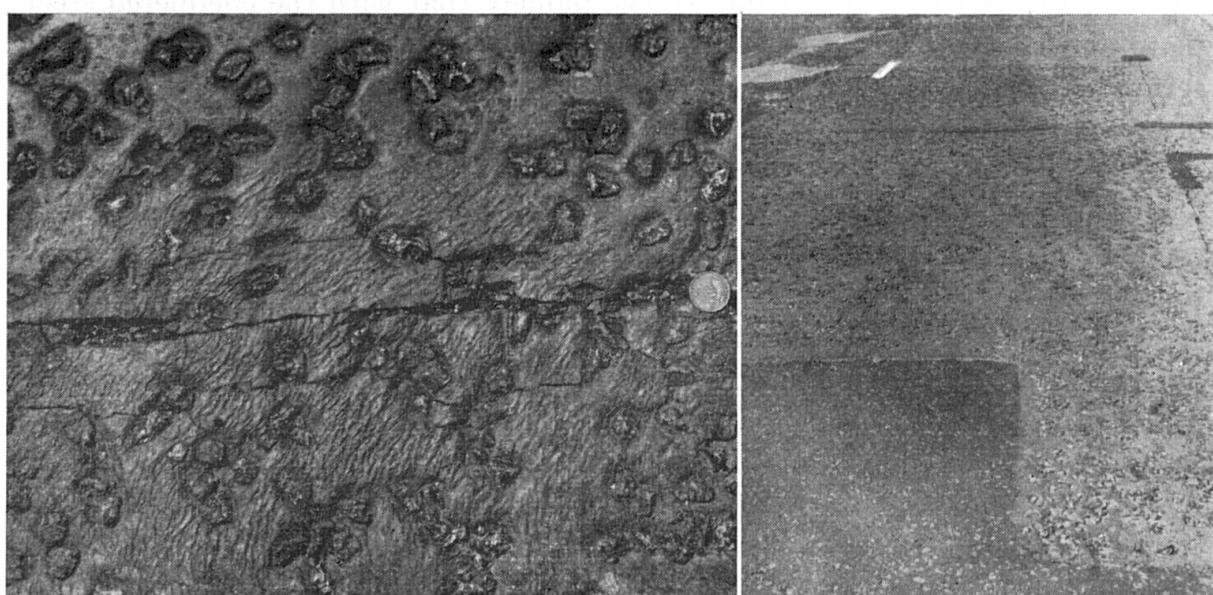
Fig. 5. Pushing of the 1-in. Mastic Asphalt Surfacing on the Side Plate Due to the Bond Being Broken Between the Surface and the Steel.

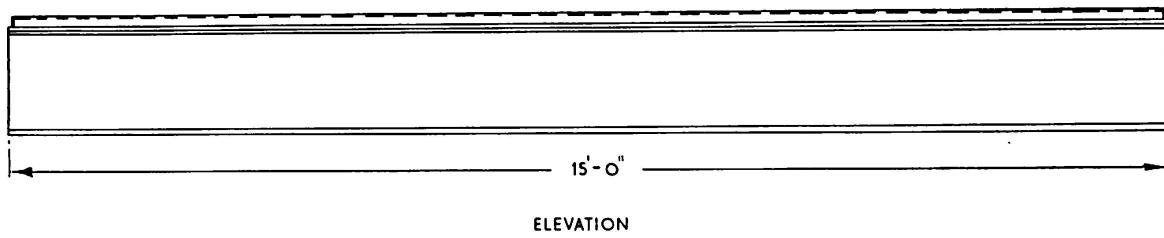
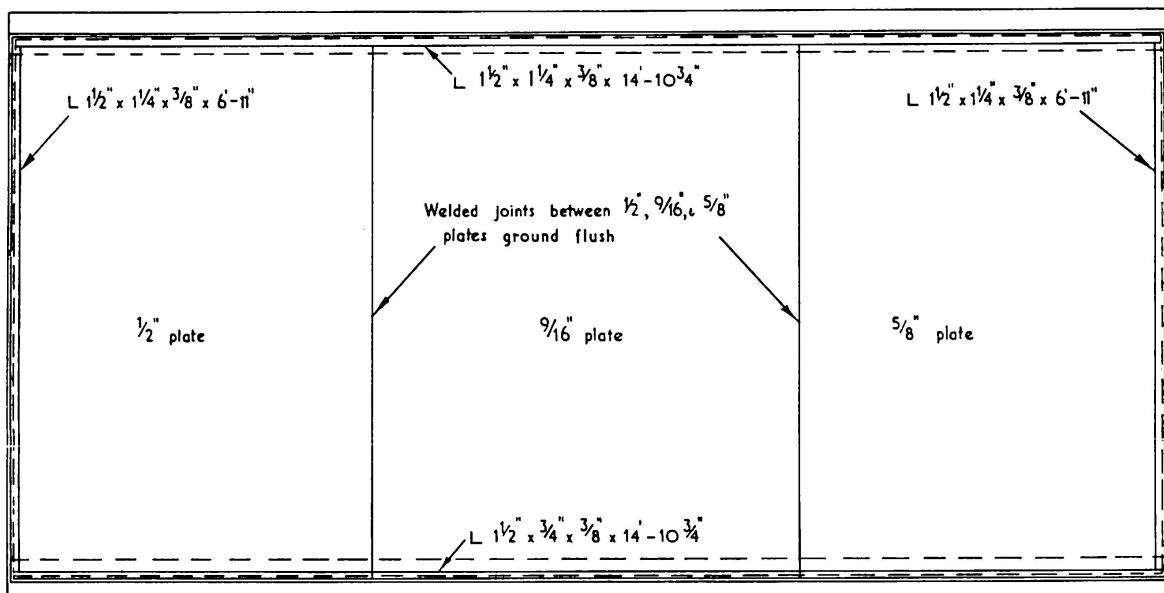
Fig. 7. Panel Used for Second Experiment.

The large panel was similar in construction to those described earlier. Angle-iron was welded along its edges as shown in fig. 7 in order to contain the asphalt. Two of the existing panels, namely that with the chequered steel plate and that carrying the 2-in. mastic asphalt surfacing, were taken out of service and replaced by the 15 ft. by 7 ft. plate in November 1950. Two methods of laying the surfacing were employed and the methods used to seal the edges are shown in fig. 7. The panel was subjected to traffic and weathering for $5\frac{1}{2}$ years and was removed for inspection in July, 1956. The surfacing was removed near to the corners to inspect the sealing and the results were as follows:

Corner A. The edge here was formed by $1\frac{1}{2}$ in. by $1\frac{1}{4}$ in. angle and was filled with a proprietary rubber/bitumen sealing compound. The joint was found to be perfect.

Corner B. The edge here was formed from either $1\frac{1}{2}$ in. by $1\frac{1}{4}$ in. or $1\frac{1}{2}$ in. by $\frac{3}{4}$ in. angles and filled with damp-proof mastic. There was an obvious construction joint between the two courses of mastic and this was filled with dust and dirt. Little adhesion occurred between the damp-proof mastic and the angle-iron: the latter showed signs of rusting.

Corner C. The construction was as for *B*. The joint between the two mastic layers was more pronounced and showed evidence of pushing. The adhesion

to the angle-iron was poor and water had entered, causing some corrosion of the angle. The steel deck plate was undamaged.

Corner D. The construction was as for *A*. The joint appeared perfect but droplets of water were found in three small pockets (1 to 2 sq. in.) under the mastic. They caused some discoloration but the zinc film was intact and the deck plate undamaged. There was no evidence to indicate how the water had reached the small pockets.

3. Special construction is necessary to keep water out of the edge joints. Angle-iron at the edges of the deck plates, filled with rubber/bitumen sealing compound together with a surfacing of $1\frac{1}{2}$ in. of stone-filled mastic asphalt gave a joint that withstood heavy traffic for at least 6 years.

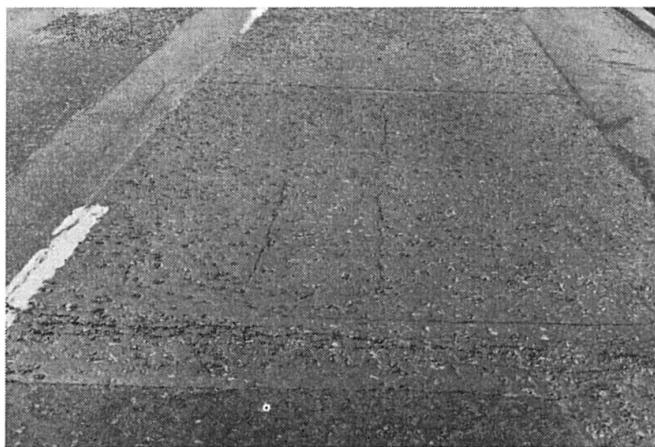
The cracks formed over the stiffeners are shown in fig. 8. On stripping the surfacing it was found to be cracked right through over the three central stiffeners for nearly the whole distance between the transverse supports. The

Fig. 8. General View of Bridge Panels After $2\frac{1}{2}$ yr. with 1-in. Surfacing in Foreground. Note the Pronounced Cracks Over the Three Central Stiffeners and Incipient Cracks Over the Outer Stiffeners.

cracks over the outer stiffeners were found to be in the form of a "vee", the point of the "vee" just touching the steel over a short distance. Where the cracks penetrated to the steel, and all around the edges of the panel, water had entered and caused considerable rusting. Fig. 9 shows the extent of this corrosion and also shows that, over the main area of the panel where the adhesion to the mastic had remained good, no penetration of water had occurred and hence no rusting. The considerable crack over the central transverse support did not extend through the surfacing and no water had penetrated to the steel.

1. A 1-in. thickness of stone-filled mastic asphalt would be too thin for use on the deck of the proposed bridge. Cracks would probably form over the longitudinal stiffeners and permit water to penetrate through to the steel plate.

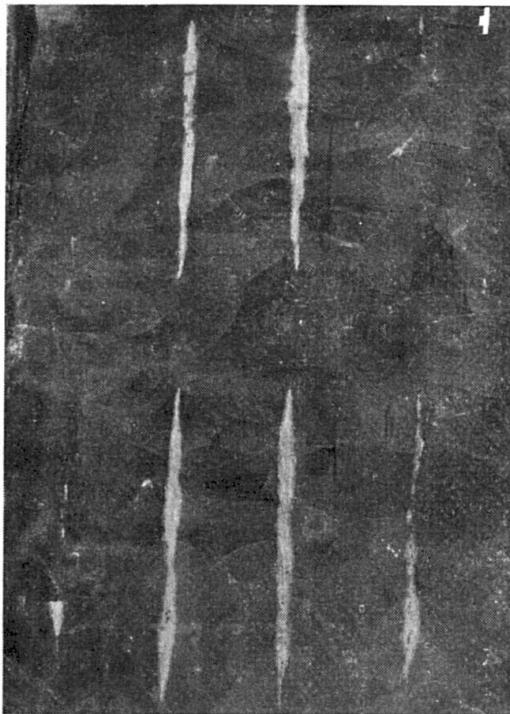
Fig. 9. The Steel Deck-Plate After Removal of 1-in. Surfacing. Note the Corrosion After 4½ yr. Owing to Water Penetrating Through the Cracks Shown Above.

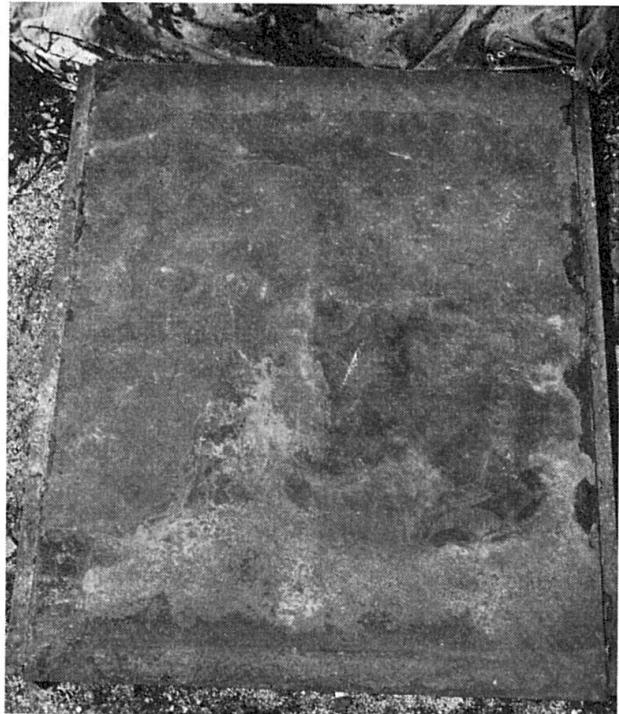
Fig. 10. The 9 ft. By 7 ft. Deck Plate After Removal of the 1½-in. Surfacing. Note Absence of Any Corrosion After 4½ yr., Due to Cracking; and Also the Very Considerable Corrosion Where the Mastic Asphalt Had Not Adhered Properly Over the Front and Centre Portions of the Plate.

There was a fairly well defined crack about $\frac{1}{16}$ in. wide over the central stiffener and a very short, faint crack over each of the two adjoining stiffeners. None of these cracks penetrated to the steel plate. As with the 1-in. surfacing, water entered all around the edges of the plate and caused considerable corrosion, particularly at the west end of the panel (on which traffic first runs). Approximately a quarter of the whole area had no adhesion between the

mastic asphalt and the steel. Here the plate was extensively rusted and the mastic asphalt was widely cracked over its underside. The cracks were filled with rust and slime, but did not penetrate to within $1/2$ in. of the top surface. No cracks were detected in the region where the adhesion to the steel was good. Fig. 10 shows a photograph of the steel plate after the $1\frac{1}{2}$ -in. surfacing had been removed.
