**Artikel:** Laboratory testing of full-size aluminium bridge

### Laboratory Testing of Full-size Aluminum Bridge

JAMES MICHALOS

Department of Civil Engineering, New York University, New York, N. Y., U.S.A.

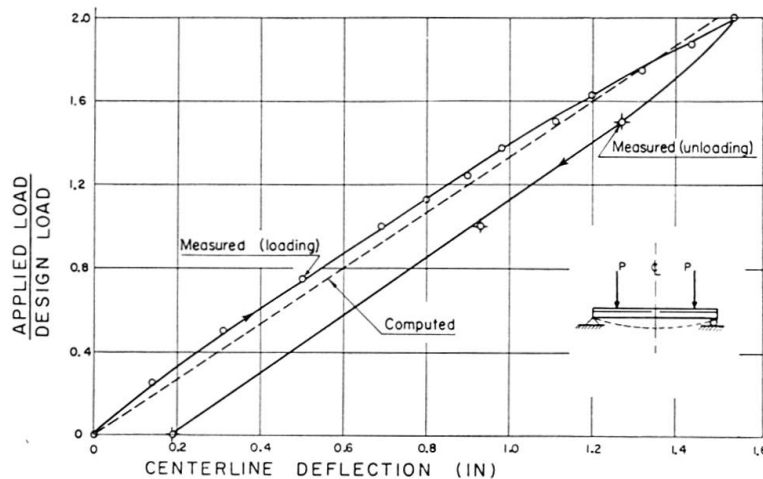
Fig. 4. Centerline Deflection.

Fig. 4 shows the vertical deflection at the centerline of the span as the load was increased to 2 times design value and then removed. The plotted values, obtained by averaging the measured deflections at the four lines of extrusions, define reasonably smooth curves during the loading and unloading stages. Up to approximately 1.5 times design load the measured deflections varied almost linearly with load but lagged in comparison to the computed

values. At loads above 1.5 times design value, the deflections increased non-linearly with load so that at the maximum of 2.0 times design value the measured vertical deflection was slightly larger than the computed value. As reported subsequently, the lag in measured deflections was due principally to end bearing friction.

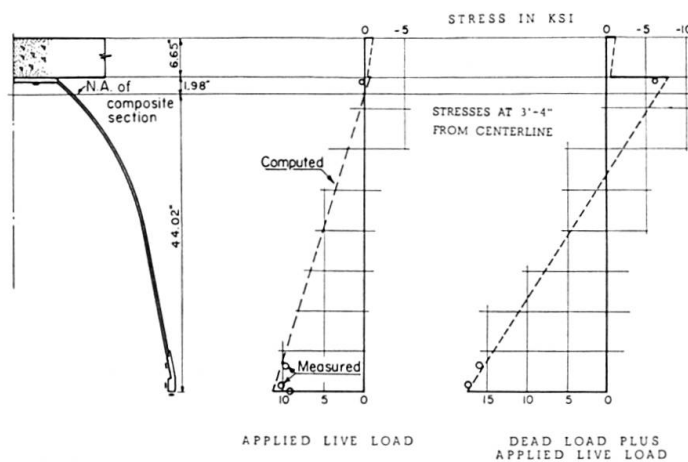
Fig. 5. Stresses at Two Times Design Moment.

Computed bending stresses and those deduced from measured strains, in kips per sq.in., are shown in Fig. 5. In the bottom extrusion the measured values are consistently lower than the theoretical values, with a maximum difference of approximately 10 percent. The strain gage readings on the under-side of the top plate, although somewhat erratic because of the very low level of stress, are consistent with the anticipated position of the neutral axis.

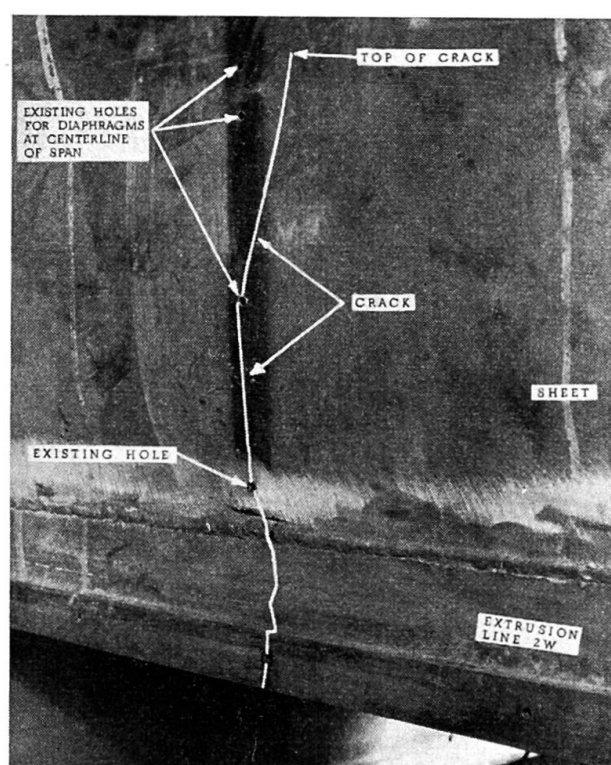
Fig. 6. Crack No. 1.

The 50,000 cycles at 1.0 times design moment were completed without incident. After 360,595 cycles at 1.5 times design moment a crack was discovered. It had progressed through an interior bottom extrusion at mid-span and gone upward into the  $\frac{1}{8}$ -in. curved sheet for a distance of approximately 16 in., almost to the mid-height of the aluminum module. Fig. 6 is a photograph, with the interior diaphragm removed, showing the full extent of the crack. Note its progression through three holes in a vertical line, starting at the  $\frac{1}{4}$ -in. hole in the bottom extrusion.

A 6-in. wide section of the bottom extrusion and a 4-in. wide by  $7\frac{1}{2}$ -in. high portion of the curved sheet was cut out to remove the bulk of the crack. The balance of the crack in the sheet was enlarged with a saw after a hole

had been drilled at its upper extremity. Matching patch plates were prepared, positioned, and then welded using the inert gas shielded consumable-electrode process. The completed repair, with additional reinforcing plates for the bottom extrusion, is shown in Fig. 7. In order to replace the interior diaphragm that had been removed, portions of the weld seam were ground down.

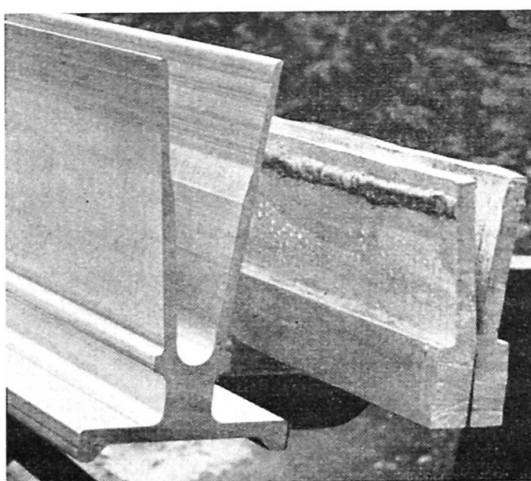
Fig. 8. New and Original Extrusions.

It was recognized that the test structure would then consist of two groups of parts with different loading histories. The new extrusions would have no history of repeated loads, while the remainder of the structure would have sustained 50,000 cycles at 1.0 times design moment and 447,000 cycles at 1.5 times design moment. In addition, there would be various difficulties involved in making such a major repair, but nonetheless the sponsor considered it preferable to replace the extrusions. A new extrusion is shown in Fig. 8 adjacent to the pair of extrusions it replaced.

After the third crack, the sponsor decided to discontinue the practice of making repairs as they became necessary and instead remove the central

49 ft. 6 in. of the bottom extrusions and replace them with others of a new design in which all holes were eliminated. Extrusions on interior lines were to be single units rather than pairs.

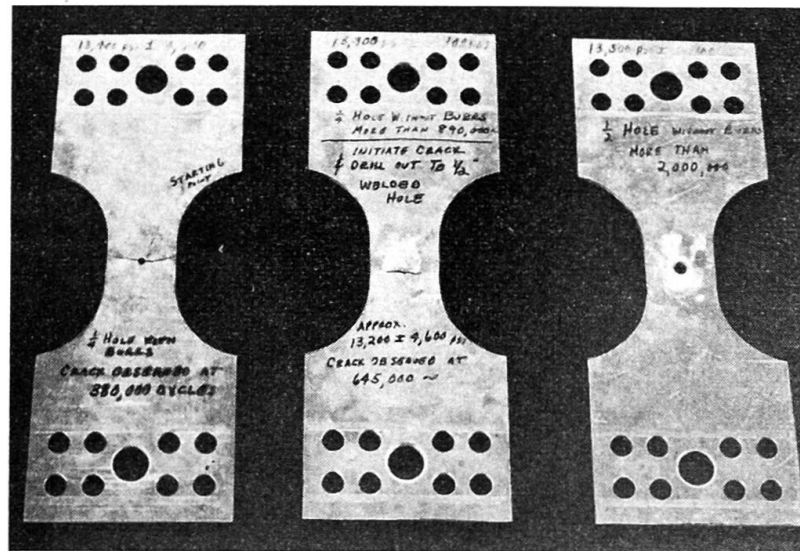
Fig. 9. Fatigue Specimens.

Fig. 9 shows three laboratory specimens that were subjected to repeated load from approximately 9,000 psi to approximately 18,000 psi. This stress range corresponds roughly to dead load and dead load plus 2 times live load. The left-hand specimen, containing a  $\frac{1}{4}$ -in. drilled hole, underwent 380,000 cycles before it cracked. The results compare well with the history of crack number 1 although the cycling of the specimen was at a higher stress level. The middle specimen, which had a drilled hole reamed to  $\frac{1}{4}$  in., underwent 890,000 cycles before cracking. The hole was then enlarged to  $\frac{1}{2}$  in. and filled by welding, and the specimen underwent an additional 645,000 cycles before cracking. The specimen on the extreme right was drilled and reamed to  $\frac{1}{2}$  in. After more than 2,000,000 cycles no crack was observed.
