Artikel: Laboratory testing of full-size aluminium bridge

Autor: Michalos, James / Kubo, Gerald G. / Birnstiel, Charles

Laboratory Testing of Full-size Aluminum Bridge

Department of Civil Engineering, New York University, New York, N. Y., U.S.A.

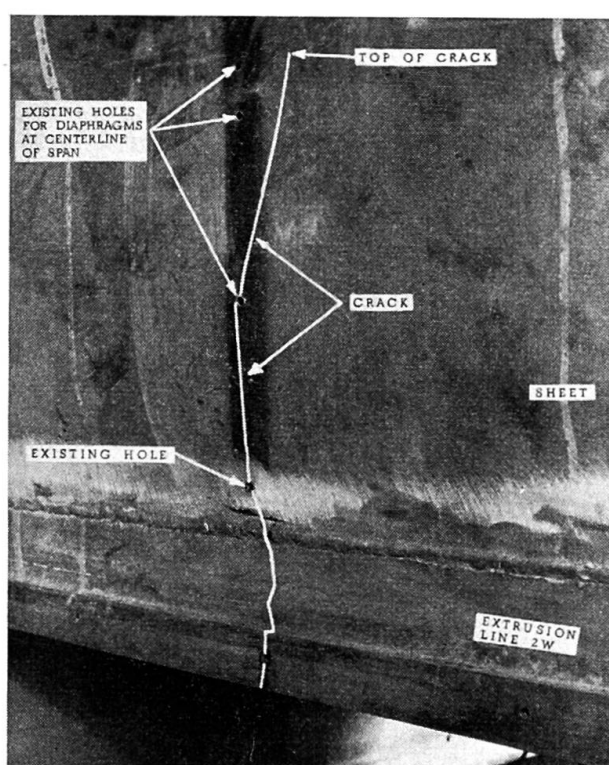
Fig. 6. Crack No. 1.

The 50,000 cycles at 1.0 times design moment were completed without incident. After 360,595 cycles at 1.5 times design moment a crack was discovered. It had progressed through an interior bottom extrusion at mid-span and gone upward into the $\frac{1}{8}$ -in. curved sheet for a distance of approximately 16 in., almost to the mid-height of the aluminum module. Fig. 6 is a photograph, with the interior diaphragm removed, showing the full extent of the crack. Note its progression through three holes in a vertical line, starting at the $\frac{1}{4}$ -in. hole in the bottom extrusion.

All of the serious cracks that developed in the structure involved some sort of stress raiser which eventually led to distress under repeated load. The original stress raisers were the holes in the bottom extrusions. As the result of unsatisfactory repair of the cracks induced by these holes, new stress raisers were introduced, and these, coupled with poor weld penetration in some instances, resulted in the formation of still other cracks. In no case was a crack observed that was not due to one of these causes.

A 6-in. wide section of the bottom extrusion and a 4-in. wide by $7\frac{1}{2}$ -in. high portion of the curved sheet was cut out to remove the bulk of the crack. The balance of the crack in the sheet was enlarged with a saw after a hole
