Behaviour of Four Prestressed Concrete Platform Roofs Between 1955 and 1963

P. W. ABELES

Two pairs of two platform roofs were built at Potters Bar near London in 1954/55. As seen in Fig. 1, each of the four roofs is 130 ft. long and approximately 36 ft. wide supported by four columns. Each roof consists of a cantilever slab of a thickness of 3—4 in., supported by two main beams, the slab being prestressed by means of post-tensioned four-wire cables placed in grooves 12 in. apart. Each of the two main beams of 130 ft. length, cast and prestressed in situ, is supported by two columns 65 ft. apart. Thus in both cases for the slab as well as for the beams there are only negative bending moments with tension at the upper sides under uniformly distributed load which allowed the provision of straight posttensioned tendons.

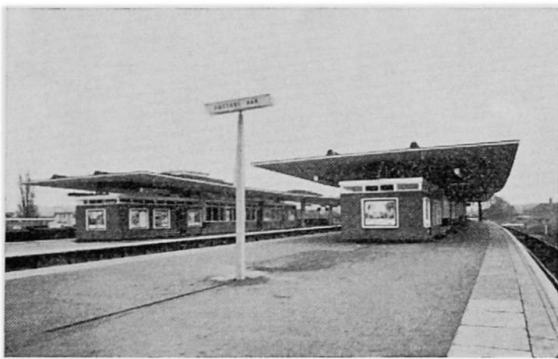
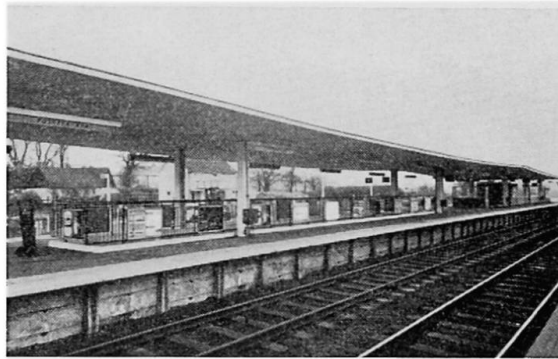
excessive deformation and by the infiltration of water into a lightweight concrete topping (which was afterwards provided at the centre portion to improve the drainage), the deadload was appreciably increased and exceeded there the working load with the consequence that cracks developed at the underside i. e. where compressive stresses were expected, as described in more detail elsewhere¹). Consequently, modifications were made by removal of the "lightweight" concrete topping and roofing cover over the centre portion of the roof and ensuring satisfactory drainage, thereby keeping the dead load within the design value, when all cracks at the underside closed. Figs. 3 and 4 show the

roof after this modification, when the deformations were greatly reduced and the recoveries were in good agreement with the anticipation based on the calculation with an E -value more appropriate to the actual strength.

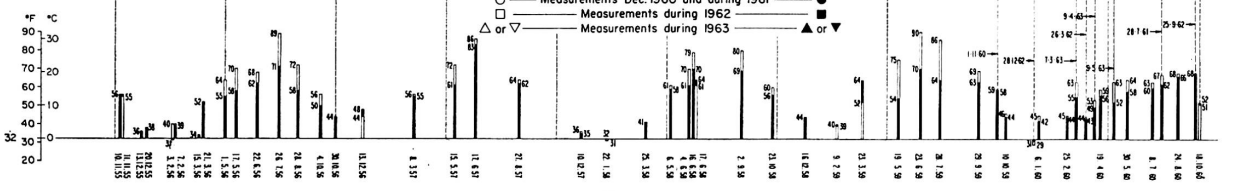
Fig. 5.

Measurements of the levels of the four corners A , of the four cantilever ends B and of the two points C and D at the centre of the roofs have been made for all four roofs at certain intervals. In Fig. 5 the maximum and minimum levels of each roof have been plotted for the time between November 1955 and November 1960. The abscissa representing the time is divided into 10 divisions, each of which indicates half a year, and the date is given underneath. The maximum and minimum of deflections of all four roofs are shown by solid lines when at least two readings were available and by dotted lines where only a single reading applied. Fig. 5 relates to the measurements of 16 points each at the corners A and the cantilever ends B , and covers the points C and D at the centres where eight readings each were taken.

It is seen that the deflections varied to a great extent during each year and were mainly dependent on the temperature. Obviously, also, sunshine and relative humidity are of some influence. However, it was impossible, as originally intended, to make some distinction between the effect of temperature, sunshine and relative humidity. The latter was ascertained since Autumn 1959 and varied between 36 and 88 per cent relative humidity. The weather in England, as is well known, is very changeable and thus appreciable differences in temperature and humidity occurred often between the levelling of the first and last roof. This accounts for great variations between the minimum at individual measurements.

It was considered as possible that the excessive deformations (comprising upward deflections at the cantilevers and downward deflections at the centres of the roofs) might even increase in the course of time in consequence of further creep and shrinkage of the concrete and relaxation of the steel. However, the measurements, as shown in Fig. 5, indicate that there has, in principle, not been an excessive increase in the deformations. In general, it can be seen that with increasing temperature a relief in deformation takes place, the cantilever ends lowering and the centres of the beams rising, as indicated in Fig. 1.
