Artikel: The analysis, design and remedial repairs for a fire damaged two-way
roof truss structure

The Analysis, Design and Remedial Repairs for a Fire Damaged Two-Way Roof Truss Structure

THOMAS S. TARPY, Jr.
Structural Engineer

STANLEY D. LINDSEY
President
Stanley D. Lindsey & Associates, Ltd.
Nashville, USA

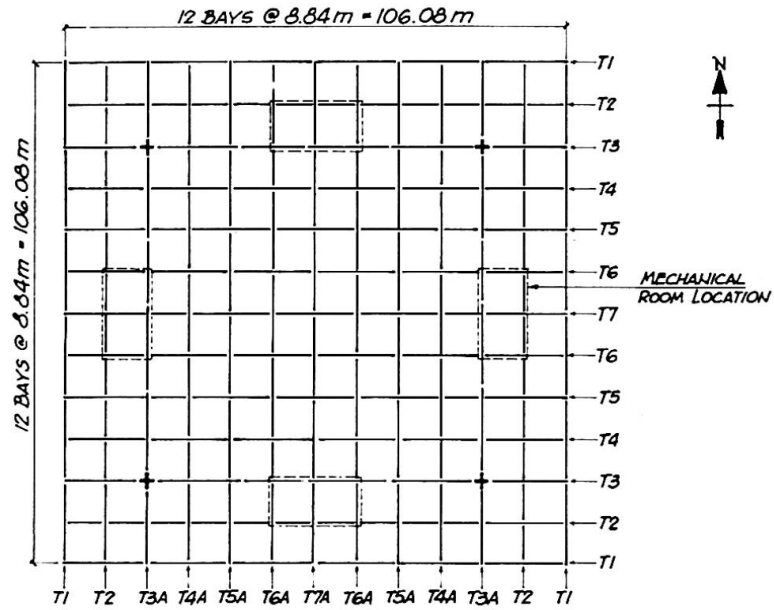
FIGURE 1. ROOF FRAMING PLAN

Nashville. The roof framework is a symmetrical two-way truss system supported on four columns as shown in Figure 1. The structural system is considered a space grid to obtain the local distribution on each truss. The four main support trusses spanning between the four columns serve to distribute the load equally to the support columns.
