Artikel: The analysis, design and remedial repairs for a fire damaged two-way roof truss structure

The Analysis, Design and Remedial Repairs for a Fire Damaged Two-Way Roof Truss Structure

THOMAS S. TARPY, Jr. STANLEY D. LINDSEY JACK R. HORNER
 Structural Engineer President Structural Engineer
 Stanley D. Lindsey & Associates, Ltd.
 Nashville, USA

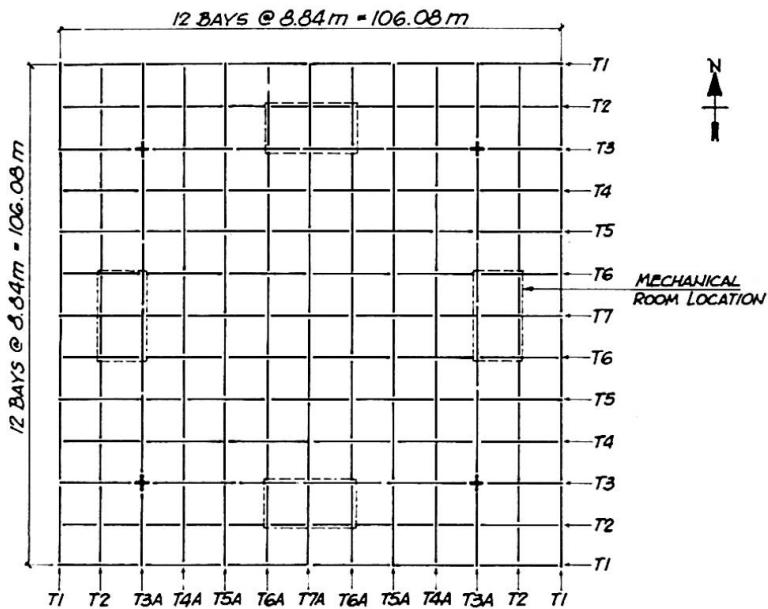
FIGURE 1. ROOF FRAMING PLAN

Nashville. The roof framework is a symmetrical two-way truss system supported on four columns as shown in Figure 1. The structural system is considered a space grid to obtain the local distribution on each truss. The four main support trusses spanning between the four columns serve to distribute the load equally to the support columns.
