**Artikel:** The analysis, design and remedial repairs for a fire damaged two-way  
roof truss structure

## The Analysis, Design and Remedial Repairs for a Fire Damaged Two-Way Roof Truss Structure

Stanley D. Lindsey & Associates, Ltd.  
Nashville, USA

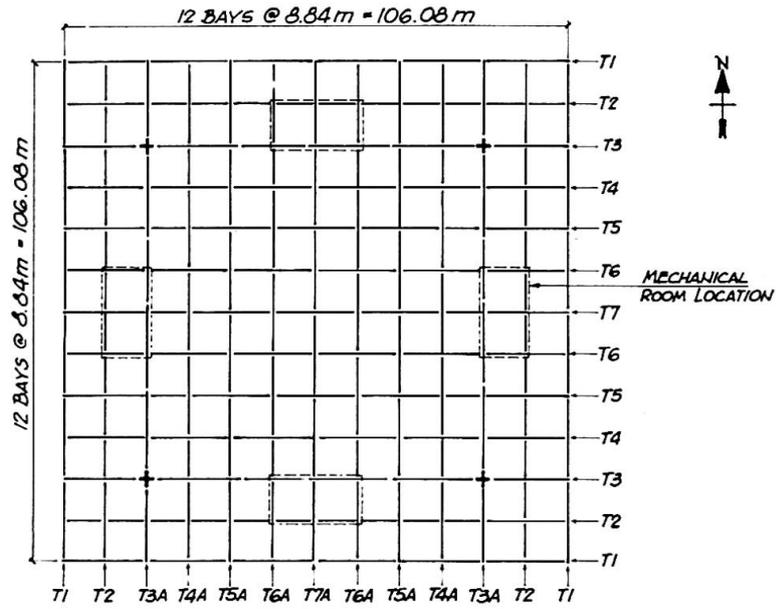
FIGURE 1. ROOF FRAMING PLAN

Nashville. The roof framework is a symmetrical two-way truss system supported on four columns as shown in Figure 1. The structural system is considered a space grid to obtain the local distribution on each truss. The four main support trusses spanning between the four columns serve to distribute the load equally to the support columns.
