Artikel: The analysis, design and remedial repairs for a fire damaged two-way
roof truss structure

The Analysis, Design and Remedial Repairs for a Fire Damaged Two-Way Roof Truss Structure

Stanley D. Lindsey & Associates, Ltd.
Nashville, USA

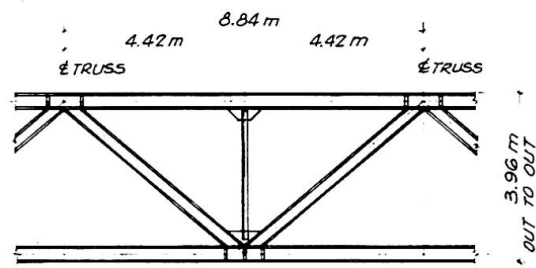
a) MAIN SUPPORT TRUSS

- a. The top chord of the main support truss had major flange buckling and lateral deformations.
- b. Virtually all bar joists and bridging were damaged beyond repair.
- c. The top chords of several adjacent trusses had warped stems.
- d. Several diagonals composed of double angles had buckled.
- e. Virtually all the miscellaneous support steel for the mechanical equipment was deformed.
