Zeitschrift:	IABSE congress report = Rapport du congrès AIPC = IVBH Kongressbericht
Band:	11 (1980)
Artikel:	Behavior of first-built composite girder bridge in Japan
Autor:	Maeda, Yukio / Saeki, Akimi / Endo, Minato
DOI:	https://doi.org/10.5169/seals-11373

Kanzaki Bridge, Osaka, Japan, was removed after 25 years' service as the first-built steel-concrete composite girder bridge in Japan. Lessons from the load history investigation of the bridge and from the strength tests of the girders and materials, are discussed in relation with the soundness or deterioration of the bridge after its 25 years' use.

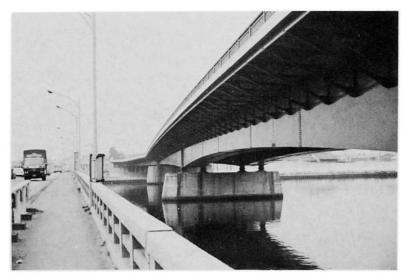
Photo. 1 Picture of Old KANZAKI Bridge

Kanzaki Bridge, Osaka, Japan, was the first steel-concrete composite bridge^{1),2)} built in 1953 to carry the Osaka Prefectural Road over Kanzaki River. Photo 1 shows the general view of the original bridge. The bridge was designed in accordance with the German Code of Practic for Composite Girder Bridges in 1950, because at that time Japan didn't have her own design specification for composite girder bridges. The bridge was removed in 1978 after 25 years' service to meet a further increase in traffic and the control of flood tide in the river. Then, it was replaced by a new non-prestressed composite box girder bridge consisting of 3-spans of 76.5 + 88.0 + 76.5 m with the effective width of 22.5 m. Photo 2 shows the new bridge by the side of the old bridge which was being demolished. Since full-size tests of composite girders which were subjected to a long history of loadings and of weather conditions, have hardly been reported, various tests of the girders of Kanzaki Bridge were carried out or are in progress, in the same way as the tests previously done at the time of the original construction, as well as an investigation on the load history of the bridge. The paper presents lessons from the behaviors of the composite girders after 25 years' use.

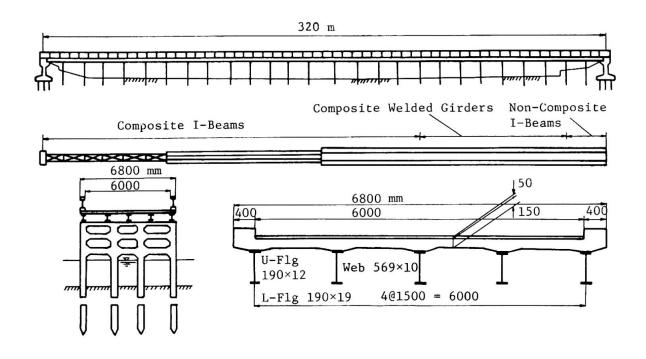
Fig. 1 General View of Old KANZAKI Bridge

Kanzaki Bridge consisted of 18 spans of 12 m length of composite I-beams, 7 spans of 12 m length of composite welded girders and 2 spans of 10 m length of non-composite Ibeams, making the total bridge length of 320 m as seen in Fig. 1. It was provided with 15 cm thick reinforced-concrete slab with 5 cm thick asphalt-concrete pavement. Inverted Tshaped reinforced-concrete abutments and pile-bent type reinforced-concrete piers were set on pile foundations. The effective width was originally 6.0 m and later in 1962-63 it was enlarged to a roadway of 8.0 m plus a footway of 2.0 m to meet an increase in traffic. The design live load was 13 ton trucks as the lst-class bridge following the Japanese Bridge Design Specification in 1939.

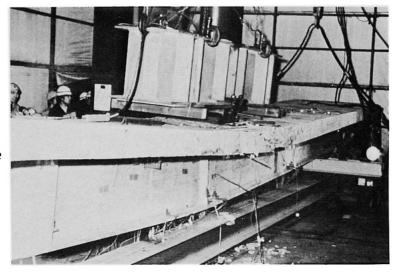
Photo. 5 Failure of Single-Web Composite Girder

Load versus strains, deflections, and slips were measured for two test girders (T-1 and T-2) up to their failure. Fig. 3 shows the relations of loads with deflections at the span center. Generally, the calculated strength of a girder is located a little below its measured strength, but the calculated strengths of T-1 and T-2 girders are a little above the measured values. Such reduction of the measured values shows the lowering of the flexural rigidities of the girders, probably due to existing cracks in their slabs.

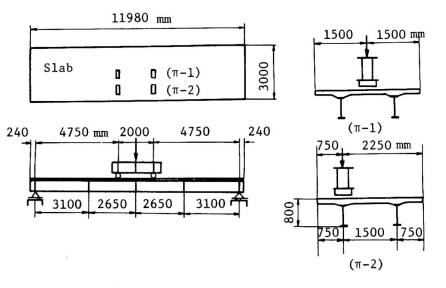
Fig. 4 Test Set-Up of π-Type Girders

Since a width-center loaded girder $(\pi-1)$ collapsed due to punching shear, its failure strength was almost equal to that of the single-web compos-

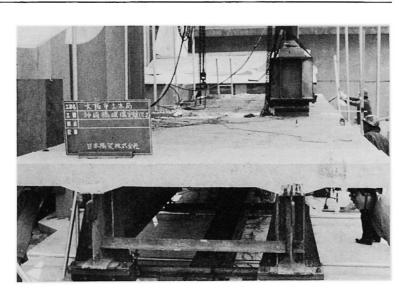
Photo. 6 Test of Two-Web Composite Girder

ite girder. In fact, the effect of bending action of the slab on the load-carrying capacity of the π -1 girder was hardly observed. At a width-off-center loaded girder $(\pi-2)$ (Photo. 6), cracking started on the upper surface of the slab at the load of 45 t. Then, the cracks were propagated in a fan-shape at the load of 80 t and finally, the failure occurred at the load of 125 t due to the development of large cracks around the loading plate. Fig. 5 shows the relations of load with vertical deflection, in which an in-

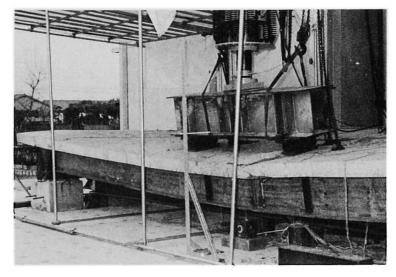
Photo. 7 Failure of Two-Web Composite Girder

crease in the deflection of K point is remarkable at about 80 tons. It is noticed that the width-off-center loading governs the ultimate strength of the composite girder more severely than the center loading. Photo. 7 shows the failure of the girder.
