Artikel: Fracture and retrofit of Dan Ryan Rapid Transit Structure

Autor: Fisher, J.W. / Hanson, J.M. / Hausammann, H.

**IX****Fracture and Retrofit of Dan Ryan Rapid Transit Structure**

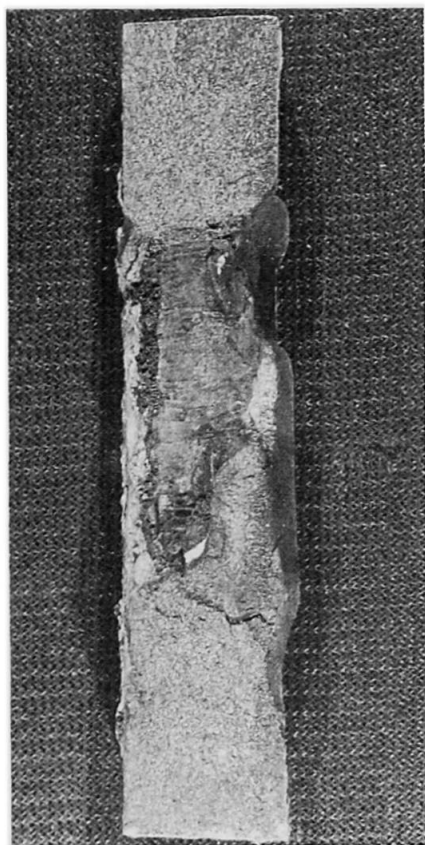
The crack surfaces of the side plates of the box girders adjacent to the flange tip were examined. Chevron markings found on the fracture surface indicated that the crack originated near the tip of the girder flange. A photograph and schematic of one fracture surface are shown in Figs. 3a and 3b. The overall fracture surface shows that the weldment connecting the flange tip to the box had a large lack of fusion area. Paint was found in some of these areas, which had penetrated from the inside of the box. The largest lack of fusion area was approximately 18 mm by 83 mm and was approximately elliptical shaped.

Fig. 3a Fracture Surface of Box Girder Web Plate

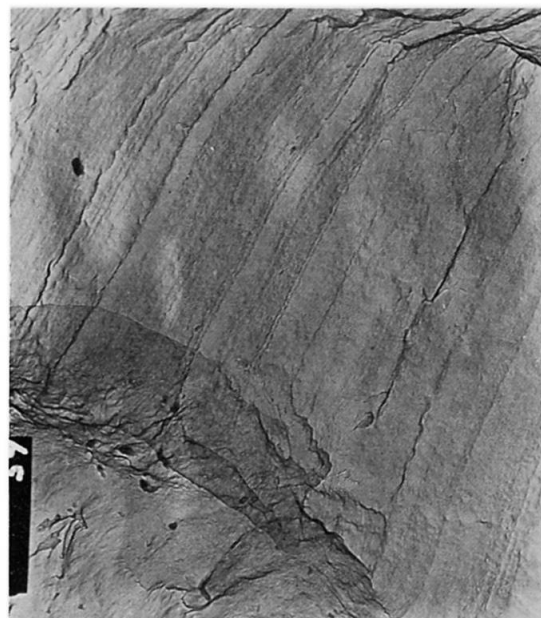
Surface replicas were prepared from different locations of the crack surface indicated in Fig. 3b and investigated with the transmission electron microscope. Fatigue striations (see Fig. 4) were found on all three fracture surfaces. These striations represent the extension of the crack front during one load cycle and confirmed the development of fatigue crack growth. Striation markings were found in regions 2 and 3 in Fig. 3b; the measured growth rate was 2.10^{-5} mm/cycle near the exterior surface and 5.10^{-5} mm/cycle near the lack of fusion area. The examination of region 4 near the upper end of the discontinuity showed mainly cleavage fracture with river patterns. The examination of each fracture surface confirmed that fatigue crack growth originated at the lack of fusion area and at the exterior weld surface at the weld toe on the box side plate. It was estimated that about 6 mm of fatigue crack growth was experienced before the cracks became unstable.

Fig. 4 Fatigue Striation Markings on Box Girder Web Surface

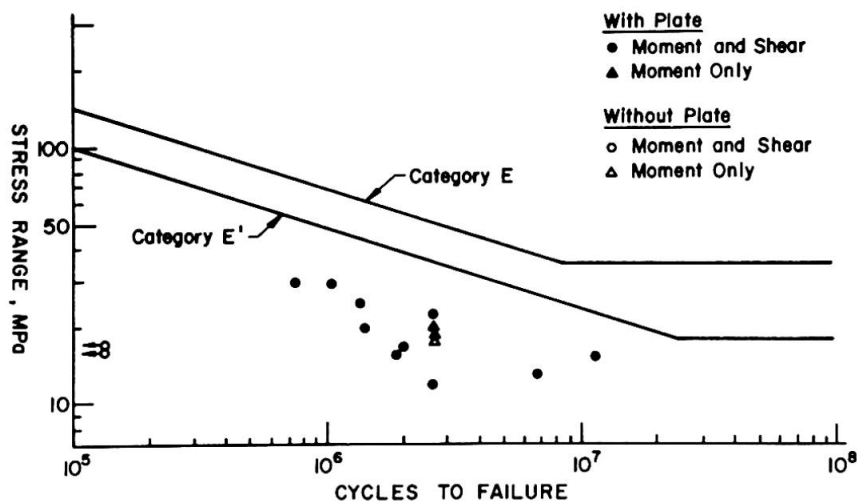
After the discovery of the fracture in the Dan Ryan Rapid Transit, fatigue tests of similar details were carried out at Fritz Engineering Laboratory, Lehigh University [4]. It was found that the fatigue strength of a web detail which simulated the penetration of a girder flange through the web was well below the most severe design category in the AASHTO Specifications [5]. Figure 5 shows the fatigue resistance provided by the tests of the simulated web penetration insert detail [4].

Fig. 5 Fatigue Strength of Simulated Web Penetration

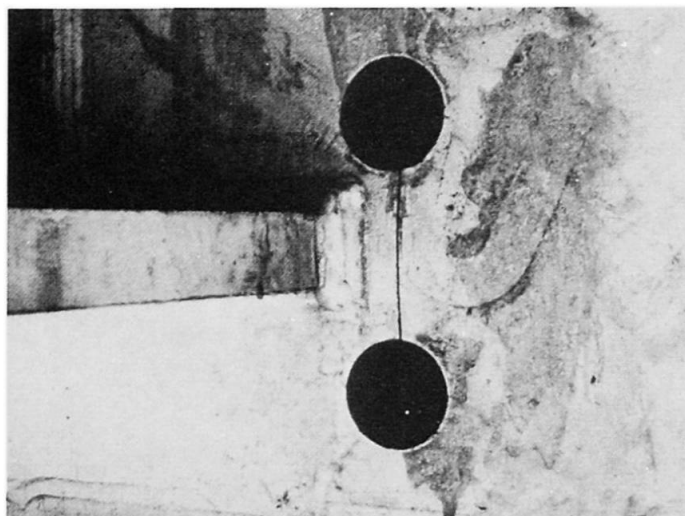
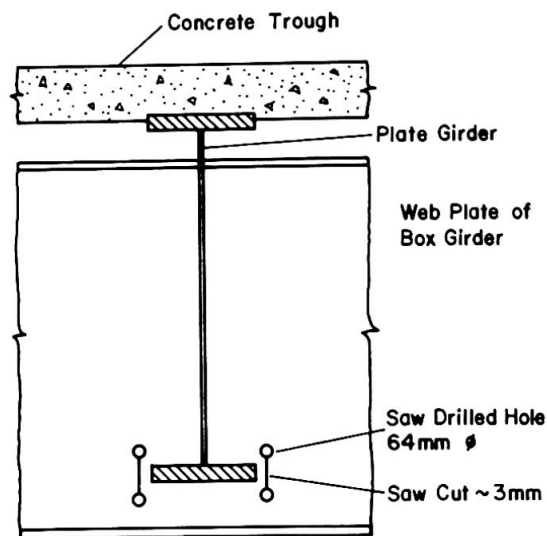
Fig. 6a Retrofitted Box Side Plate

Fig. 6b Schematic of Retrofitted Detail

Any retrofit must minimize the severe stress concentration at the intersection of the girder flange and the box girder webs and reduce the high residual stresses from the weld shrinkage. To accomplish this aim, those locations with small or negligible cracks at the flange tips were retrofitted by cutting holes and sawing between them to create a "dumbbell" configuration in the box side plates near the edges of the girder flanges, as shown in Fig. 6. This method of retrofitting was considered to release the residual stress field at the flange tip and to shield the critical location from the bending stresses.
