**Artikel:** Fracture and retrofit of Dan Ryan Rapid Transit Structure

**Autor:** Fisher, J.W. / Hanson, J.M. / Hausammann, H.

**IX****Fracture and Retrofit of Dan Ryan Rapid Transit Structure**

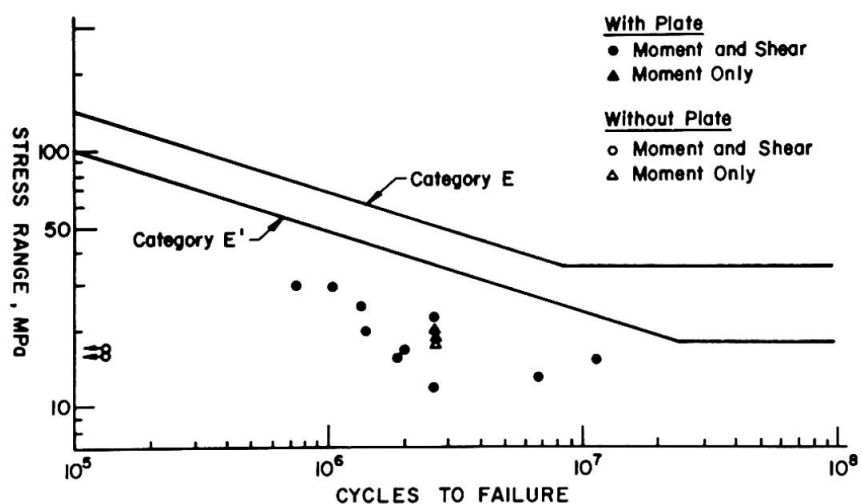
After the discovery of the fracture in the Dan Ryan Rapid Transit, fatigue tests of similar details were carried out at Fritz Engineering Laboratory, Lehigh University [4]. It was found that the fatigue strength of a web detail which simulated the penetration of a girder flange through the web was well below the most severe design category in the AASHTO Specifications [5]. Figure 5 shows the fatigue resistance provided by the tests of the simulated web penetration insert detail [4].

Fig. 5 Fatigue Strength of Simulated Web Penetration
