Artikel: Fracture and retrofit of Dan Ryan Rapid Transit Structure

Autor: Fisher, J.W. / Hanson, J.M. / Hausammann, H.

Fracture and Retrofit of Dan Ryan Rapid Transit Structure

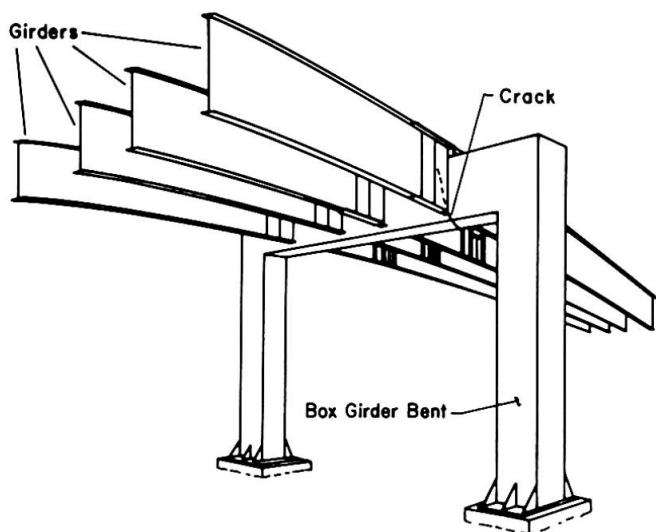
The bents have a box-shaped cross-section consisting of two column legs and a horizontal box member, as shown in Fig. 1. The top flanges of the plate girders pass over the top flanges of the boxes. The bottom flanges pierce the boxes through flame-cut slots near the bottom of the box side plates. In the fractured bents, the intersections were connected by heavy fillet welds on the outside and little or no weld on the inside. At other locations, the intersections were sometimes filled with welds. The girders intersect the boxes at different angles. The bents and the girders are fabricated of American Society for Testing of Materials (ASTM) A36 steel.

Fig. 1 Schematic Showing Box-Shaped Bent and Girders with Crack Location

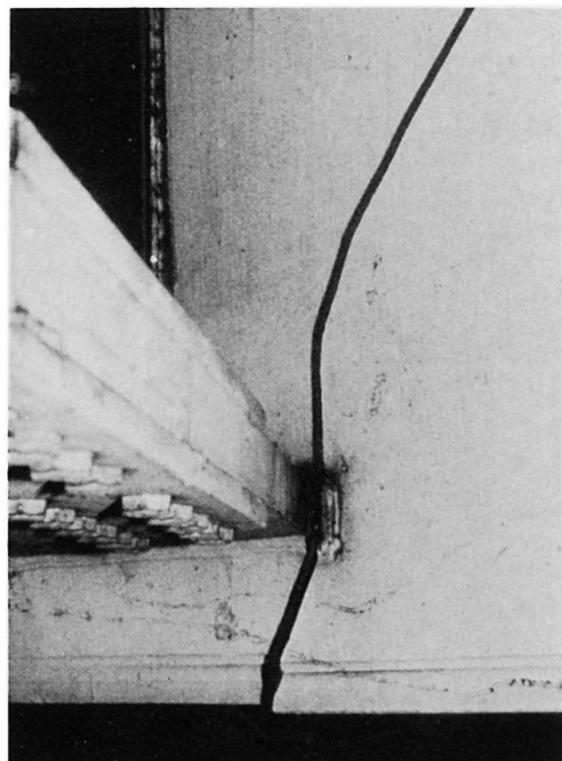
The initial field examination of the fracture indicated that all of the cracks started at the welded junction of the plate girder flange tip to the box side plate, as illustrated in Fig. 2. All three cracks completely severed the bottom flange of the box girders and the webs. Openings at the bottom flange of about 20 mm were measured.

Fig. 2 Cracked Box Side Plate

The cracks were arrested near or in the top flange. The cracks in the bottom flanges were inclined approximately 20 degrees to a normal to the longitudinal axis of the bent above the flanges of the girders. Two crack surfaces were found to be slightly corroded, the third one had a heavy oxide coating.

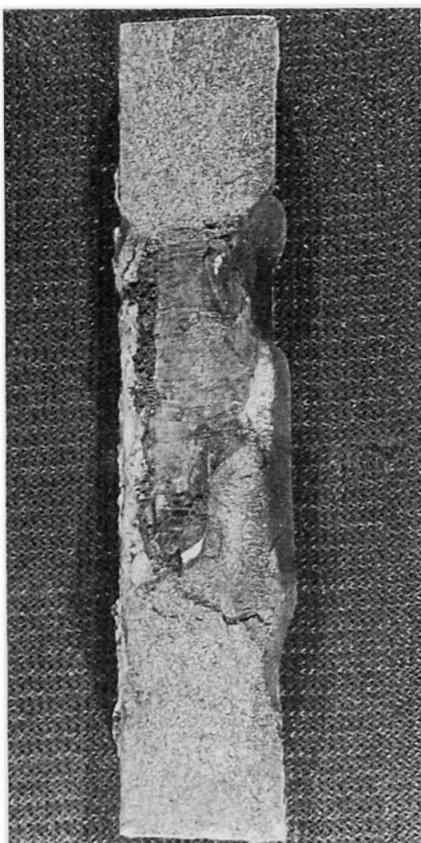
The crack surfaces of the side plates of the box girders adjacent to the flange tip were examined. Chevron markings found on the fracture surface indicated that the crack originated near the tip of the girder flange. A photograph and schematic of one fracture surface are shown in Figs. 3a and 3b. The overall fracture surface shows that the weldment connecting the flange tip to the box had a large lack of fusion area. Paint was found in some of these areas, which had penetrated from the inside of the box. The largest lack of fusion area was approximately 18 mm by 83 mm and was approximately elliptical shaped.

Fig. 3a Fracture Surface of Box Girder Web Plate

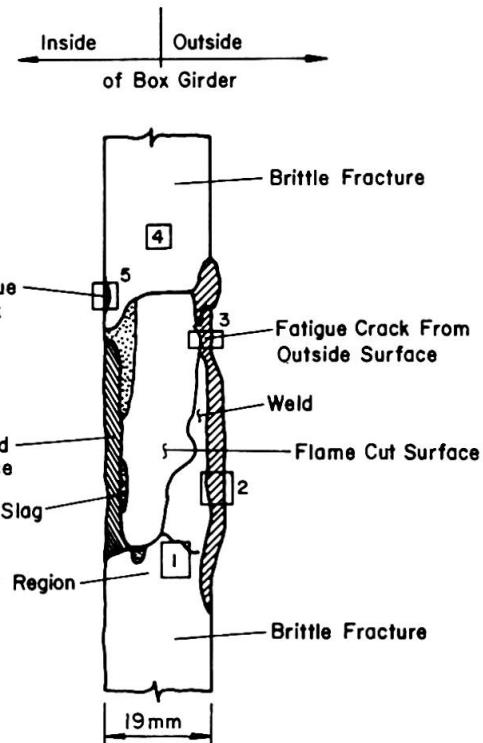
Fig. 3b Schematic of Fracture Surface

Surface replicas were prepared from different locations of the crack surface indicated in Fig. 3b and investigated with the transmission electron microscope. Fatigue striations (see Fig. 4) were found on all three fracture surfaces. These striations represent the extension of the crack front during one load cycle and confirmed the development of fatigue crack growth. Striation markings were found in regions 2 and 3 in Fig. 3b; the measured growth rate was 2.10^{-5} mm/cycle near the exterior surface and 5.10^{-5} mm/cycle near the lack of fusion area. The examination of region 4 near the upper end of the discontinuity showed mainly cleavage fracture with river patterns. The examination of each fracture surface confirmed that fatigue crack growth originated at the lack of fusion area and at the exterior weld surface at the weld toe on the box side plate. It was estimated that about 6 mm of fatigue crack growth was experienced before the cracks became unstable.

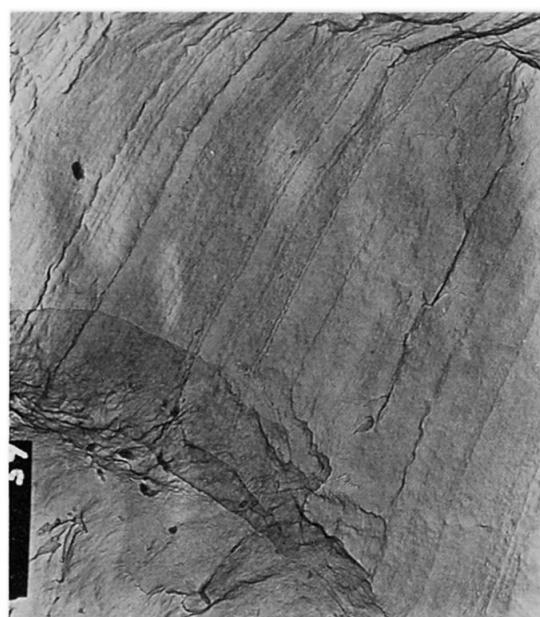
Fig. 4 Fatigue Striation Markings on Box Girder Web Surface

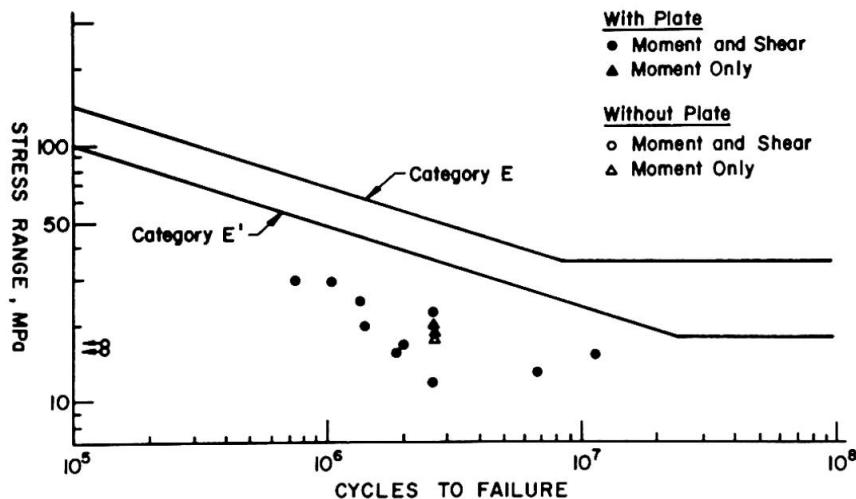
After the discovery of the fracture in the Dan Ryan Rapid Transit, fatigue tests of similar details were carried out at Fritz Engineering Laboratory, Lehigh University [4]. It was found that the fatigue strength of a web detail which simulated the penetration of a girder flange through the web was well below the most severe design category in the AASHTO Specifications [5]. Figure 5 shows the fatigue resistance provided by the tests of the simulated web penetration insert detail [4].

Fig. 5 Fatigue Strength of Simulated Web Penetration

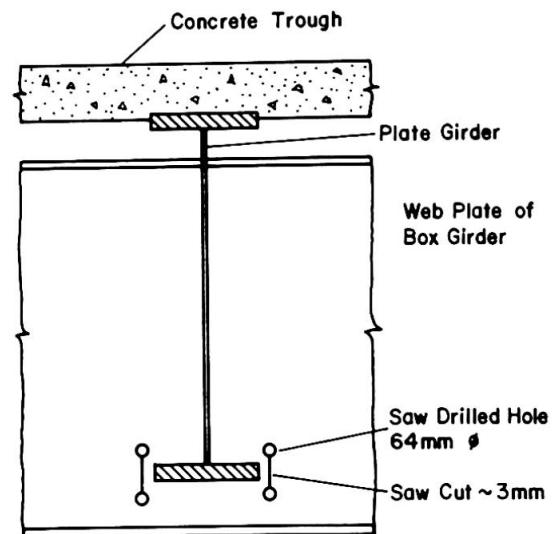
Fig. 6b Schematic of Retrofitted Detail

Any retrofit must minimize the severe stress concentration at the intersection of the girder flange and the box girder webs and reduce the high residual stresses from the weld shrinkage. To accomplish this aim, those locations with small or negligible cracks at the flange tips were retrofitted by cutting holes and sawing between them to create a "dumbbell" configuration in the box side plates near the edges of the girder flanges, as shown in Fig. 6. This method of retrofitting was considered to release the residual stress field at the flange tip and to shield the critical location from the bending stresses.
