**Artikel:** Fracture and retrofit of Dan Ryan Rapid Transit Structure

**Autor:** Fisher, J.W. / Hanson, J.M. / Hausammann, H.

# Fracture and Retrofit of Dan Ryan Rapid Transit Structure

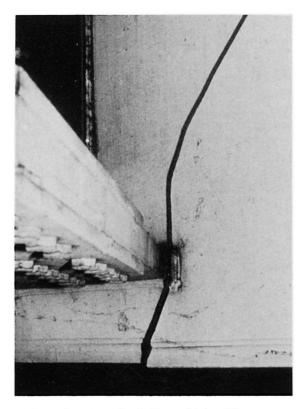
The initial field examination of the fracture indicated that all of the cracks started at the welded junction of the plate girder flange tip to the box side plate, as illustrated in Fig. 2. All three cracks completely severed the bottom flange of the box girders and the webs. Openings at the bottom flange of about 20 mm were measured.

Fig. 2 Cracked Box Side Plate

The cracks were arrested near or in the top flange. The cracks in the bottom flanges were inclined approximately 20 degrees to a normal to the longitudinal axis of the bent above the flanges of the girders. Two crack surfaces were found to be slightly corroded, the third one had a heavy oxide coating.

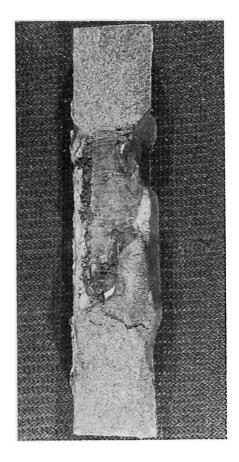
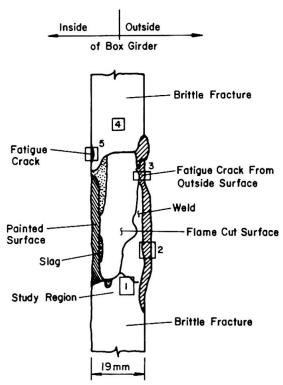
The crack surfaces of the side plates of the box girders adjacent to the flange tip were examined. Chevron markings found on the fracture surface indicated that the crack originated near the tip of the girder flange. A photograph and schematic of one fracture surface are shown in Figs. 3a and 3b. The overall fracture surface shows that the weldment connecting the flange tip to the box had a large lack of fusion area. Paint was found in some of these areas, which had penetrated from the inside of the box. The largest lack of fusion area was approximately 18 mm by 83 mm and was approximately elliptical shaped.

Fig. 3b Schematic of Fracture Surface

Fig. 3a Fracture Surface of Box Girder Web Plate

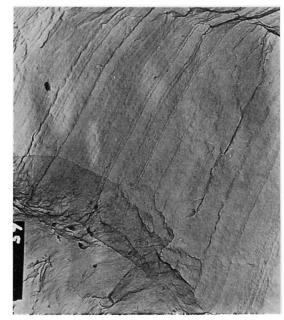
Surface replicas were prepared from different locations of the crack surface indicated in Fig. 3b and investigated with the transmission electron microscope. Fatigue striations (see Fig. 4) were found on all three fracture surfaces. These striations represent the extension of the crack front during one load cycle and confirmed the development of fatigue crack growth. Striation markings were found in regions 2 and 3 in Fig. 3b; the measured growth rate was  $2.10^{-5}$  mm/cycle near the exterior surface and  $5.10^{-5}$  mm/cycle near the lack of fusion area. The examination of region 4 near the upper end of the discontinuity showed mainly cleavage fracture with river patterns. The examination of each fracture surface confirmed that fatigue crack growth originated at the lack of fusion area and at the exterior weld surface at the weld toe on the box side plate. It was estimated that about 6 mm of fatigue crack growth was experienced before the cracks became unstable.

Fig. 4 Fatigue Striation Markings on Box Girder Web Surface

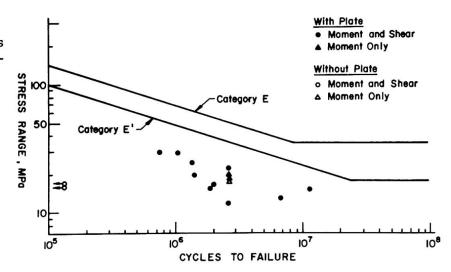
After the discovery of the fracture in the Dan Ryan Rapid Transit, fatigue tests of similar details were carried out at Fritz Engineering Laboratory, Lehigh University [4]. It was found that the fatigue strength of a web detail which simulated the penetration of a girder flange through the web was well below the most severe design category in the AASHTO Specifications [5]. Figure 5 shows the fatigue resistance provided by the tests of the simulated web penetration insert detail [4].

Fig. 5 Fatigue Strength of Simulated Web Penetration

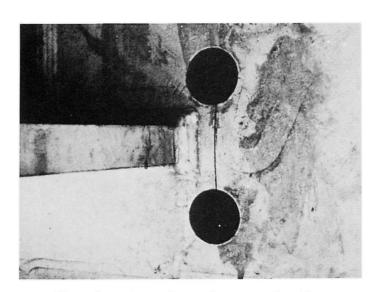
The cracking of three bents in the viaduct of the Dan Ryan line developed from fatigue crack growth at the weld junctions of girders which pierced the side plates of the box-shaped bents. Subsequent inspection revealed fatigue cracks at similar locations in nearby bents. Brittle fracture occurred when a critical combination of crack size and stress resulted in a critical stress intensity equal to the material fracture toughness at the low temperature. The cracks developed in the bents at the junction of the girder flange and side plates. The initial fabrication conditions provided cracklike conditions that were very susceptible to fatigue crack growth. It was a difficult area to weld because of the skewed angle between the girders and the bent. Comparable conditions have been observed in other structures with similar details and steps are being taken to retrofit those structures as well.

Fig. 6a Retrofitted Box Side Plate

Fig. 6b Schematic of Retrofitted Detail

Any retrofit must minimize the severe stress concentration at the intersection of the girder flange and the box girder webs and reduce the high residual stresses from the weld shrinkage. To accomplish this aim, those locations with small or negligible cracks at the flange tips were retrofitted by cutting holes and sawing between them to create a "dumbbell"configuration in the box side plates near the edges of the girder flanges, as shown in Fig. 6. This method of retrofitting was considered to release the residual stress field at the flange tip and to shield the critical location from the bending stresses.
