Artikel: Reconstruction of a railway station in Budapest

Reconstruction of a Railway Station in Budapest

TIBOR SIGRAI

UVATERV

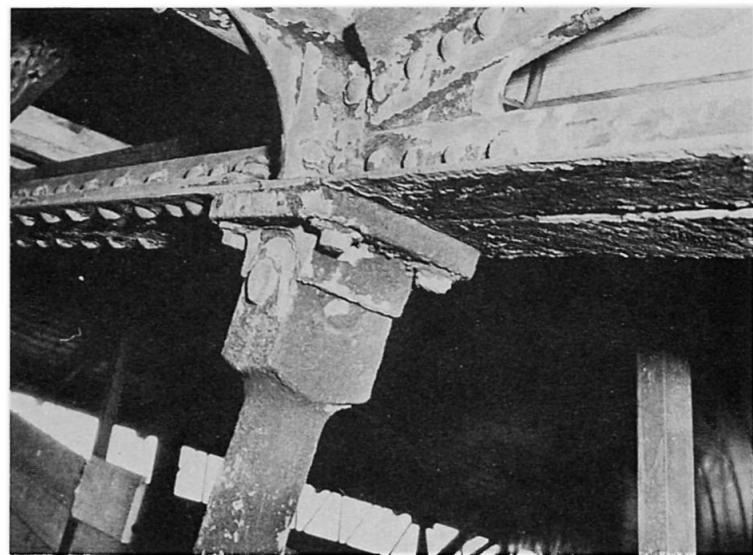
The extent of the corrosion at the middle part of the trussings, that are the most exposed to the fumes reached or surpassed the 50% limit. The corrosion of the bearing columns was caused by the faults in the rainwater drains. At the same time in the case of the decorative frame corners and the tension bars, the extent of the corrosion was negligible. The corrosion was also negligible at the two frame trusses to be found near the Great Boulevard, where the locomotives did not pull in.

5. Detail of a corroded trussing

The reconstruction took into consideration the point of view of the historical interest. It was based on saving of the less corroded structural parts, on the construction of a horizontal support system, on the load relief of the frame corners, and finally – taking into account that the problem was the mixed construction of the remaining and new parts – based on a conception that needs a very thorough manufacturing and assembly technology. The new track-hall, regarding its appearance, is almost the same as the old one, apart from minor details. The curtain wall, facing the Great Boulevard of Budapest, remained as it was and also remained the first two frames attached to it. These were cleaned by metal-spraying and were stiffened at the necessary places. The same principle applies to the decorative corners of the other frame structures. The latticed frame trusses between the frame corners are made anew by welding. The shape, the dimension and arrangement of the sections follows the original very closely.

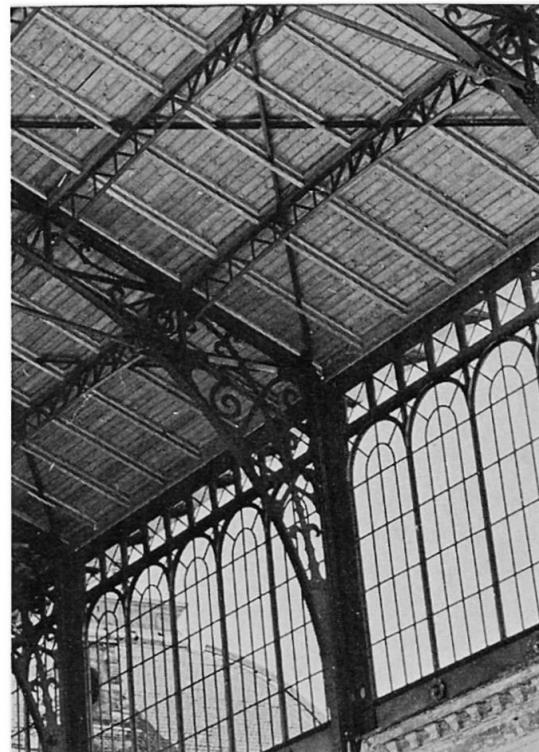
6. A renewed frame corner

During the strengthening of the columns only those parts of the original columns were demolished which reached into the track-hall. The new and partly double-walled column section encases the remaining part of the original column, securing this way the composite action. Thus the remaining frame corners are located between new frame-beams and new columns. The full set of the tension bars of the trussings remained in the original state. But all of the latticed purlins had to be replaced. Also completely new are the construction of the roof glazing, the side glass-screens and the wind-braces, where the longitudinal wind-brace appears as a new structural element. The curtain wall on the exit side was totally destroyed and had to be completely rebuilt.

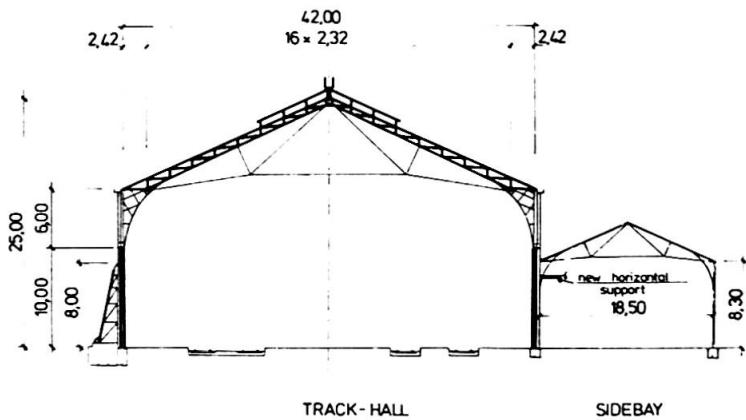
7. The remaining and the new parts of the frame structure

The weight of the remaining steel parts is 140 tons, 27% of the original steel structure weighing 515 tons. Nevertheless the value of the saved parts surpasses many times that of the heavier new parts because of the high cost of manufacturing of the bars.

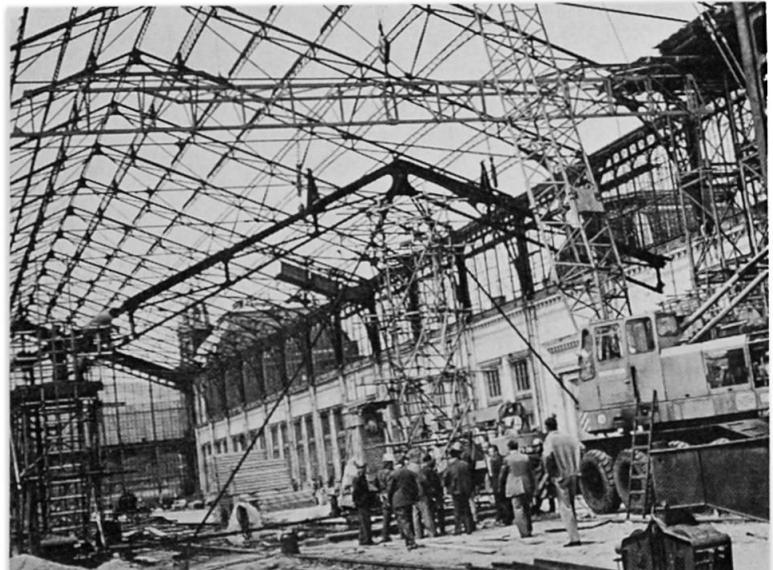
8. The demolition of a trussing

The demolition started at the exit side with the curtain wall, for this ascafolding was built on which the demolished structure was cut into transportable pieces. The demolition of the trussing was carried-out with the help of a rocker device that was fixed to the structure, and after the trusses were cut at the boundary line of the remaining frame corners they were lowered by an autocrane to the floor.

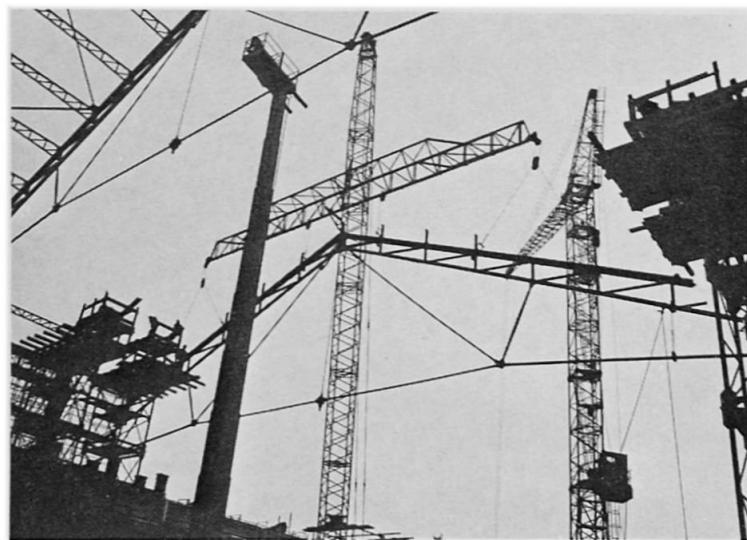
9. The lifting in of a new trussing

The new trussing part was assembled on the ground in the vertical position and the tension bars were adjusted in this position. With the help of the rocker device, the trussing

was lifted-in between the two corners. The tension bar was connected and the trussing was placed into its final position by further lifting to allow the connection of the trussing onto the corner parts with the plates. Afterwards the purlins and the windbraces were lifted-in. During the erection of the steel structure of the end wall for the exit side the 42 m long bridge, manufactured in three pieces was lifted in by three cranes simultaneously. The connections were made in the air, then the bridge was lowered onto its supports. The reconstruction of the roof boarding was made according to its original shape and over the boarding one layer of roof-plate water-proofing was placed finally on its top a zinc sheet covering was laid.

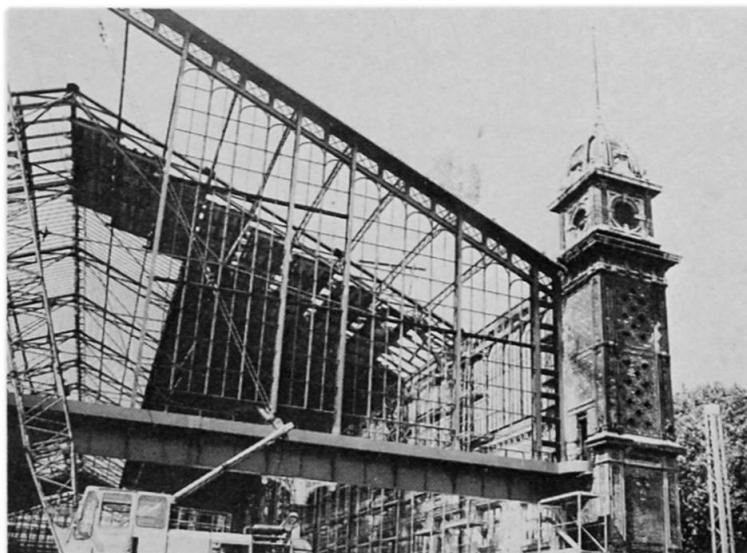
10. Erection of the new curtain wall

The new curtain wall was constructed as a closed frame-structure by building into a new vertical Vierendel-truss on each edge.
